Richford Streetscape Audit Summary: 6/13/2022

Richford Streetscape Audit Points of Interest

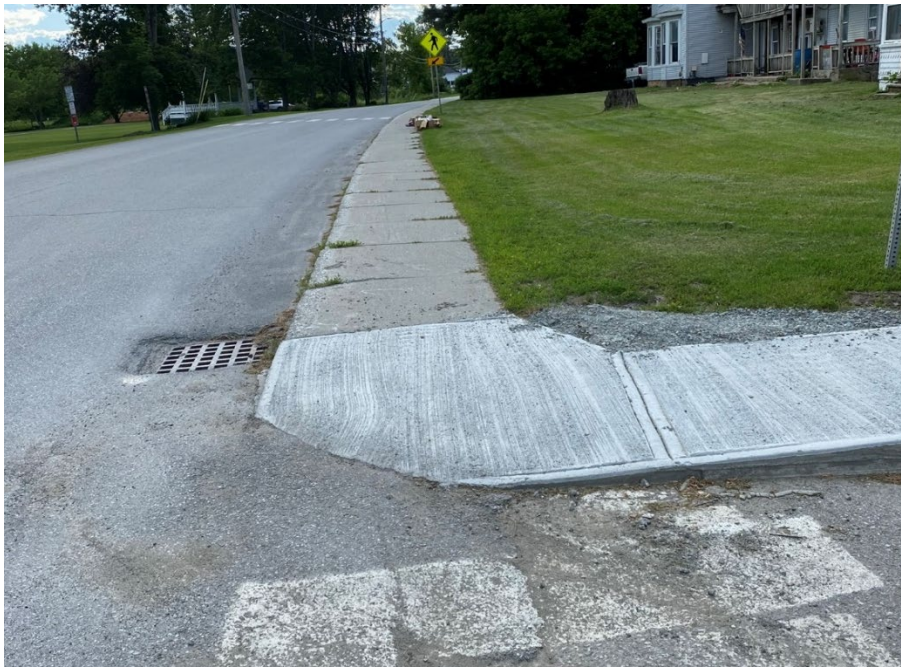
B: The curb cut at the intersection of River Street and North Avenue does not meet ADA standards. While it is newly paved with a curb ramp, there is no tactile ground surface indicator and it is dangerously angled out towards River Street, rather than crossing North Avenue.

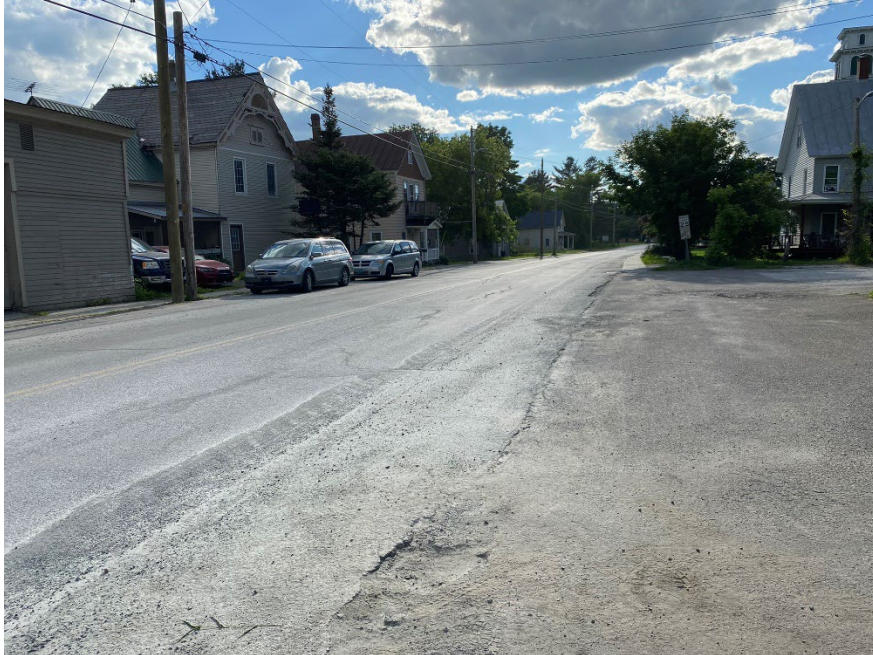
C: The municipal parking lot creates a large open area with no sidewalk or crosswalk. Access management should be considered. This parking lot may see increased future use, as the Town is considering allowing it to be used for residential parking in lieu of on-lot parking spaces for future developments.

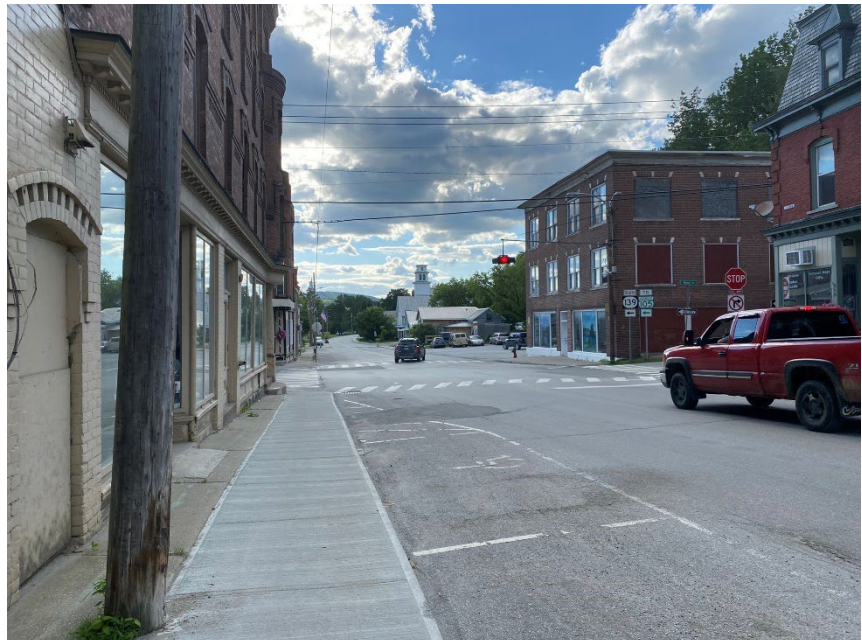
D: The sharp corner and narrow street with on-street parking on the intersection of River and Main Street is a safety concern. Tractor-trailer trucks often end up on the sidewalk while turning.

D: The sharp corner and narrow street with on-street parking at the intersection of River and Main Street is a safety concern. Tractor-trailer trucks often end up on the sidewalk while turning.

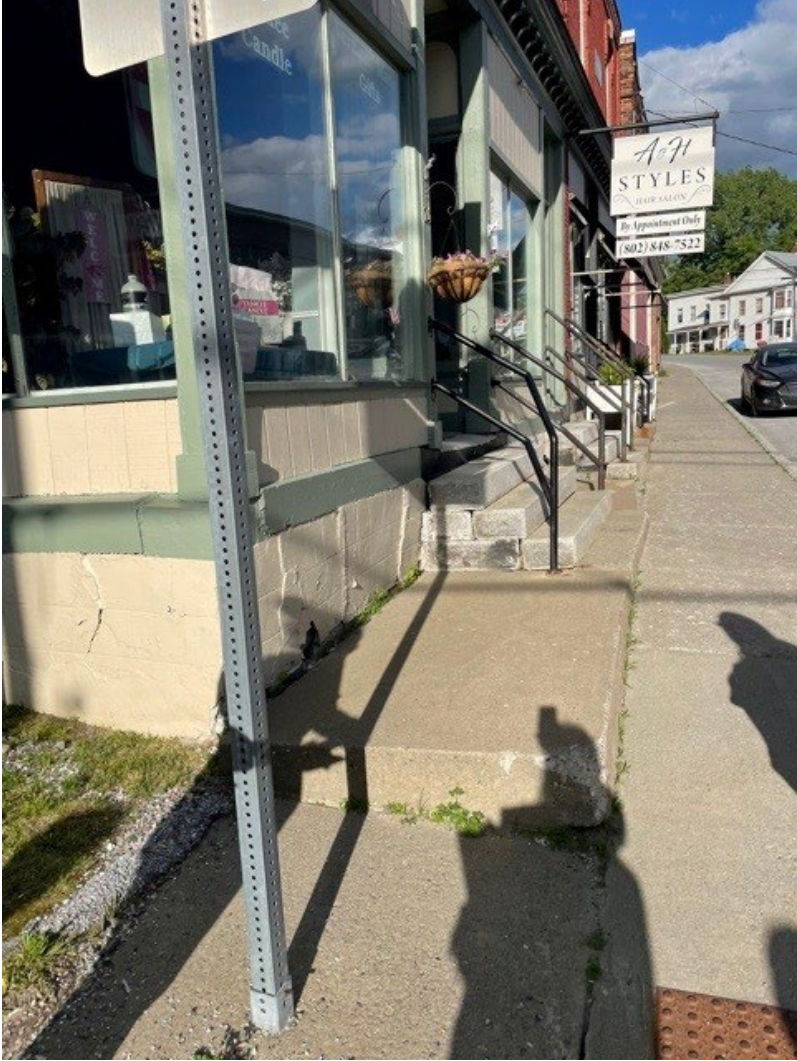
E: Buildings on this section of River & Province Street are raised above street level and all require one or more step to enter, making them not accessible. There was a discussion about the possibility of raising sidewalks in this section of street, which would allow better access to the buildings for those with disabilities.

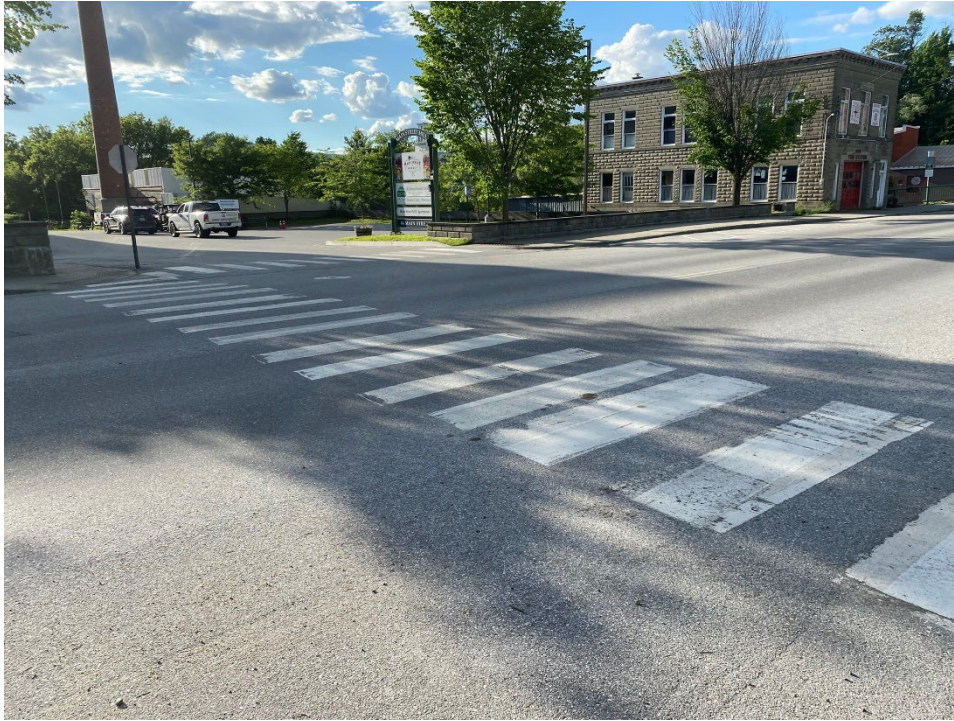
G: The crosswalk across Main Street to Main Street Mill is very long, making it challenging to cross.

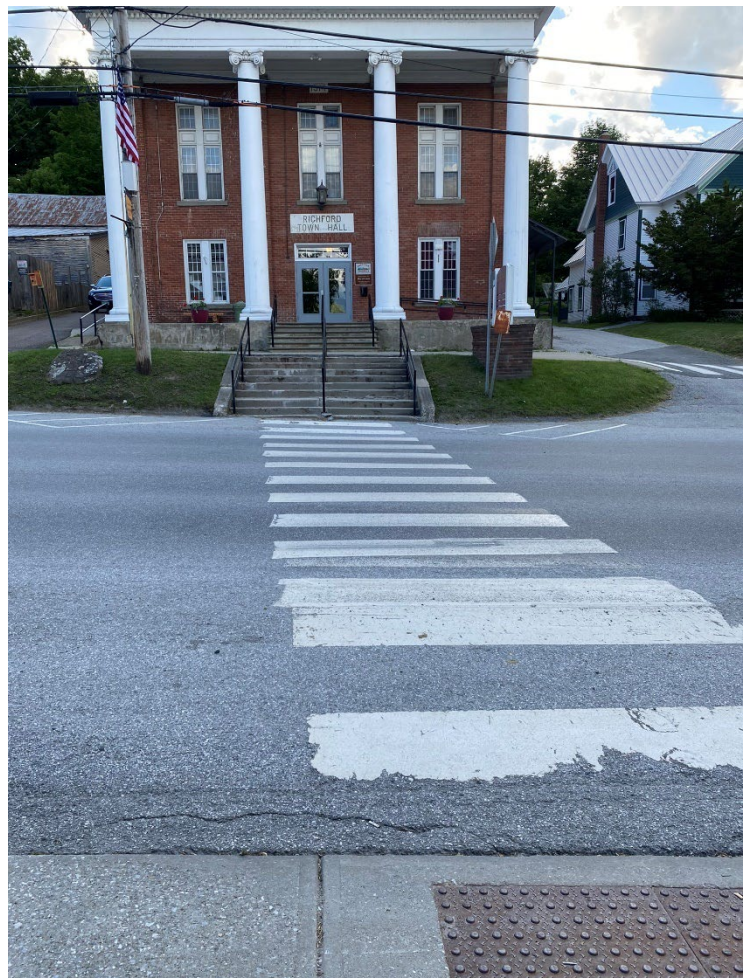
H: The crosswalk from Town Hall across Main Street is long. Getting onto the crosswalk on the Town Hall side requires using stairs, so it is not accessible to all. There is no separation between the bottom stair and the start of the road, which creates a safety challenge.

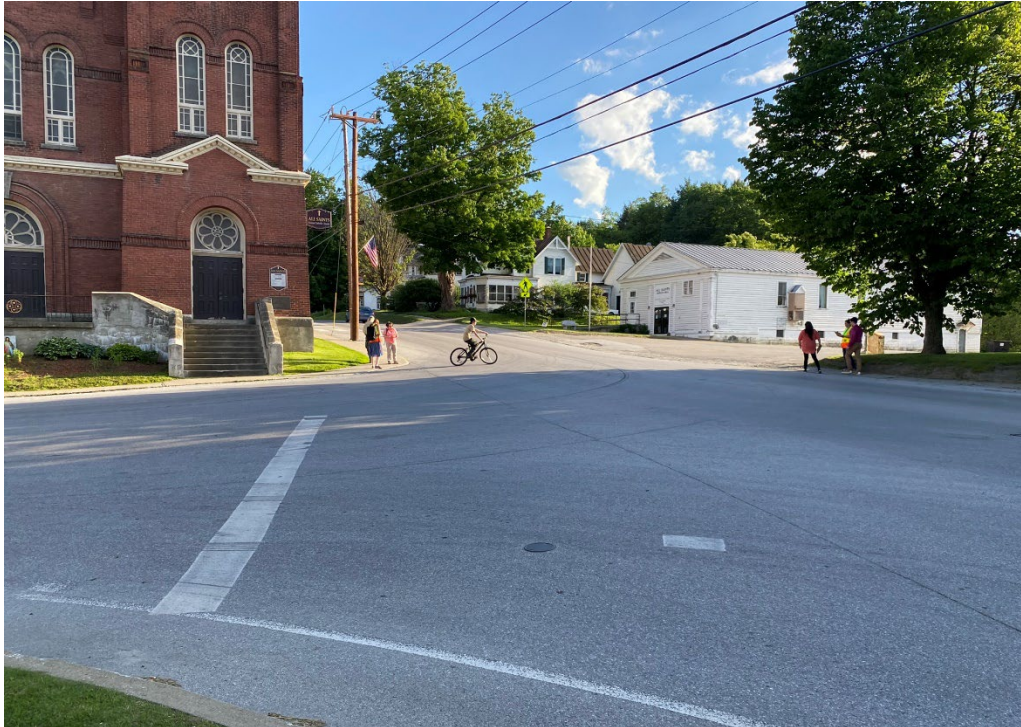
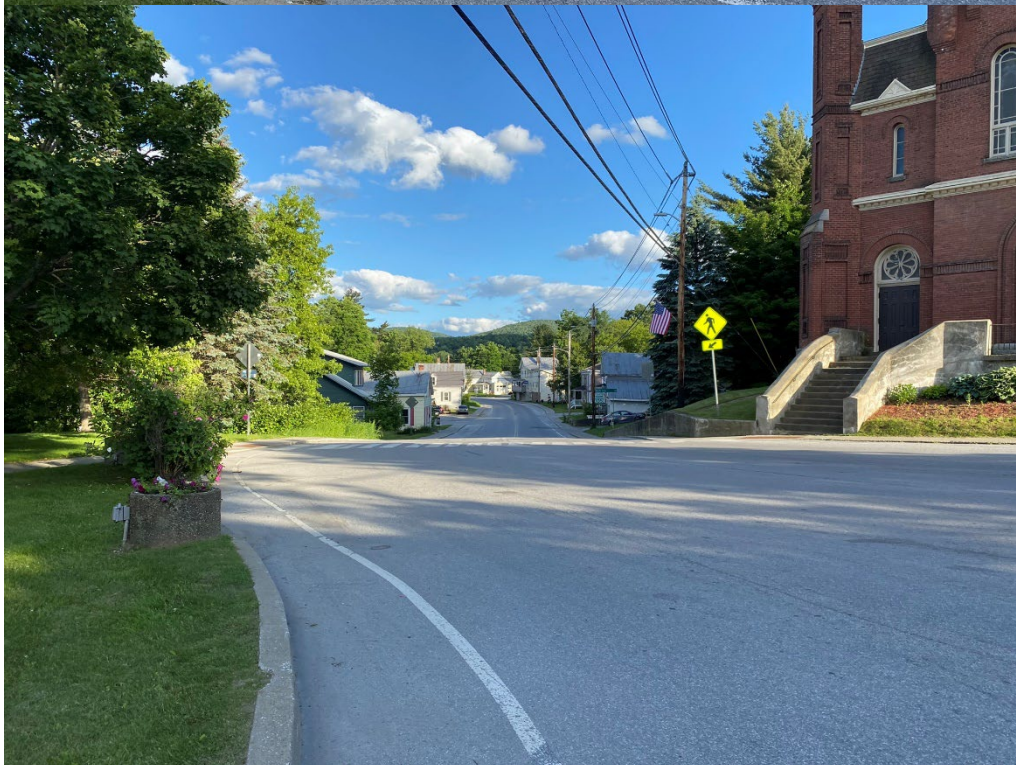
I: The crosswalk across Troy Street requires going across Memorial Park, and does not follow Main Street. Many people will not use the crosswalk if their destination is on Main Street. Instead, they will cross closer to the intersection with Main Street where this is no crosswalk and it is a very wide crossing. Auditors discussed adding a pedestrian island in this area.

I: The crosswalk across Troy Street requires going across Memorial Park and does not follow Main Street. Many people will not use the crossing if their destination is on Main Street. Instead, they will cross closer to the intersection with Main Street where this is no crosswalk and it is a very wide crossing. Auditors discussed adding a pedestrian island in this area.

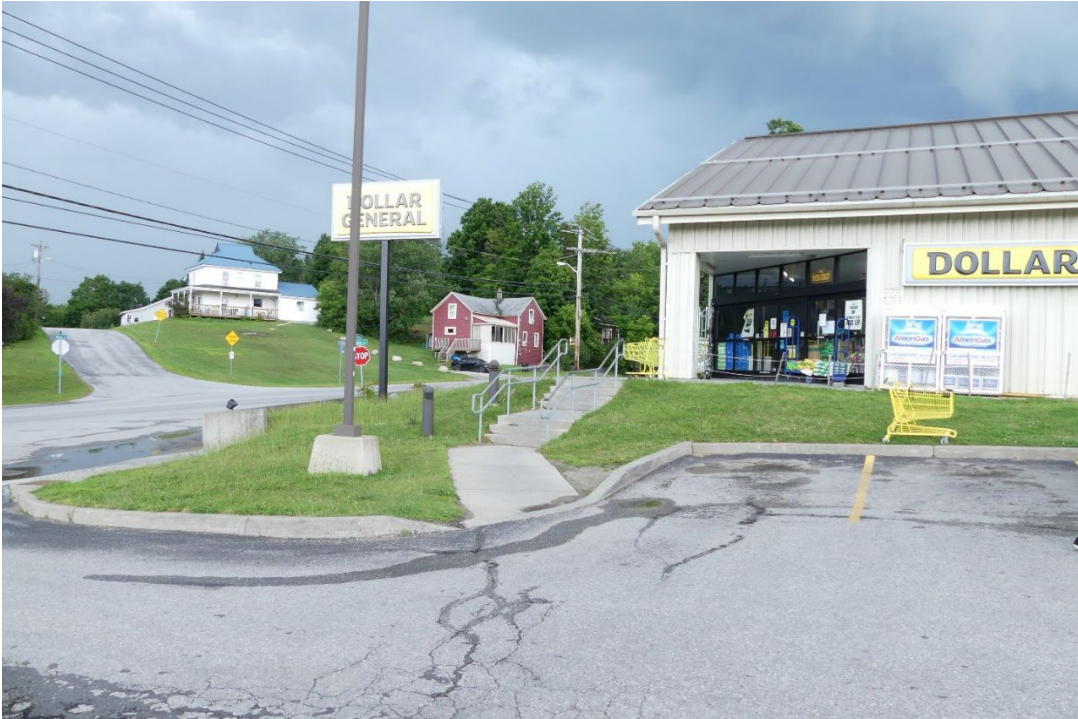
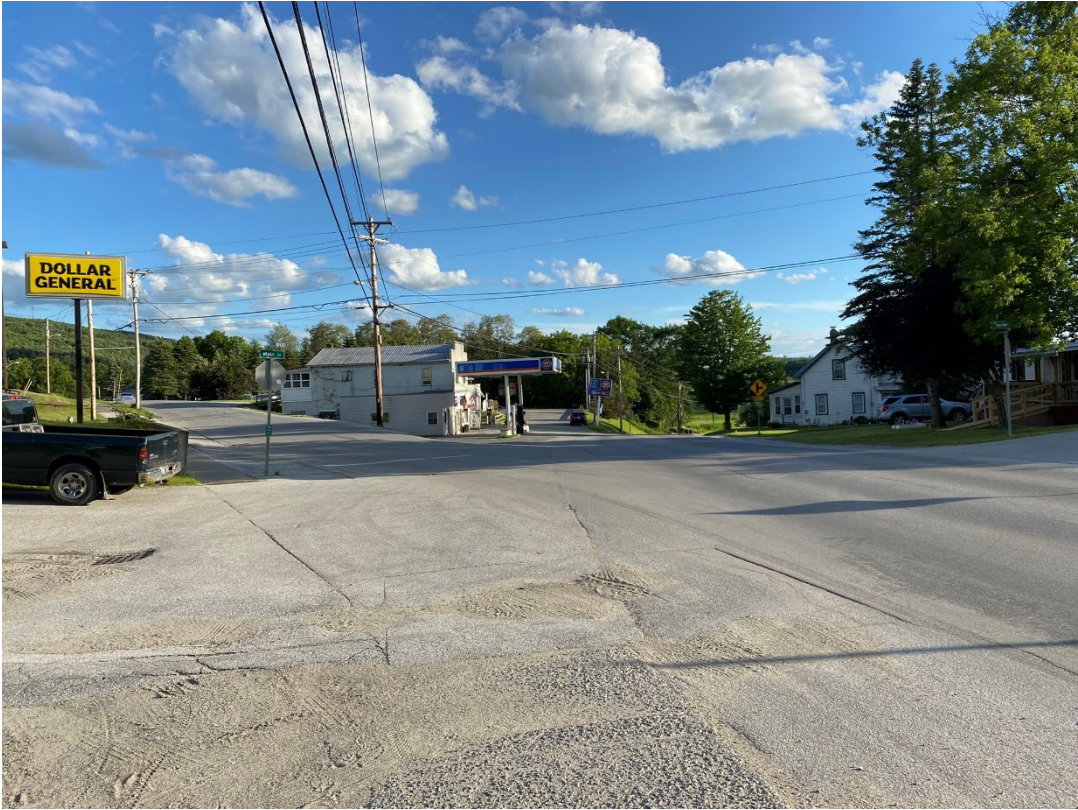
K: The intersection by Dollar General is generally unsafe due to traffic moving at high speeds, and the sidewalk ending at Dollar General. There is no crosswalk for residents on the west side of Main Street to cross towards Dollar General.

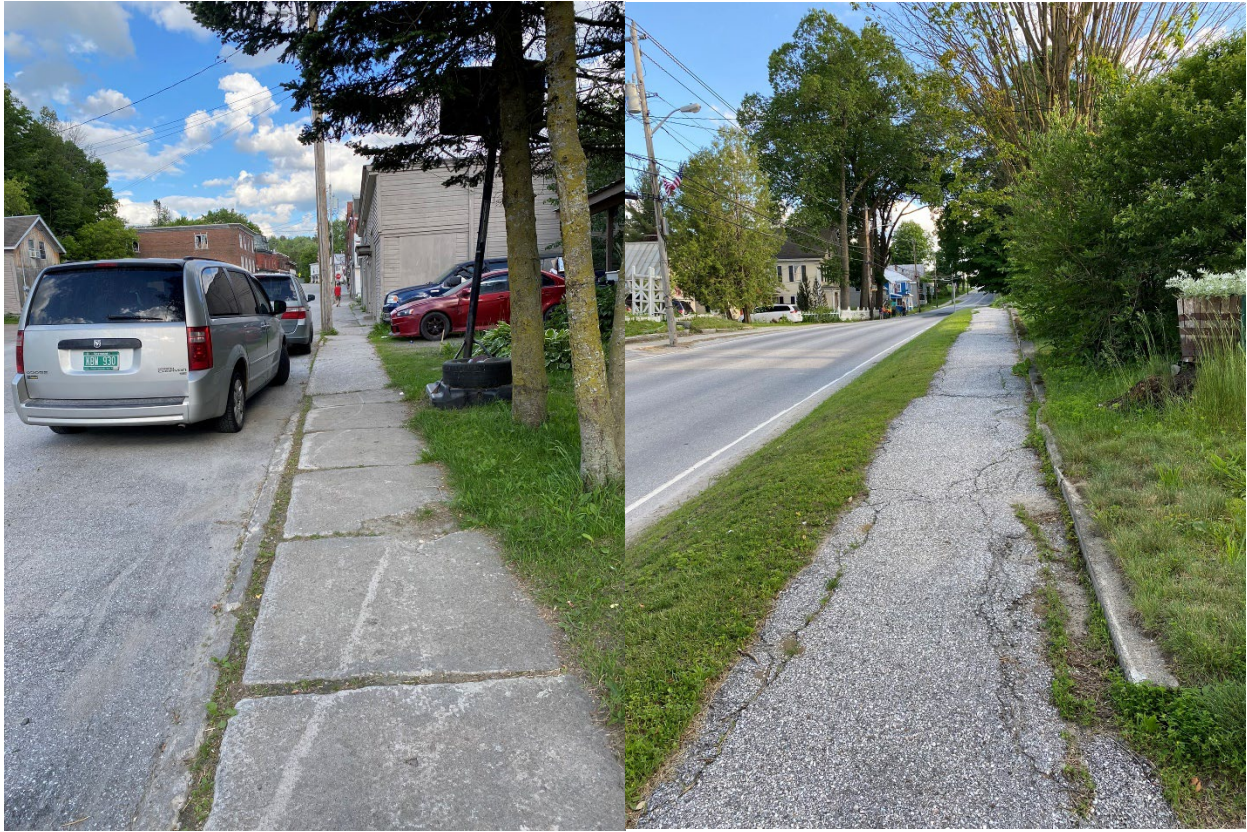
L: There are many sections of sidewalk that are in poor condition creating a hazard for pedestrians.²

L: : There are many sections of sidewalk that are in poor condition creating a hazard for pedestrians.
