US Route 7 / VT 104A Intersection and VT104A Bridge No. B1 over Arrow head Mountain Lake

In the Town of Georgia, Vermont

Table of Contents

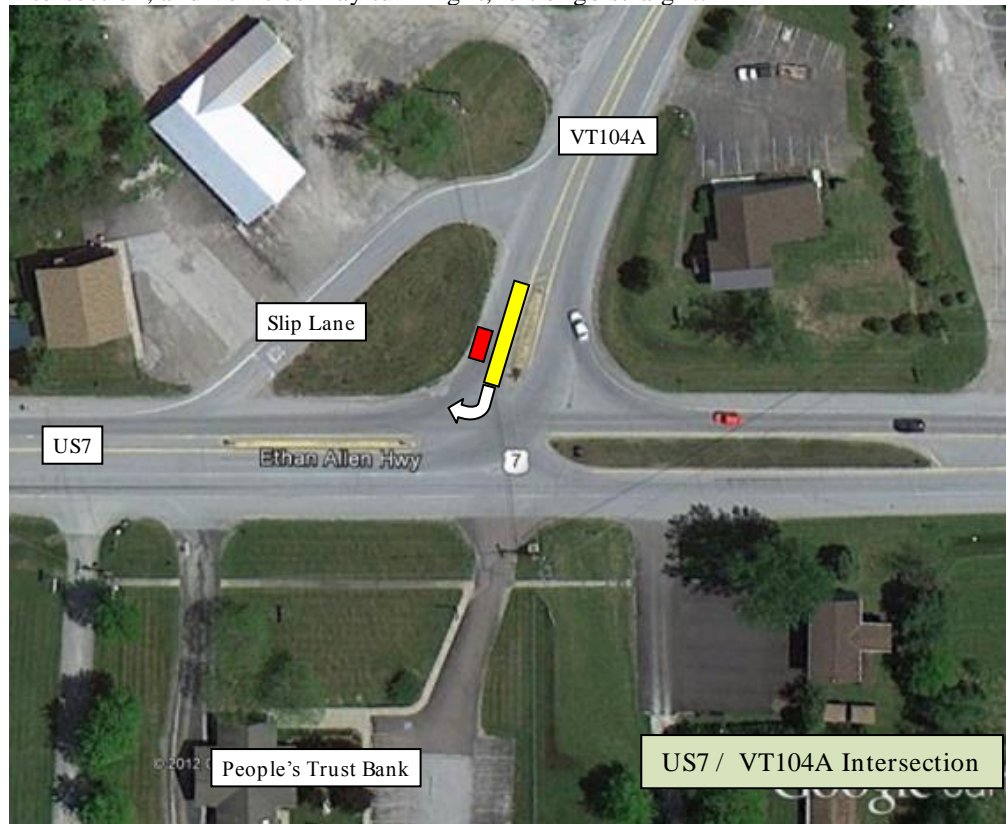
It is important to note that the westbound VT104A approach is striped as one lane, however vehicles are frequently observed forming a left and a right (and/ or a through) lane. In addition, right turning trucks are observed starting the right turn from the left side of the approach in an effort to make the right turn without the rear wheels off-tracking into the grass. This is problematic when right turning automobiles move up beside the trucks unaware that the trucks will turn right. This has resulted in crashes since the truck drivers (in yellow above) do not expect the

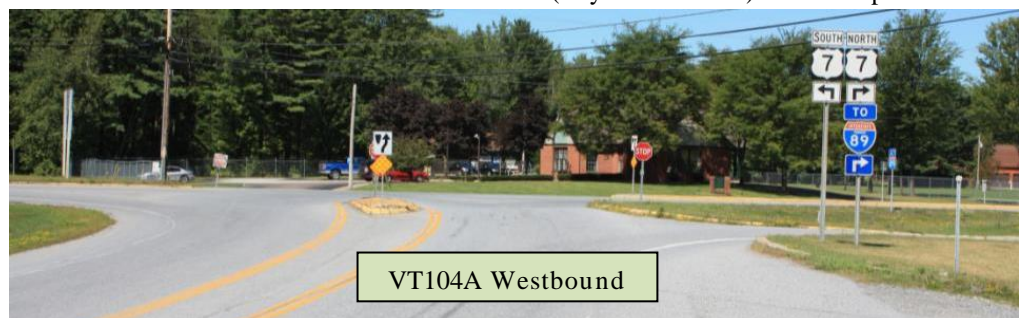
The VT104A westbound to US7 northbound slip lane is a minor concern because some motorists use it to avoid delays at the stop sign at US7. This slip lane is meant to provide access to the adjacent businesses, but it also introduces some confusion for

motorists uncertain about whether they should be using it to turn right onto US7. The re-entry point at US7 is at a very skewed angle and introduces a second potential point of conflict for vehicles on US7 in less than 100 feet. The below photo also shows that the placement of the exiting guide signs might suggest that motorists should use the slip lane to access US7, which is not the intent.

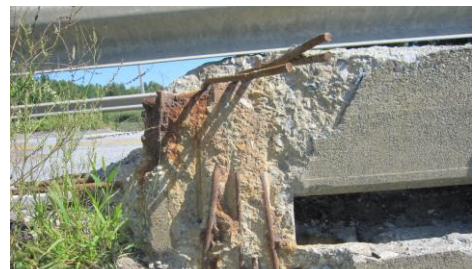
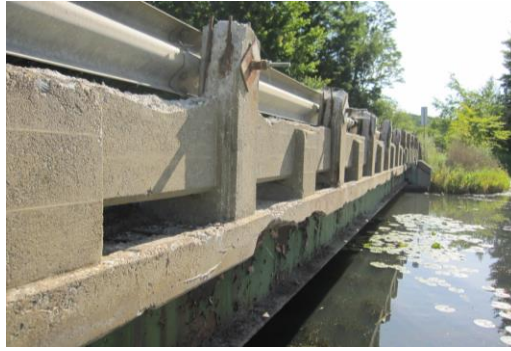
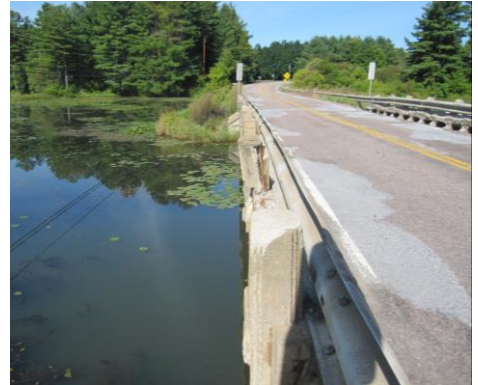
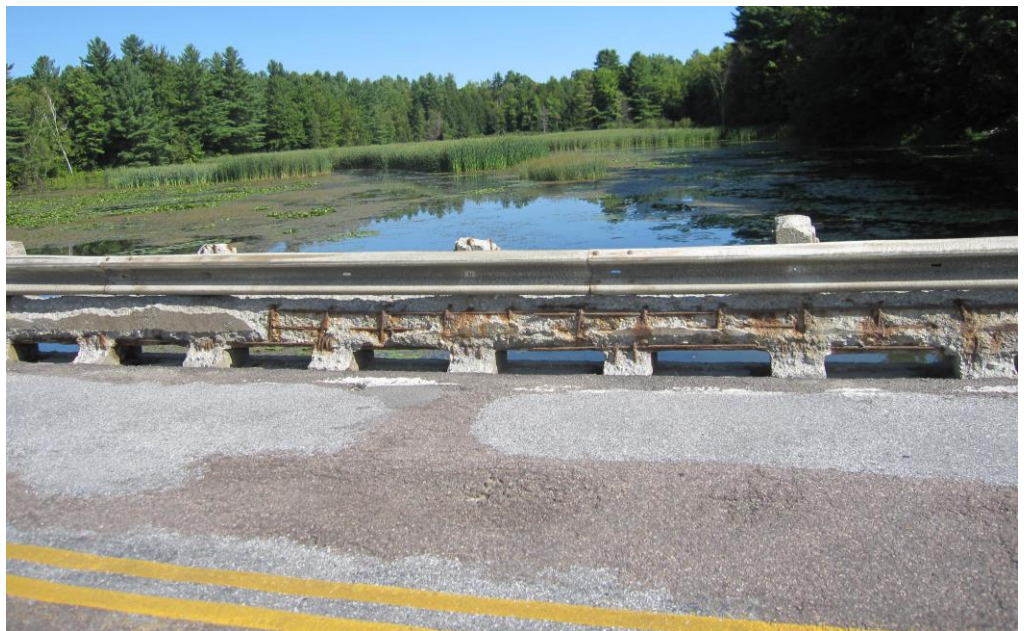
The existing bridge, built in 1937, is in satisfactory condition overall, but there is ongoing deterioration of the deck and rusting of the steel beams. The existing concrete guardrail posts are severely deteriorated and the steel beam guardrail has become detached from the posts in areas and is an immediate safety concern.

The latest VTrans bridge rating yielded a Sufficiency Rating of 72 (with a score of 100 being the best). This is not a poor enough rating for the bridge to be considered a priority by VTrans. The supporting steel members appear to be in fair condition; however the guardrail system is in poor condition and the deck appears to have areas of concern. The guardrail is of particular concern since it may not contain an errant vehicle on the narrow bridge. The existing concrete posts are in various stages of disrepair and in some locations the steel beam rails have become detached from the posts. The below photos illustrate some of the areas of concern.

The Alternative 2 – Widen Bridge and Causeway alternative is the recommended bridge improvement alternative. This is primarily because it addresses the primary deficiency, which is the bridge and causeway width, while maintaining the existing span length and therefore controlling costs.
