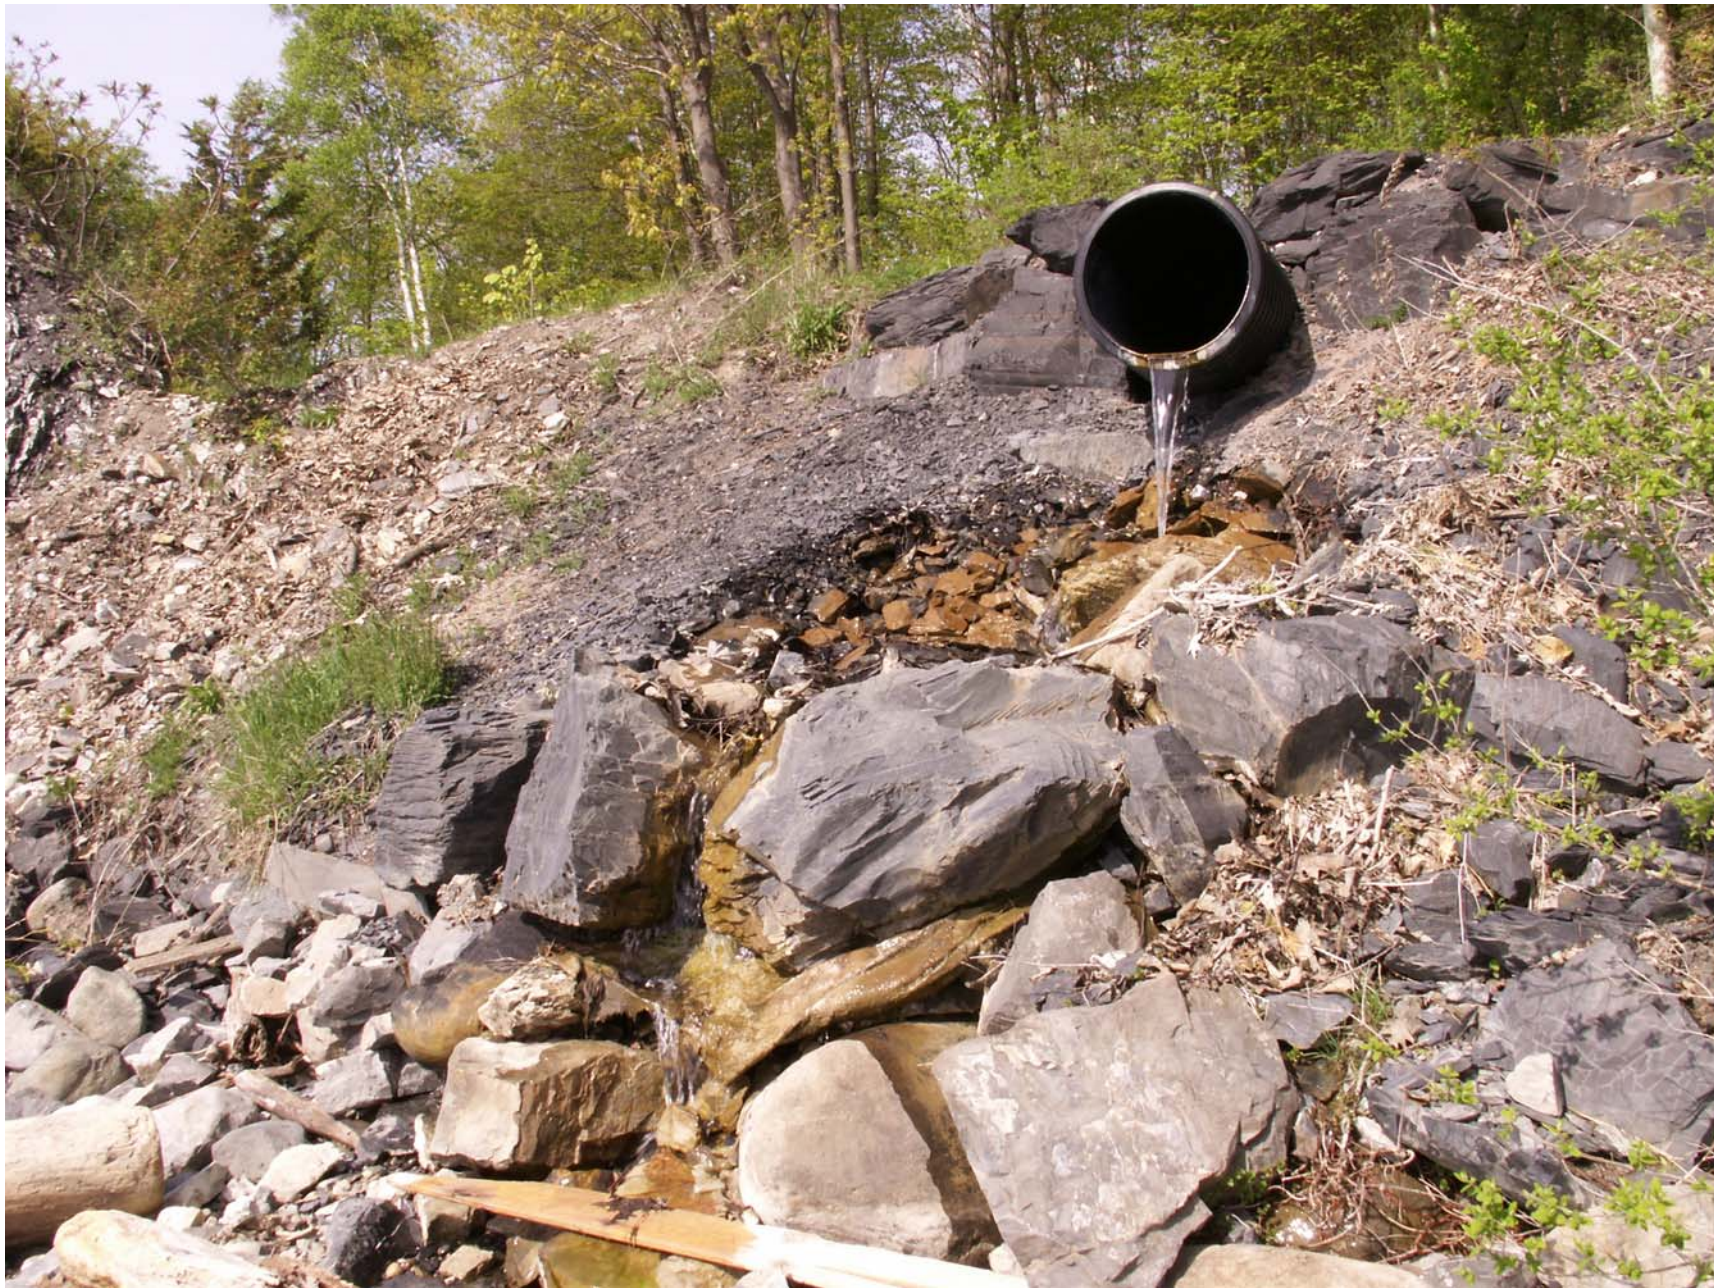
Perched culvert erodes the shoreline

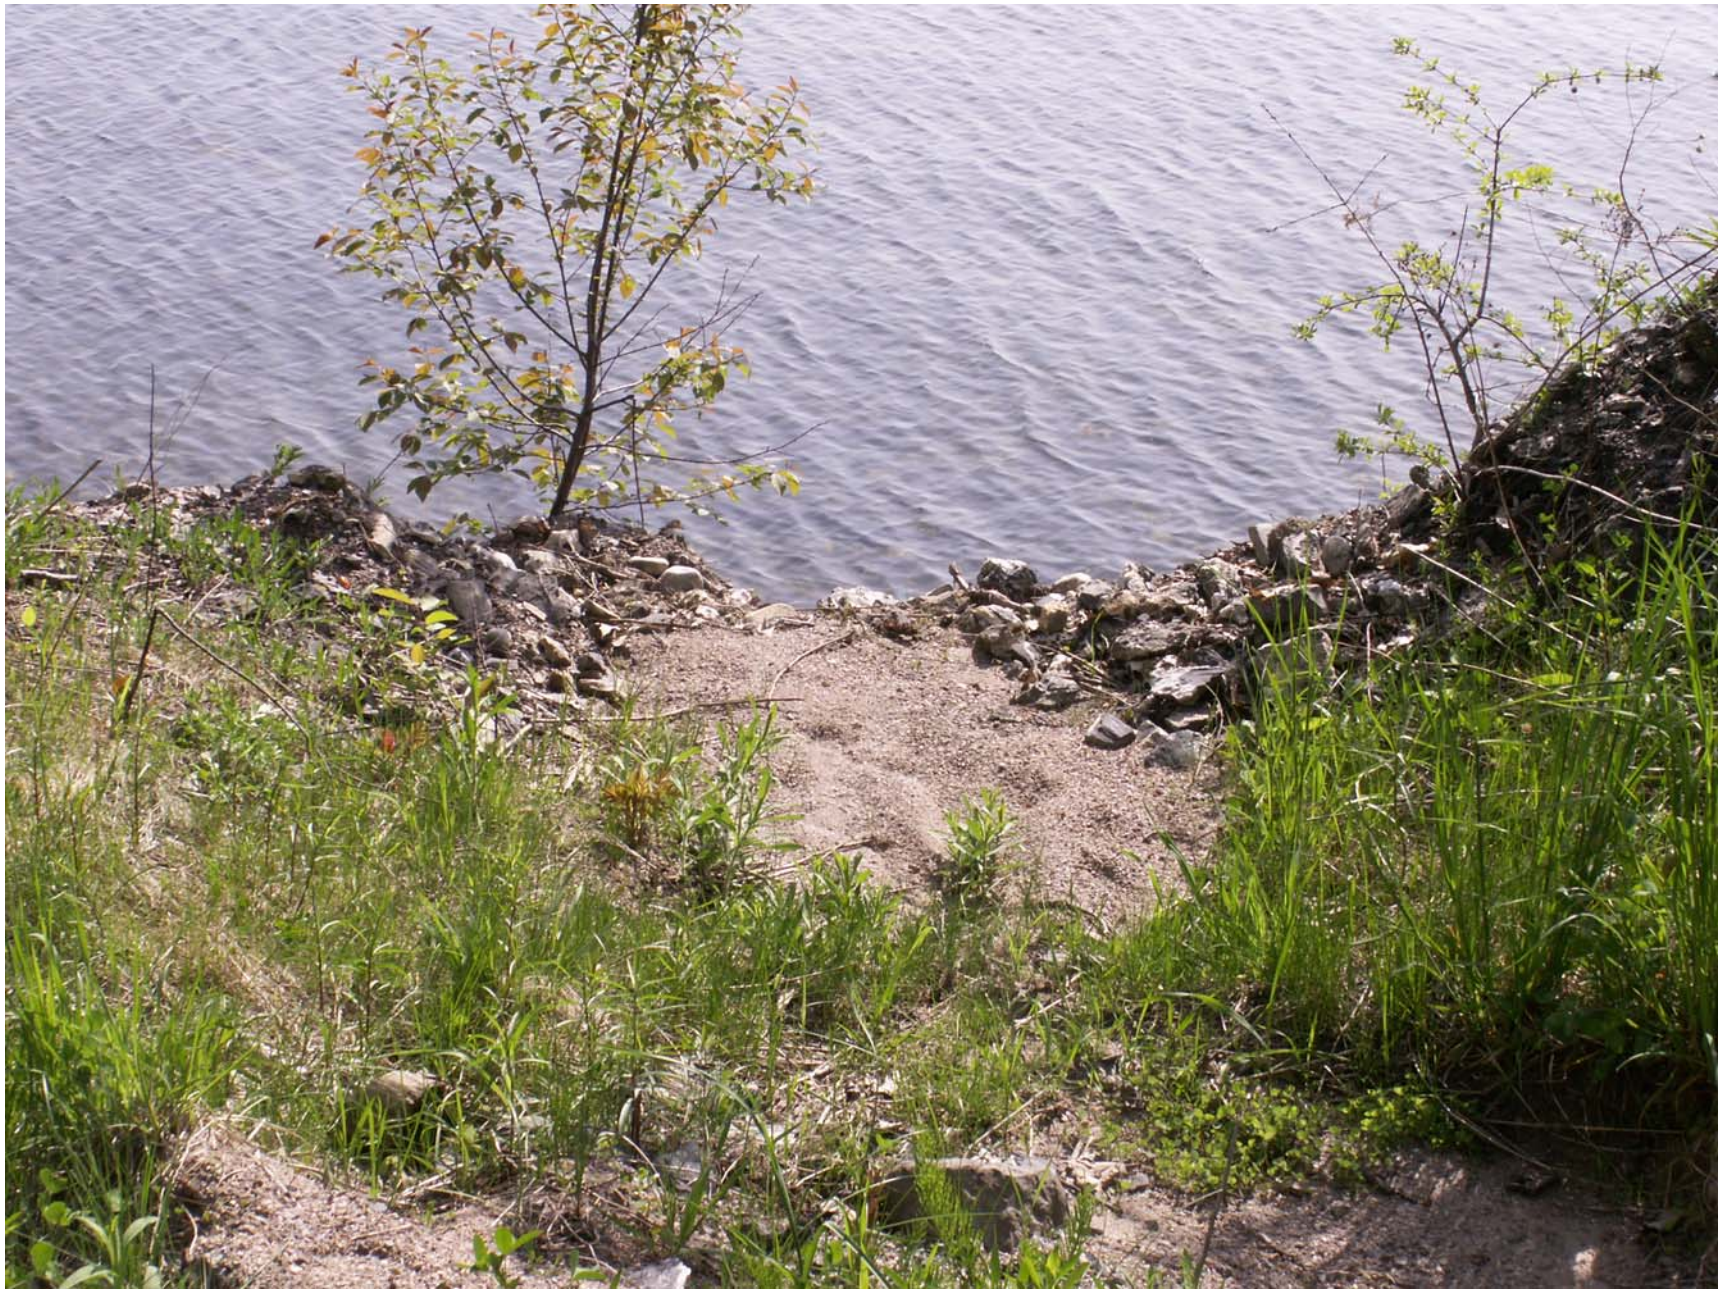
Rock fines at the road's edge indicate concentration point for stormwater runoff

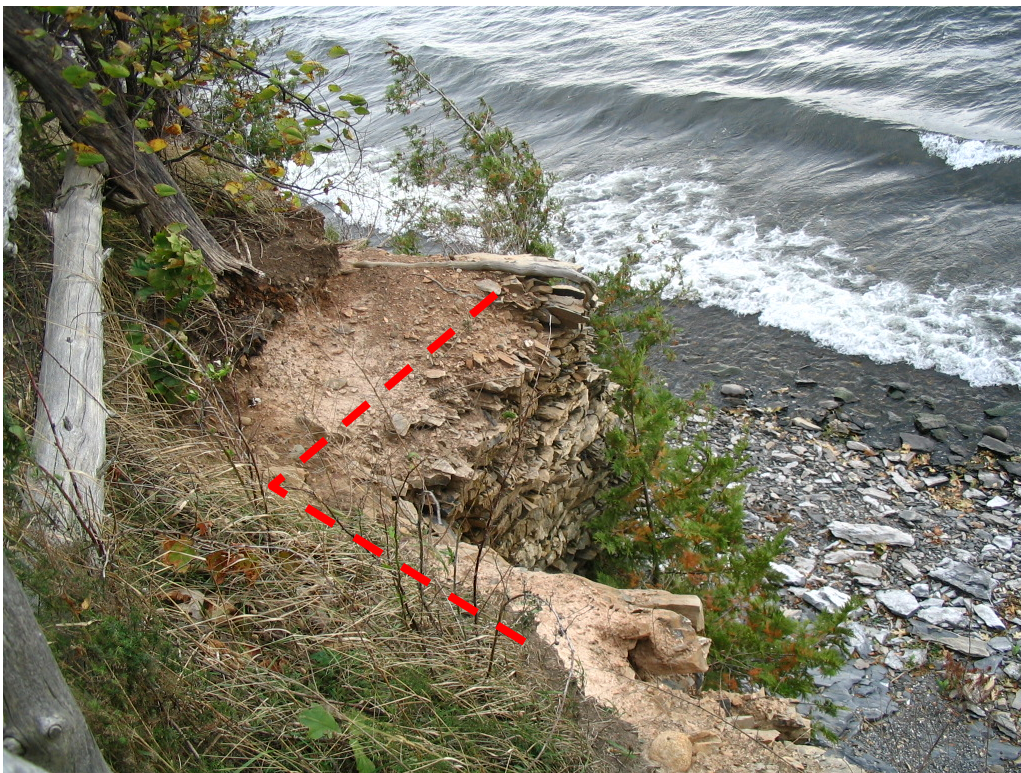
V-shaped notches in the shoreline
Indicate a concentration point for water

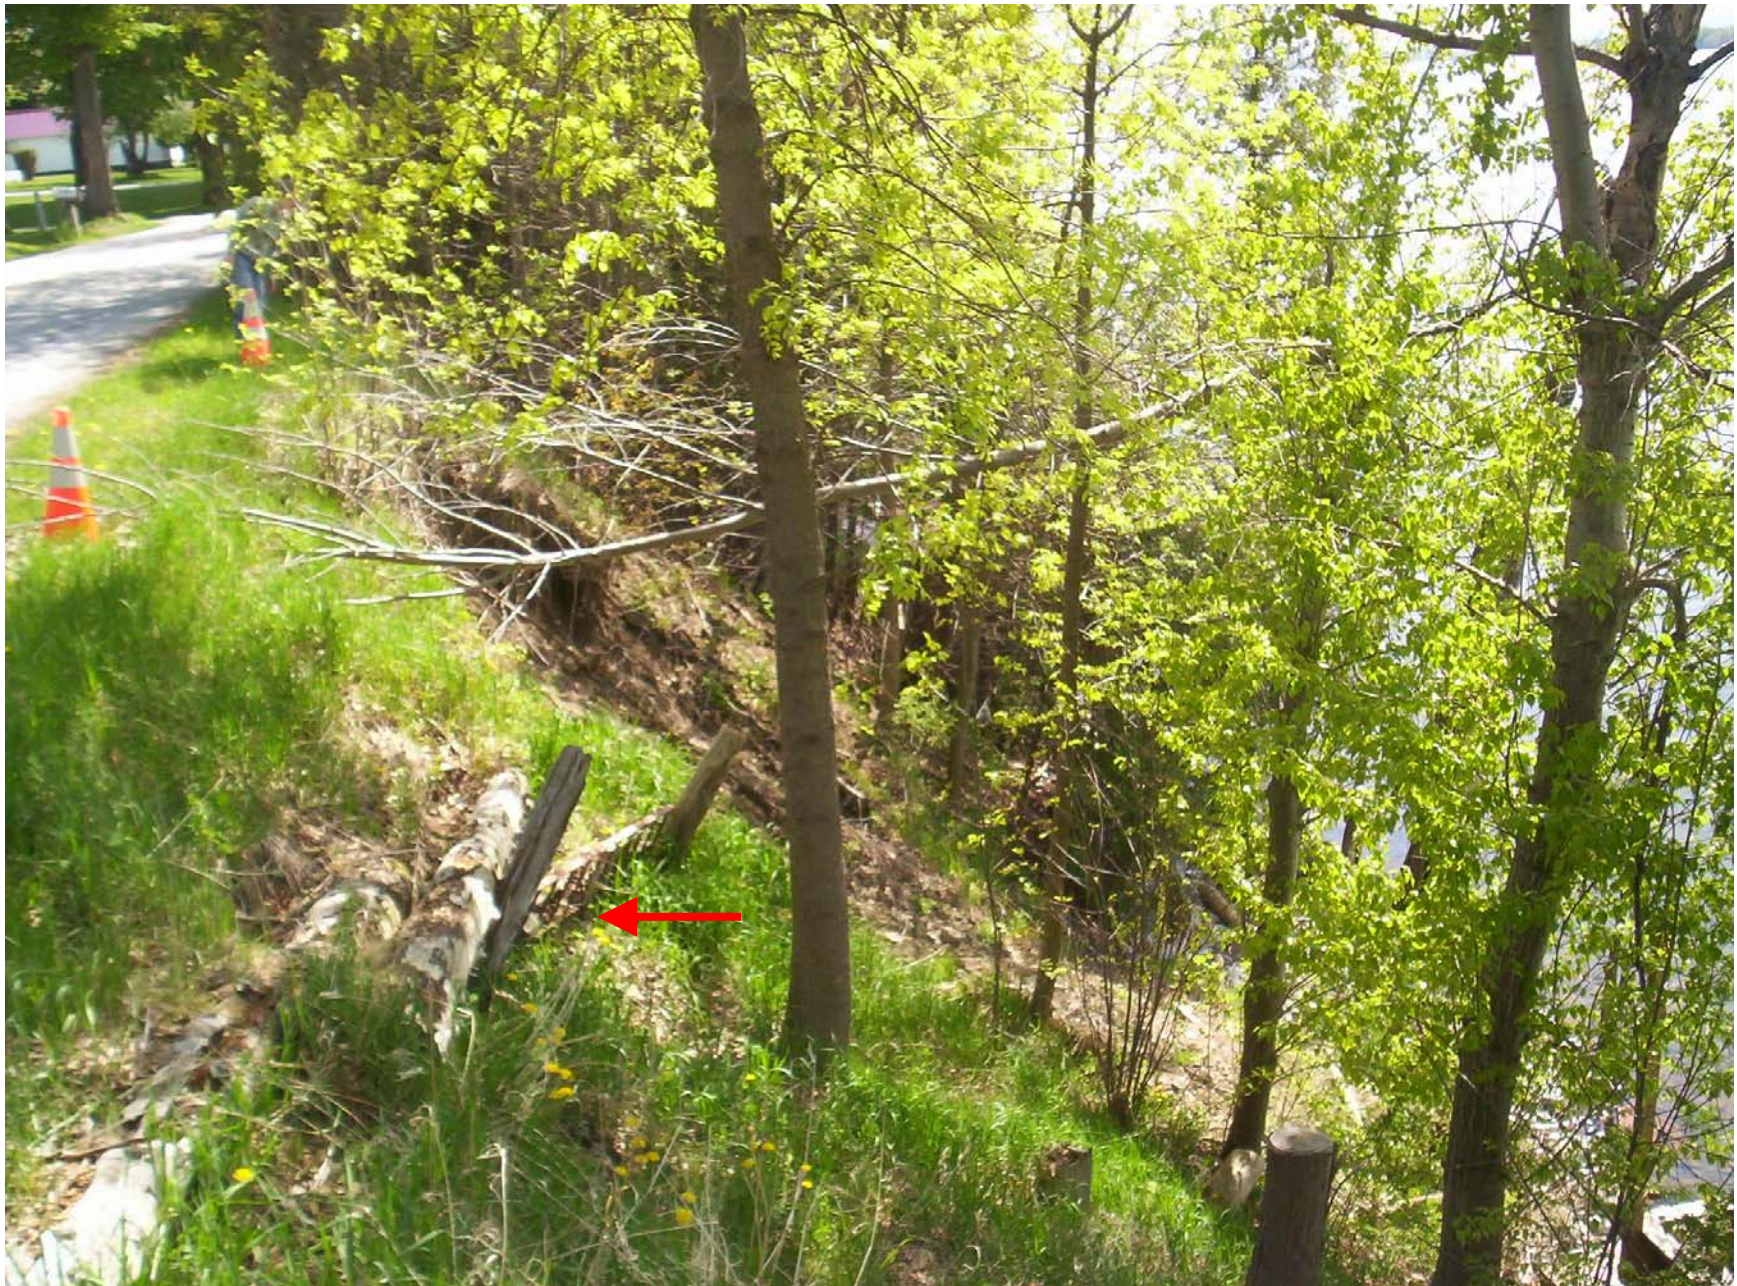
Soil creep is visible in the foreground where the stakes are no longer vertical

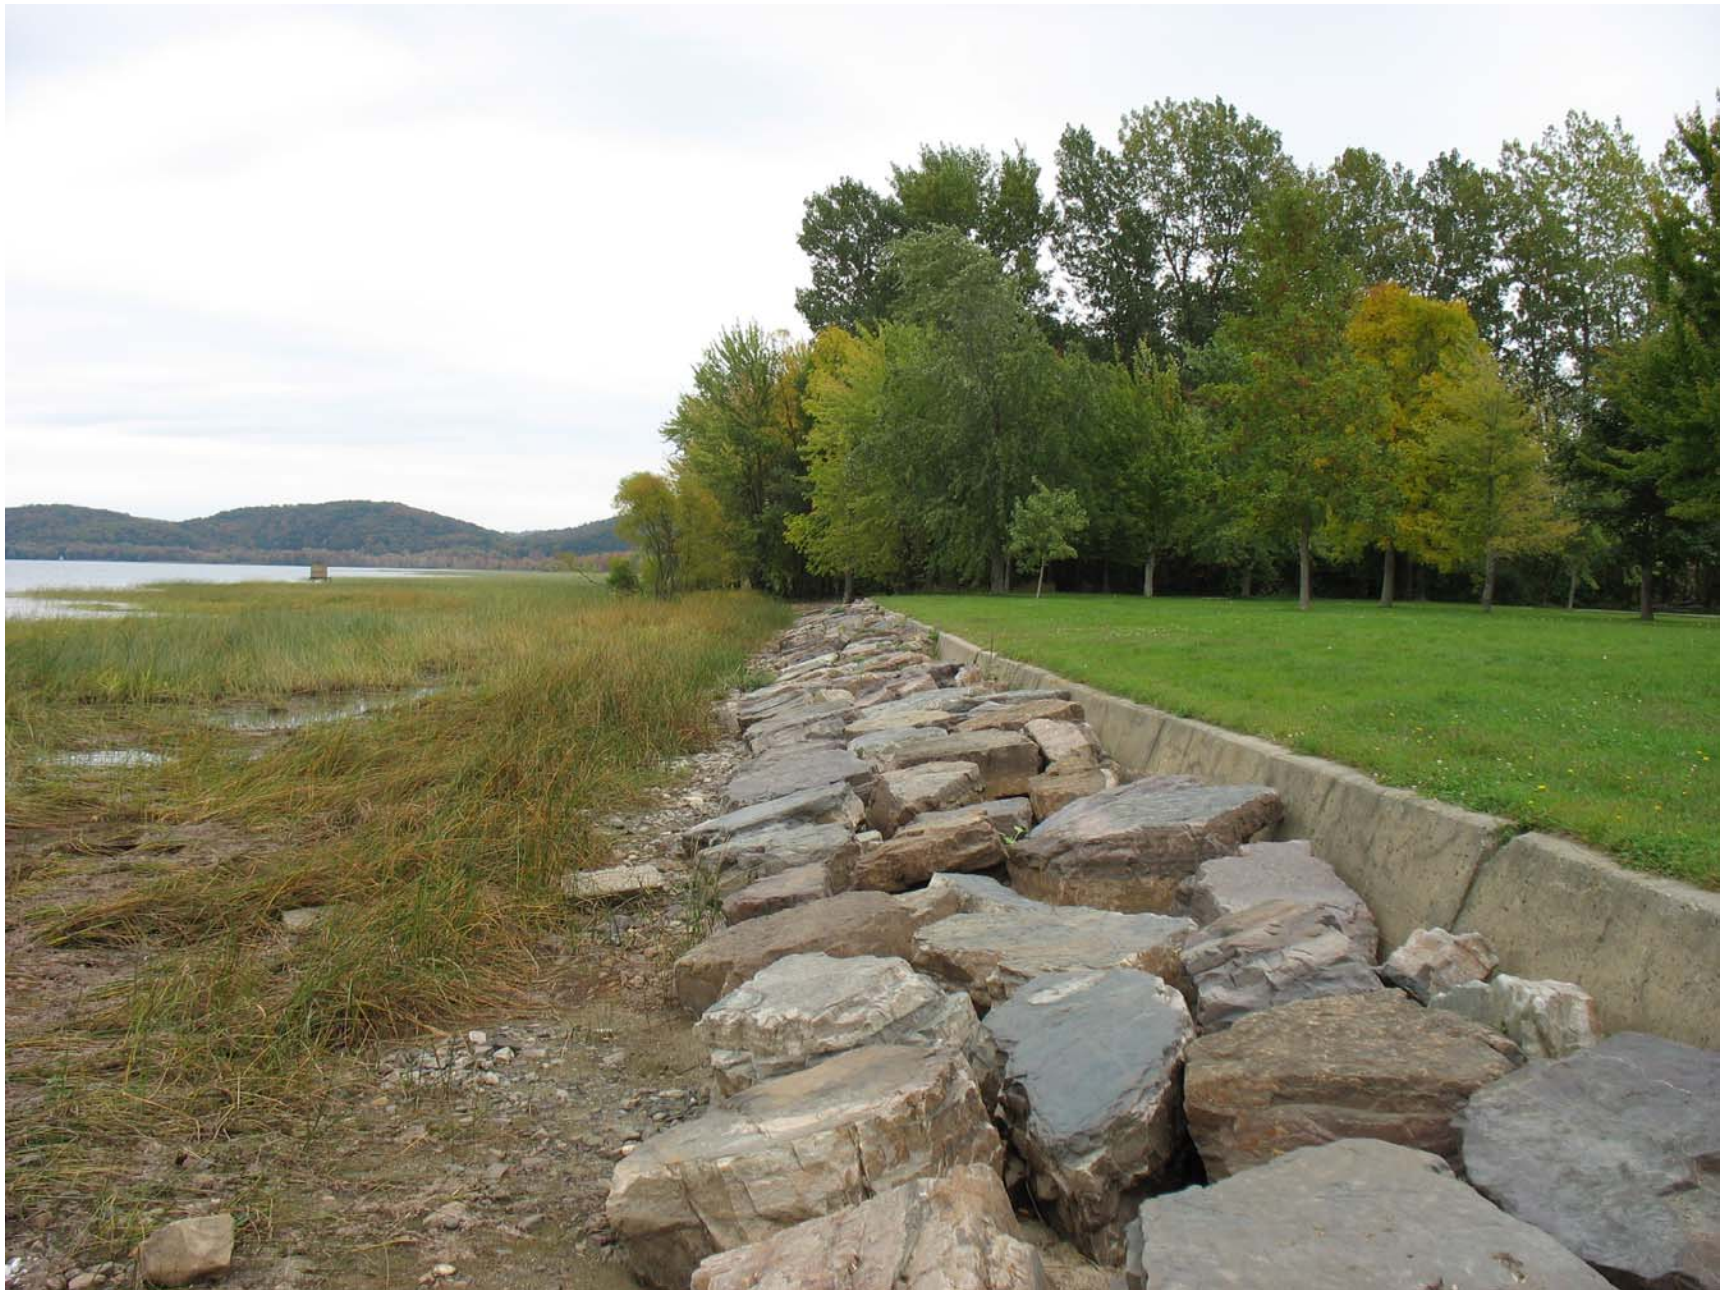
Adapting an existing concrete wall to accommodate ice push

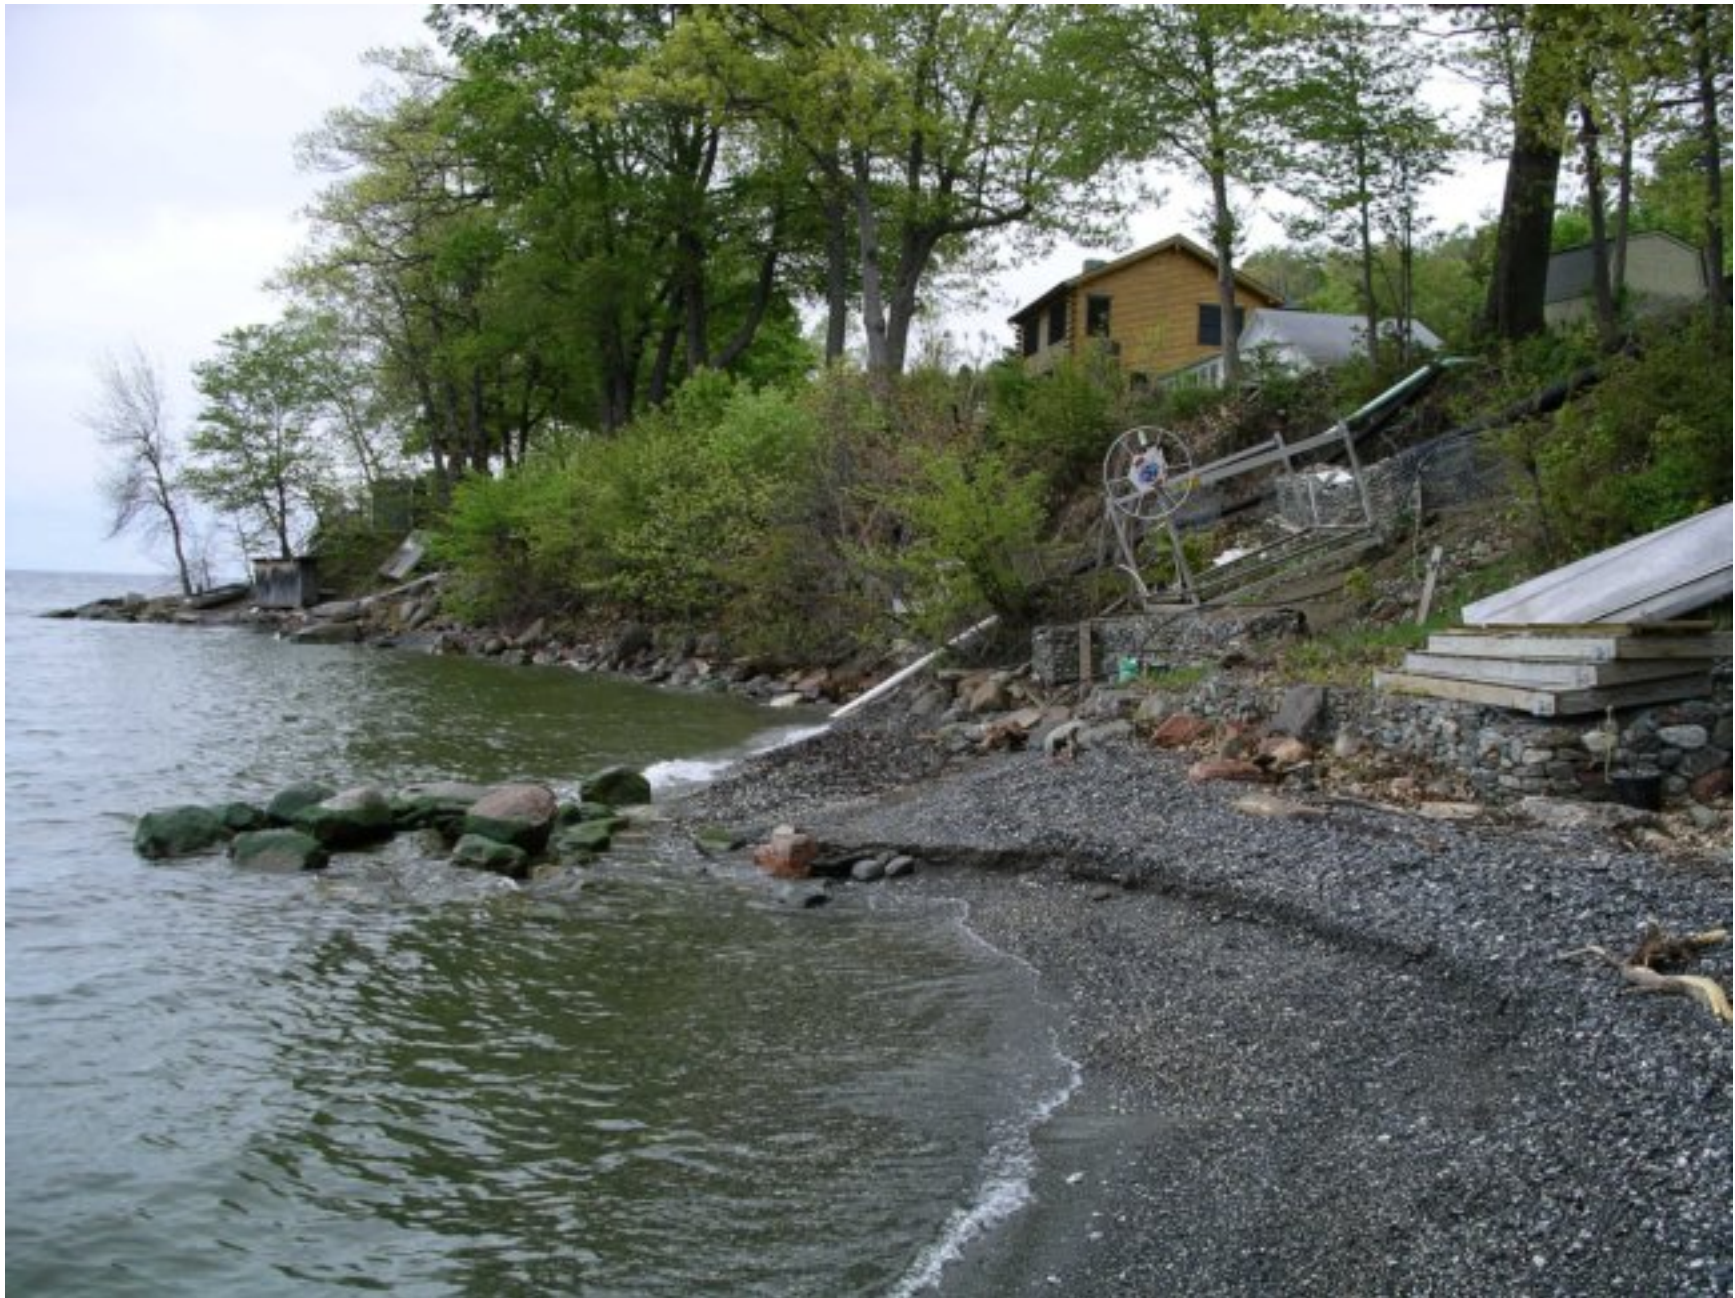
Rock jetty interrupting shoreline drift; notice erosion on this side of jetty

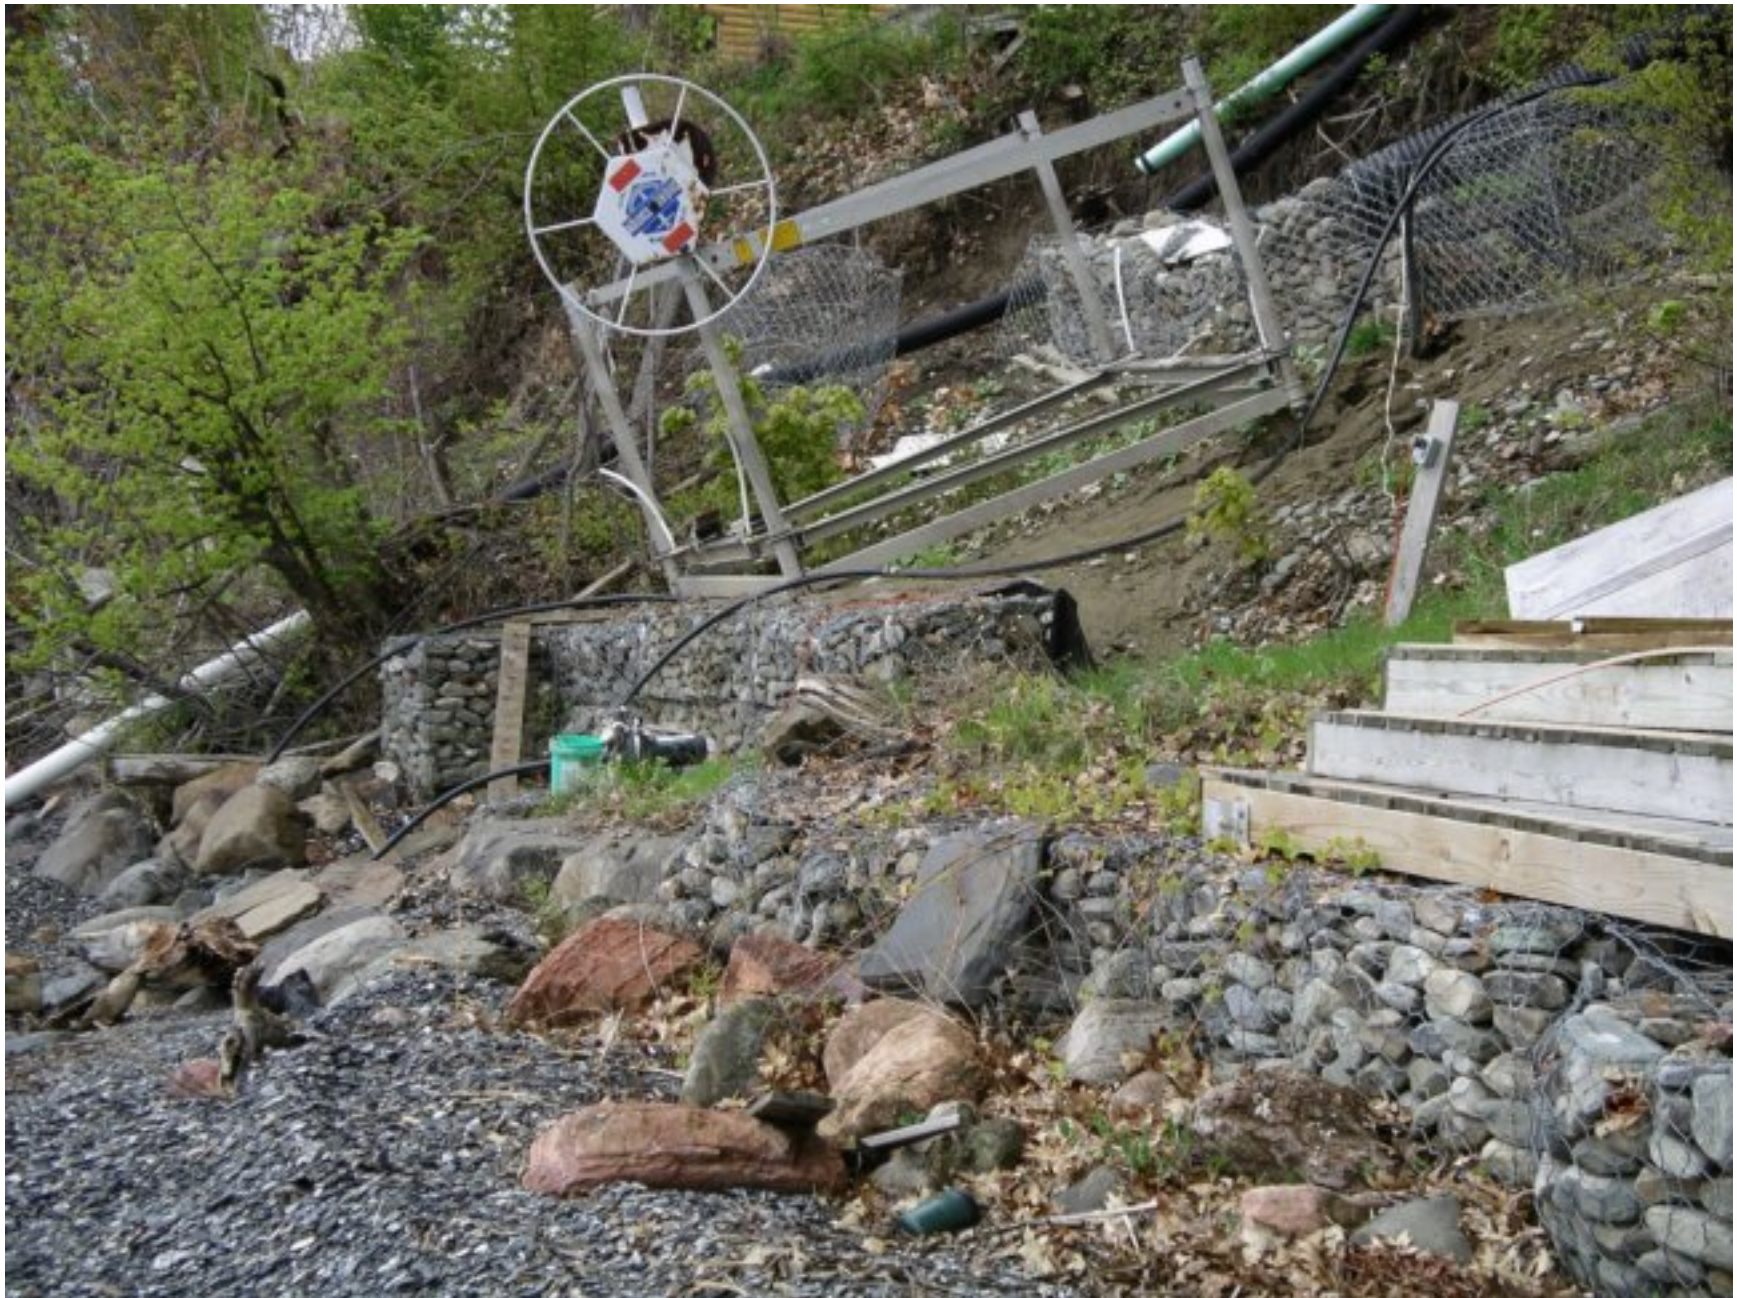
Successive attempts at erosion control. What is causing the erosion?

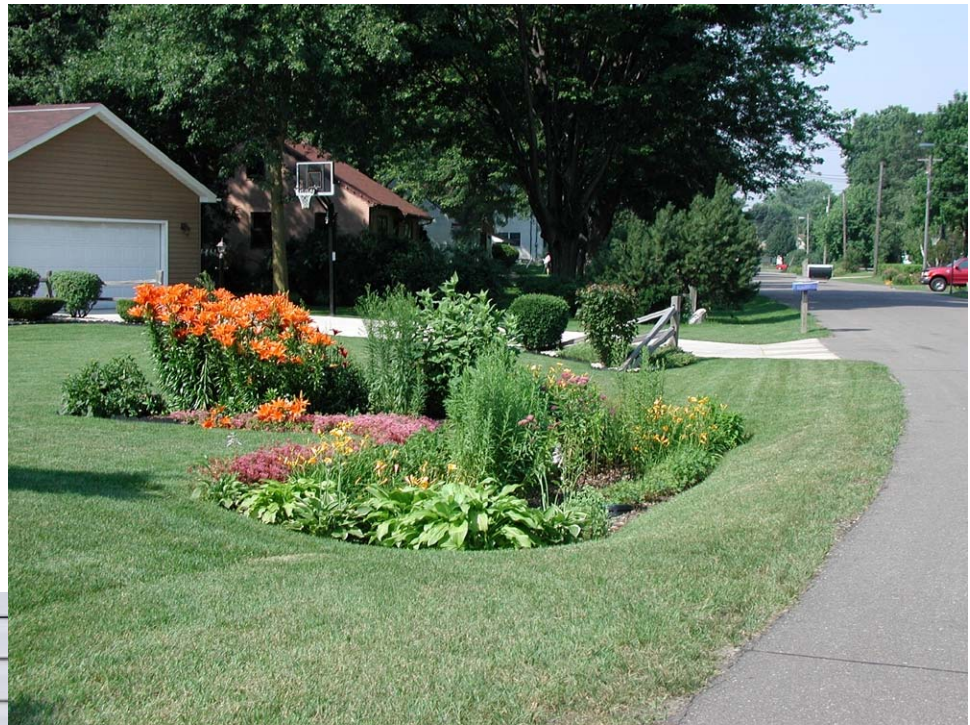
Residential rain garden

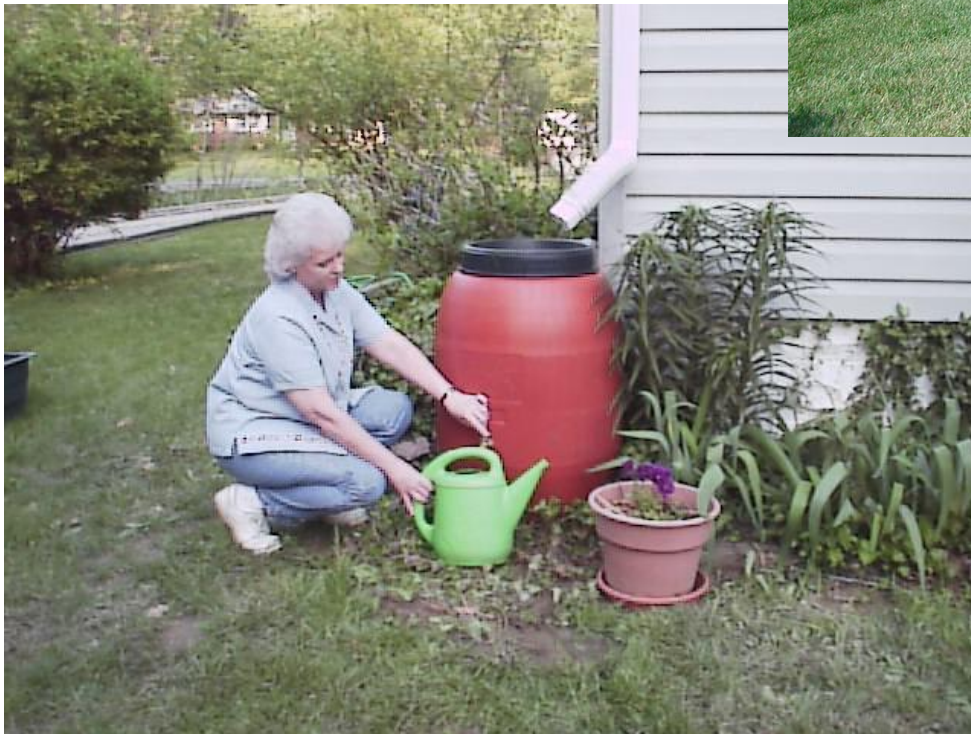
Rain barrels catch water from gutters for later use

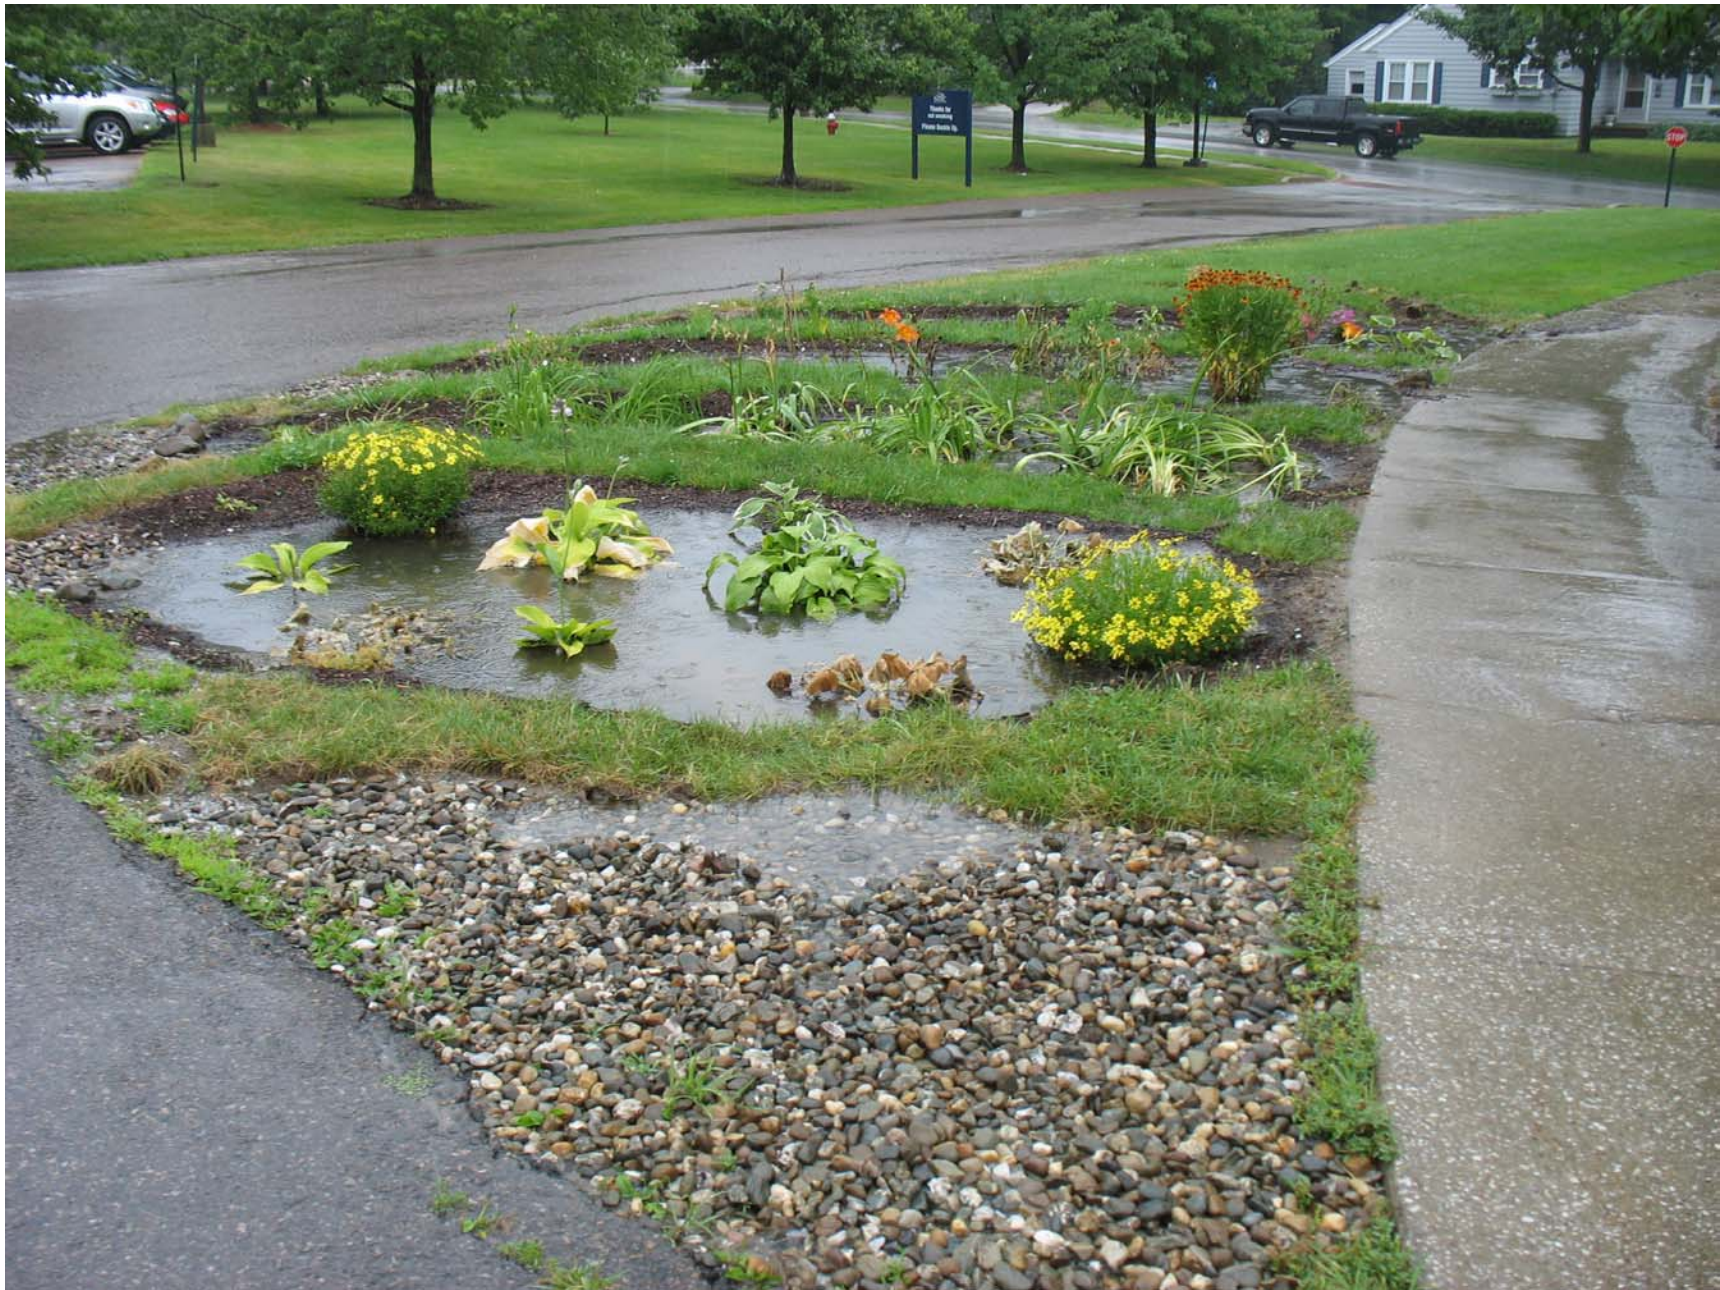
A newly planted rain garden at the Northwestern Medical Center holds rain

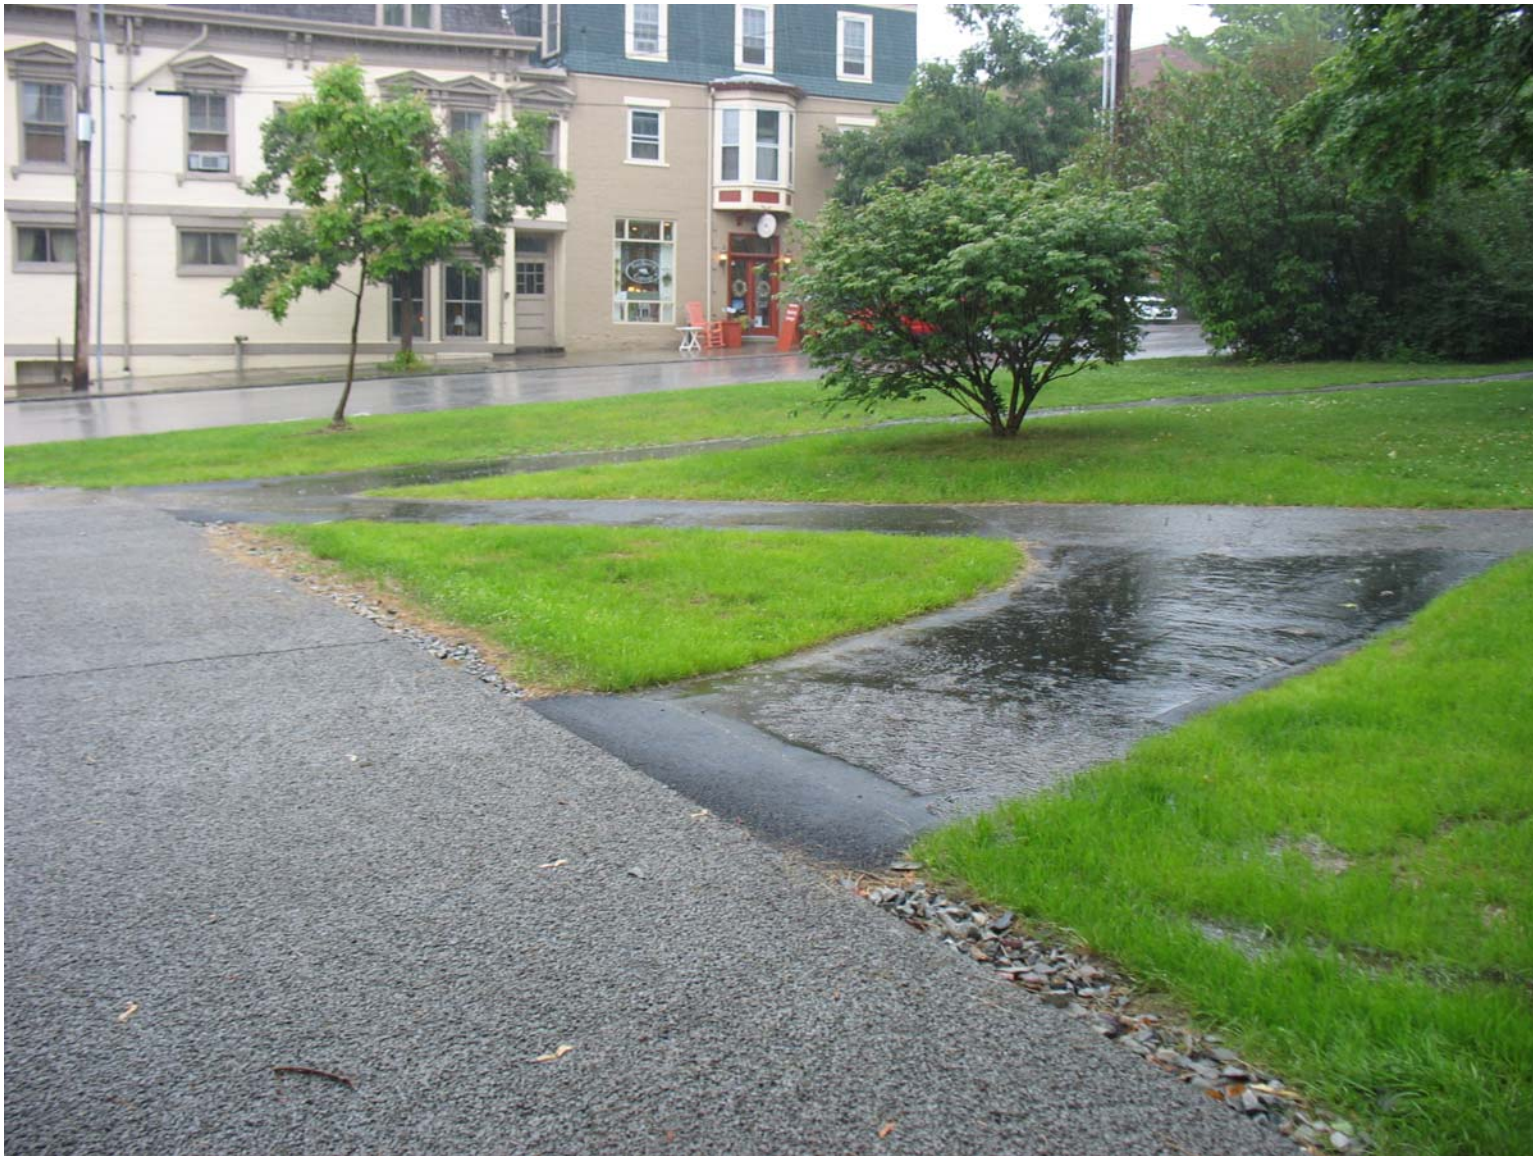
Porous concrete sidewalk in Taylor Park, St. Albans – Notice how wet the asphalt walk is compared to the porous walk.
