1.0 INTRODUCTION

This engineering report presents the results of an investigation of the Stevens Brook and the Rugg Brook watershed. The investigation addresses long-standing concerns regarding flooding and flood-related damages as well as impaired water quality within the floodplain of these two brooks.

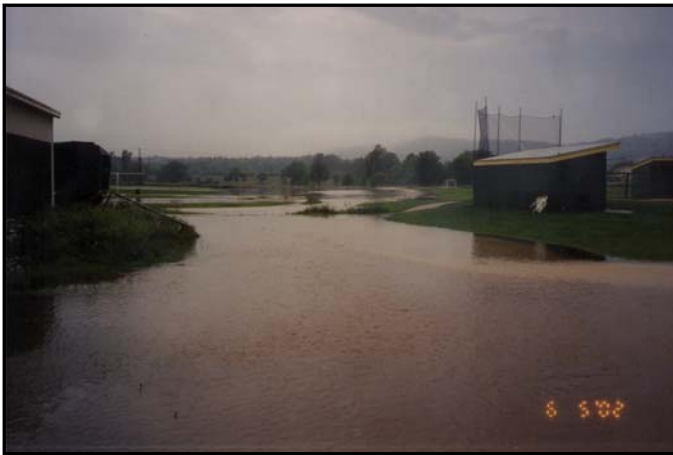
Flooding of the Collins-Perley Sports Complex on June 5, 2002.

These streams are relatively small in size, and the drainage area of each one is approximately three square miles in the areas where much of the flood damages occur, notably near the western City limits. Despite this small size, there is a long history of flooding and flood related damages along their floodplain corridors. Indeed, significant out-of-bank flooding occurred several times in June 2002.

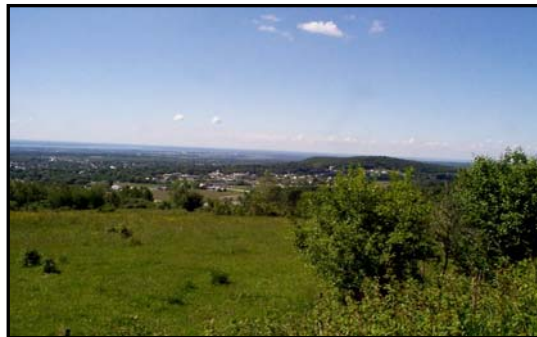
Westerly view from upper watershed

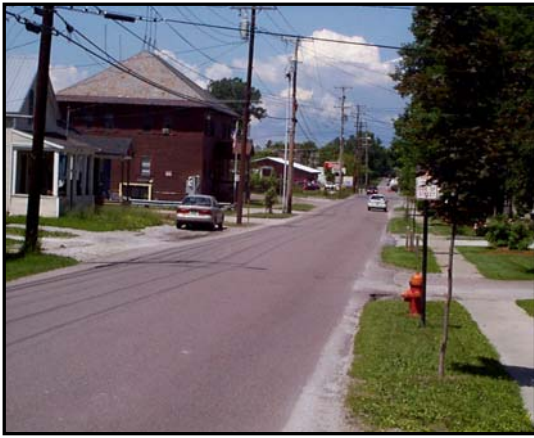
Typical developed area in the watershed.

The land use in the center section of the watershed is predominately urban. Medium to high-density residential development dominates the land use in the upstream (eastern) portion. Commercial and high-density residential land use exists from US 7 (Main Street) downstream to the wastewater treatment facility. The drainage area of Stevens Brook at Main Street is 1.8 square miles.

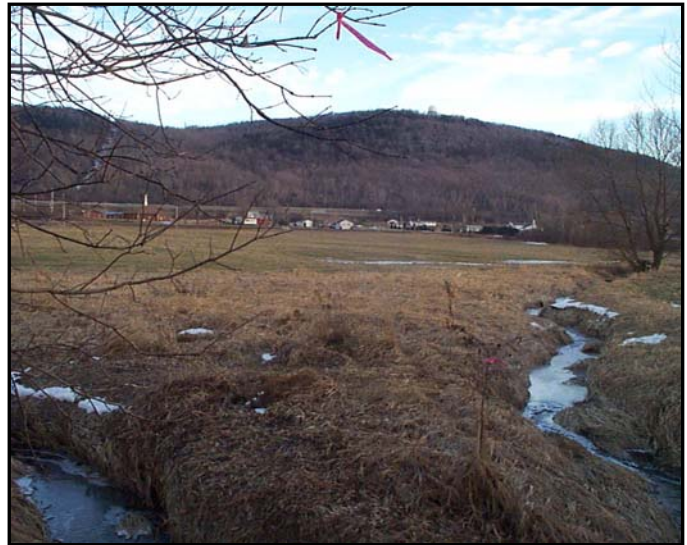
*Easterly view of the Rugg Brook headwaters.
Note the Interstate in middleview and the
abandoned radar station in the background.*

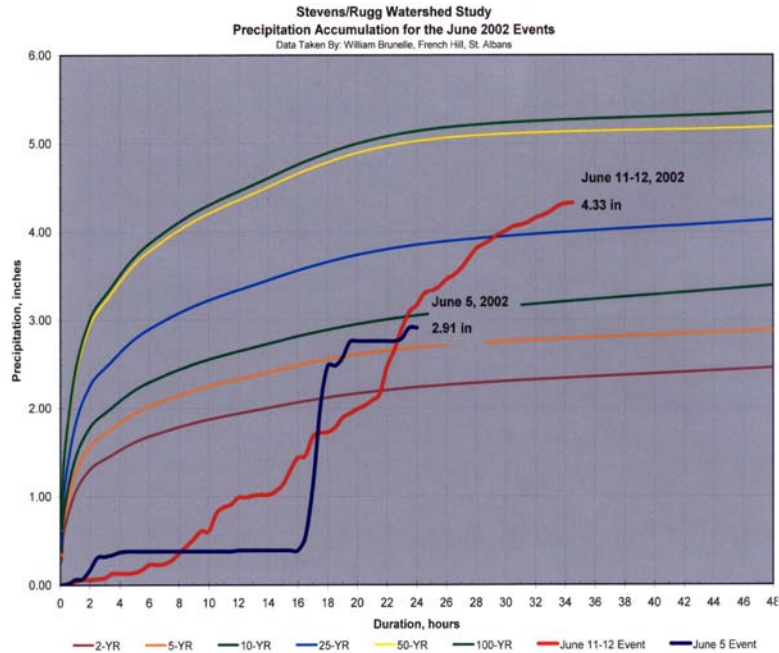
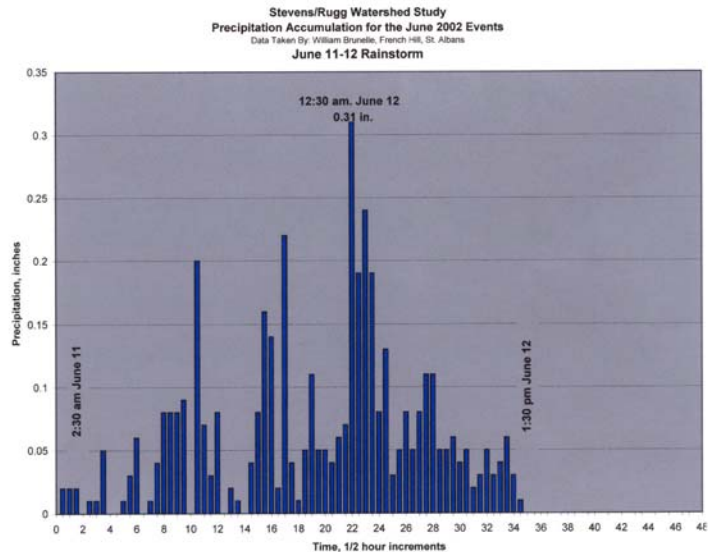
Figure 3: Precipitation Tables

The precipitation which occurred during the June 11–12 storm event was measured to be 4.33-inches of rainfall. A 2.91-inch rainfall preceded this the week before on June 5, 2002. The June 11 – 12 storm was estimated to be between the 30-year and 40-year rainfall recurrence frequency, resulted in flood damages throughout the City and portions of the Town of St. Albans. The two adjacent graphs illustrate the temporal distribution of the rainfall.

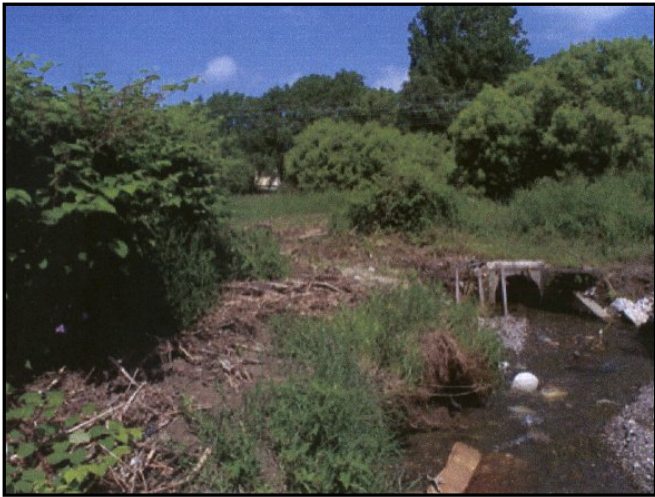
Inlet to diversion structure

Water is diverted into the channel when flood stages at its inlet on Stevens Brook reach a certain level. Water flows along the channel until it discharges over an outlet control weir, then under Nason Street, where it then enters Rugg Brook.

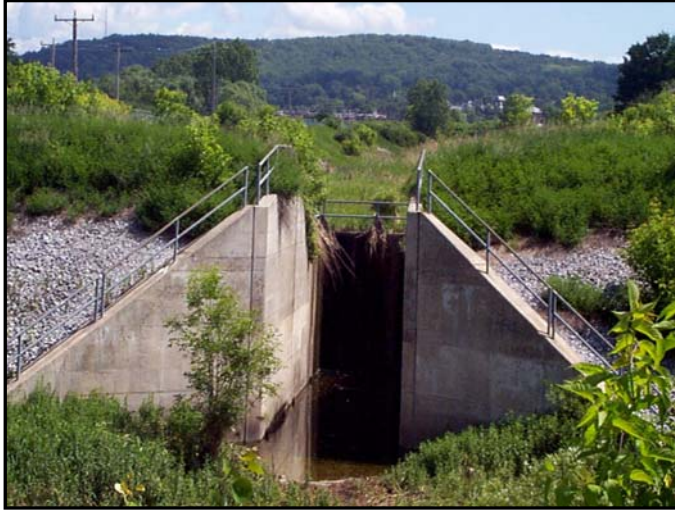
Outlet from the diversion structure.

The Diversion Structure has been effective according to some local officials. The frequency of flooding has definitely been reduced in the historical flood plain since the structure was constructed. However, several City officials have stated that the structure was not installed as originally intended, and that not enough water is diverted into the channel. Conversely, others have reported that the channel is not functioning as intended because too much water is diverted into Rugg Brook, which has resulted in accelerated erosion and associated impacts to the stream banks along Rugg Brook.

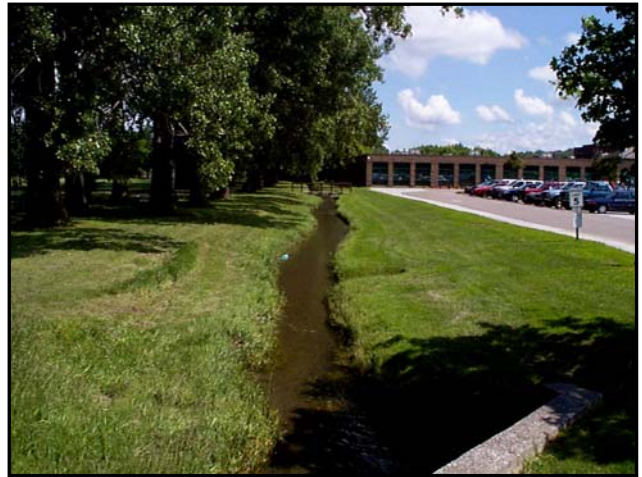
Straightened channels and lack of vegetated buffer reduces ability to filter pollutants from parking lots and contributes to flooding.

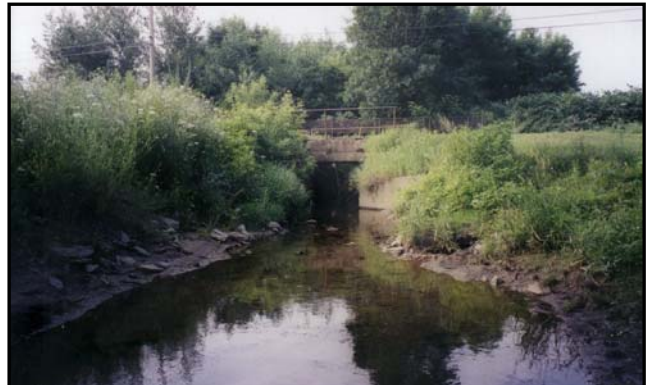
Severely constricted channels and structures trap flood borne debris, causing flooding.

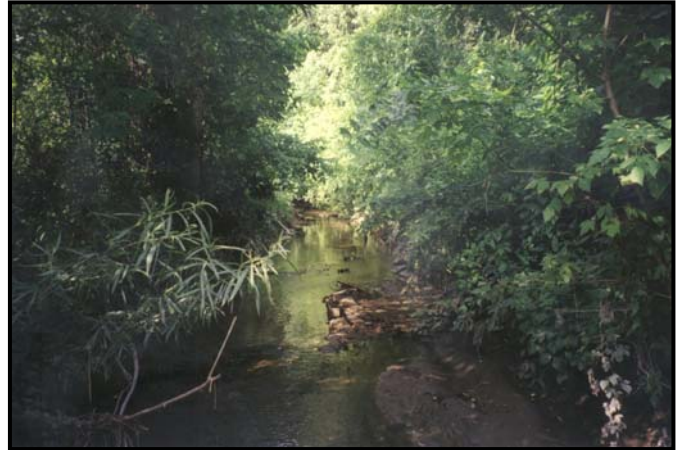
Examples of quality vegetated buffers do exist on the Stevens and Rugg brooks, and should be protected from future development.
