TO: LAMOILLE BASIN WATER QUALITY COUNCIL (BWQC)  
FR: LAMOILLE BASIN CLEAN WATER SERVICE PROVIDER (CWSP) STAFF  
RE: MATERIALS FOR MEETING ON 7/21/23  
DA: 7/14/23

**3. Project prioritization**

### 10% DESIGN - WILD BRANCH AT GULF ROAD

### Preliminary Design (30%)- Gulf Road Bridge Replacement/Floodplain Restoration

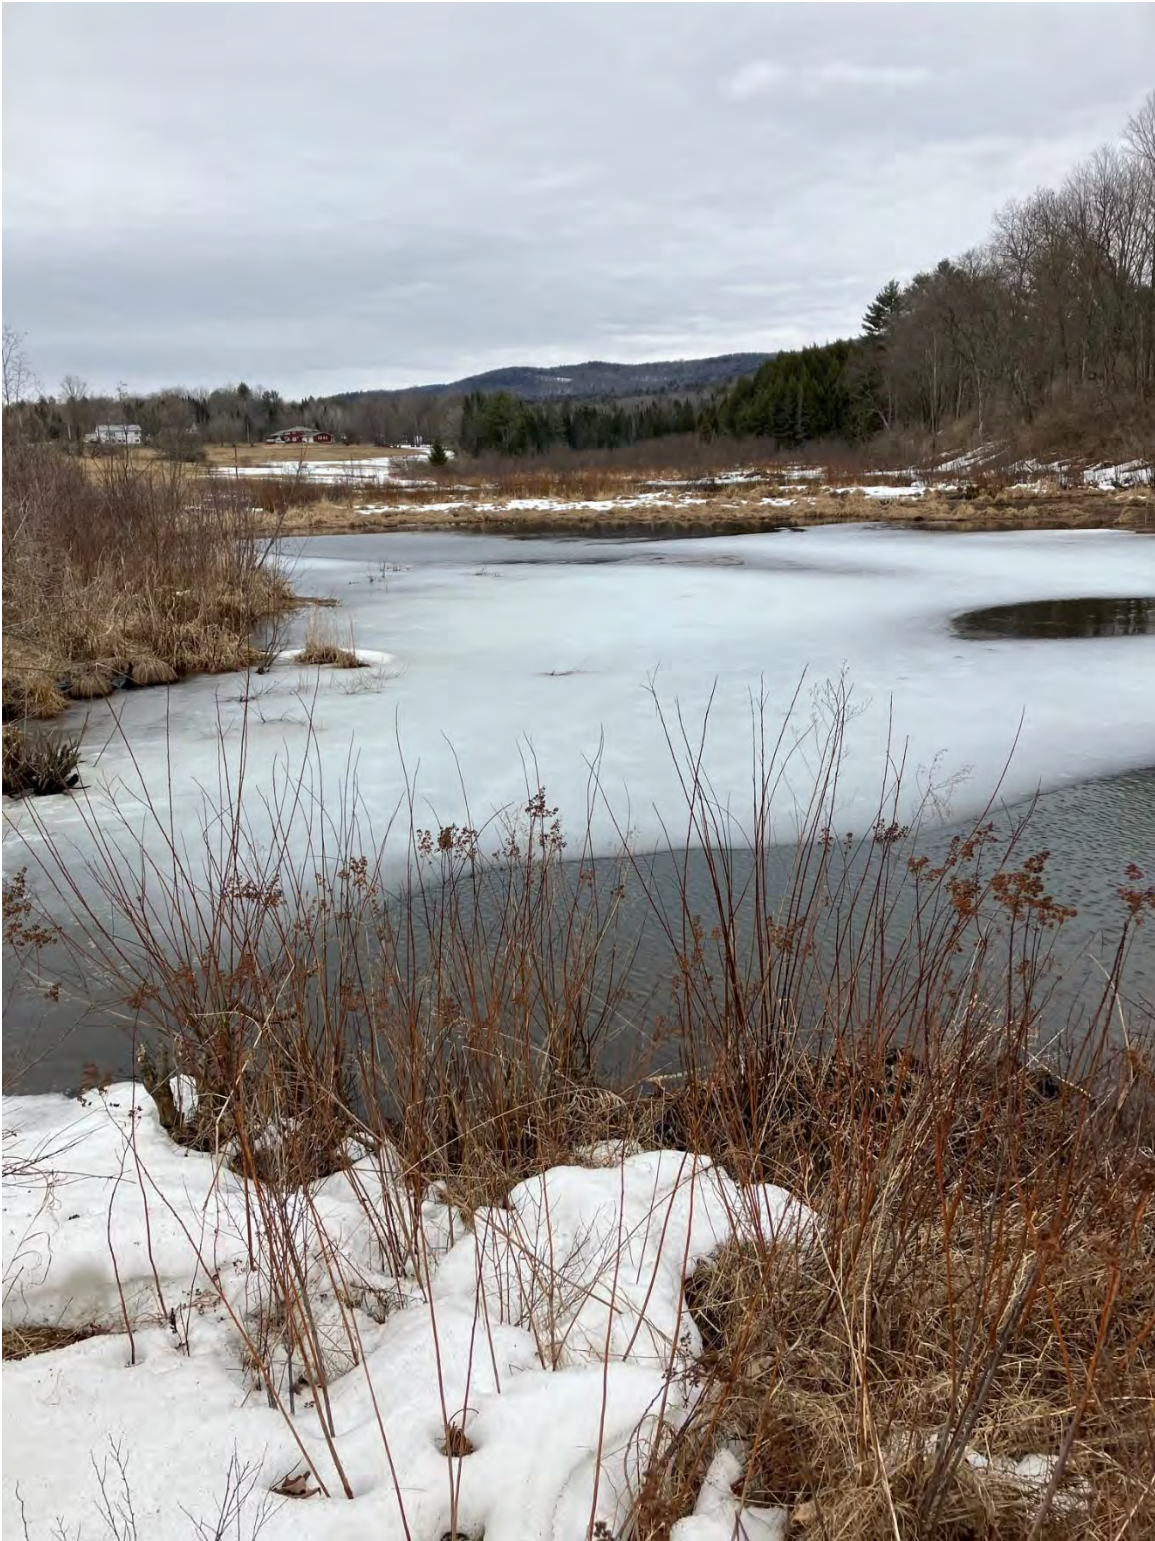
*View of the Wetland*

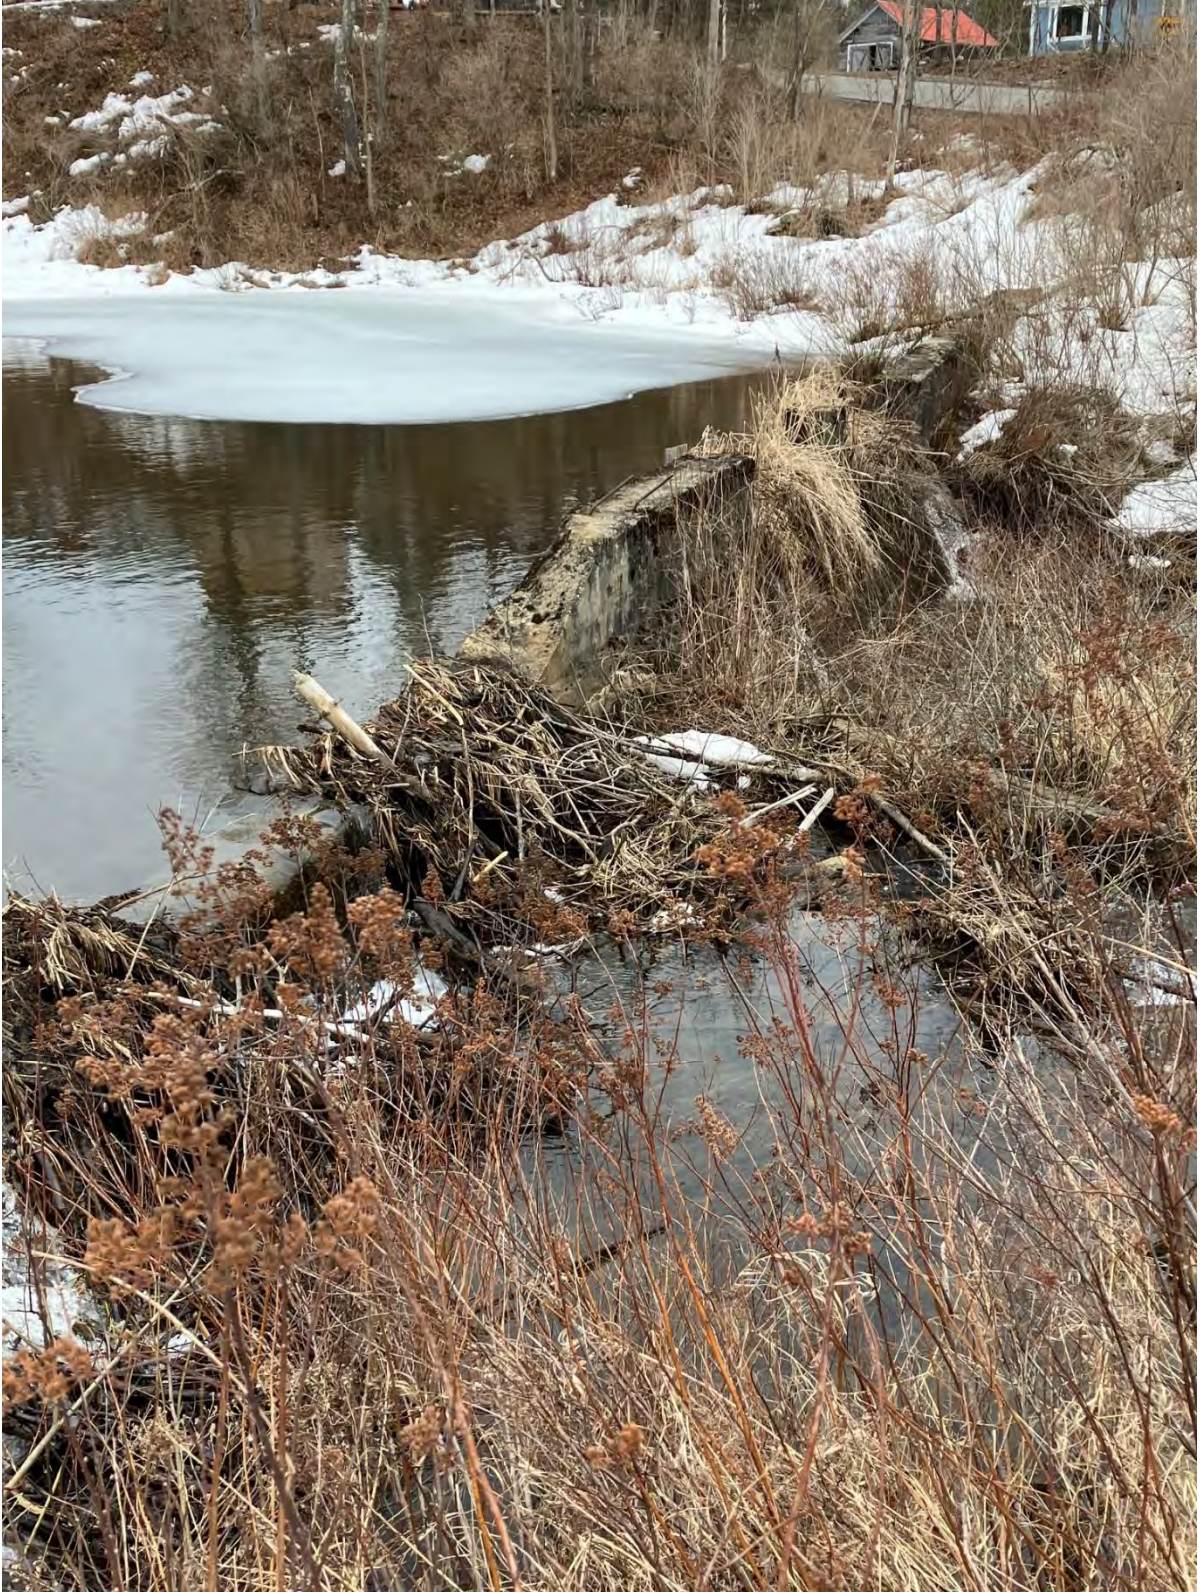
*View of the Dam over Centerville Brook*

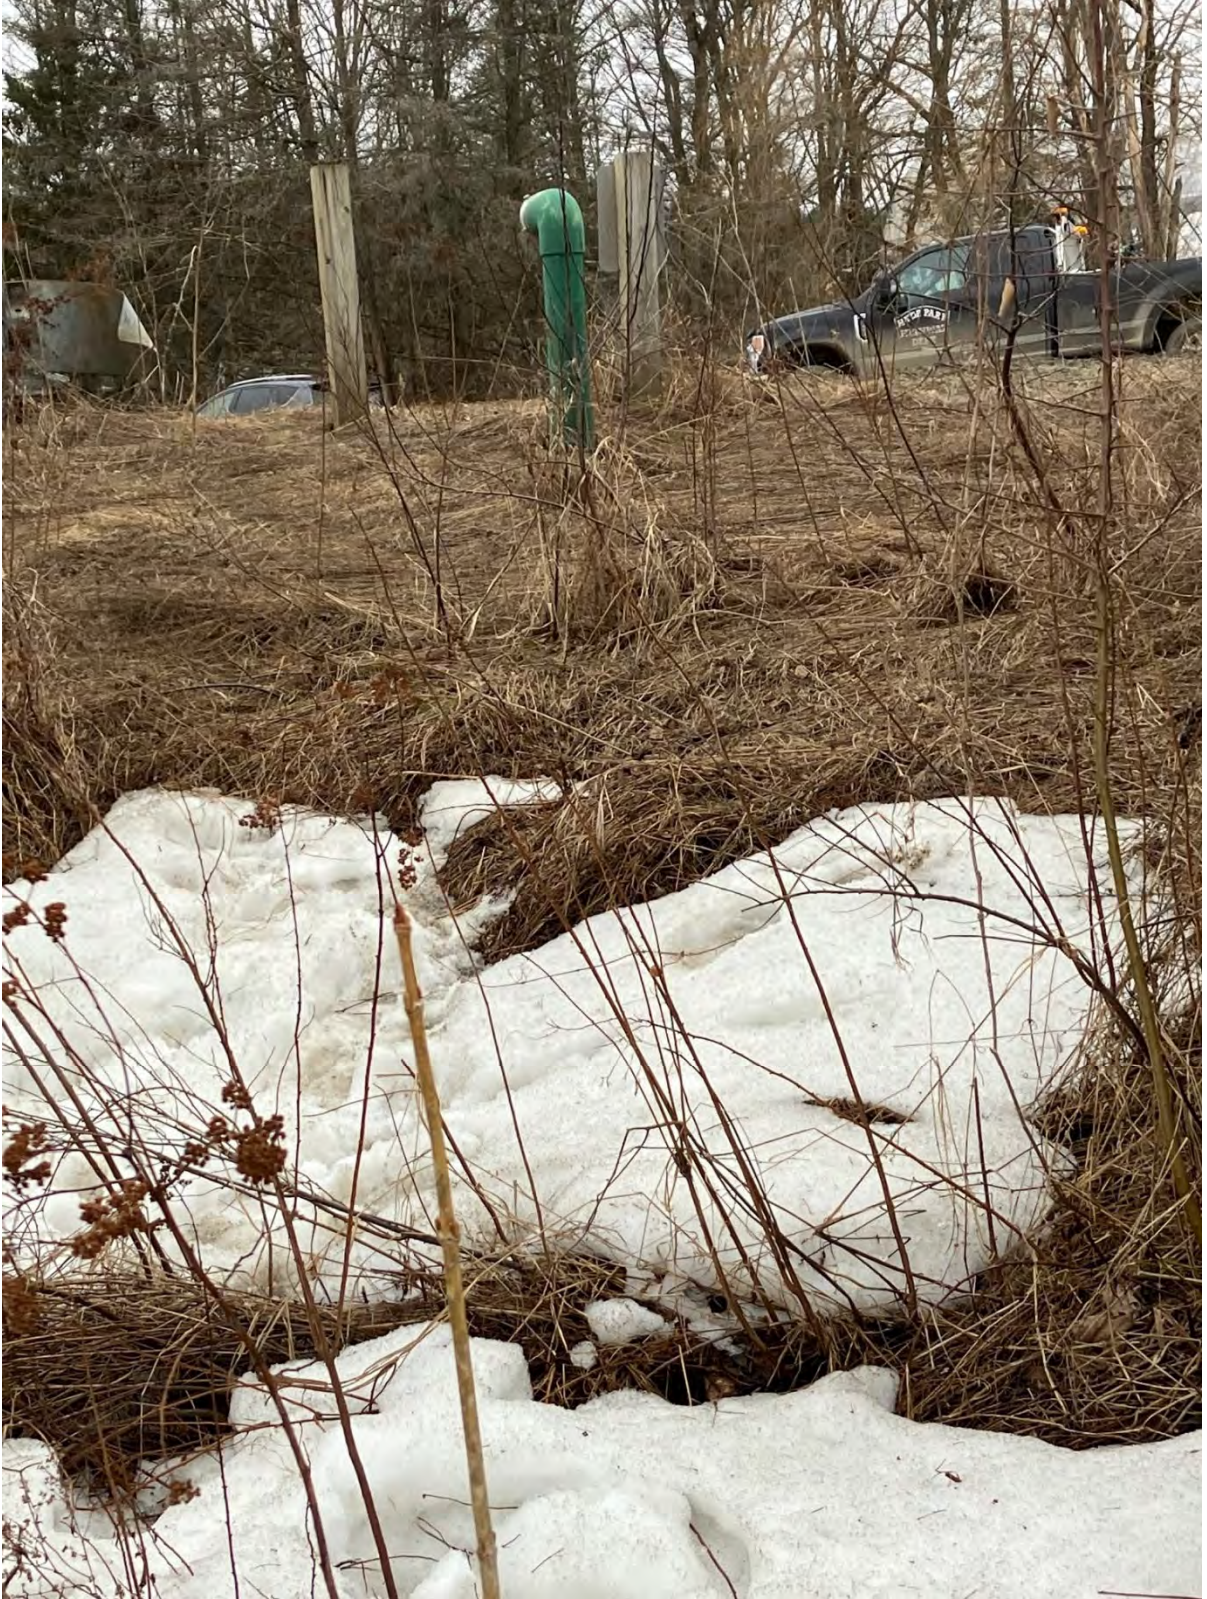
*Dry hydrant. Must consider when designing this project.*

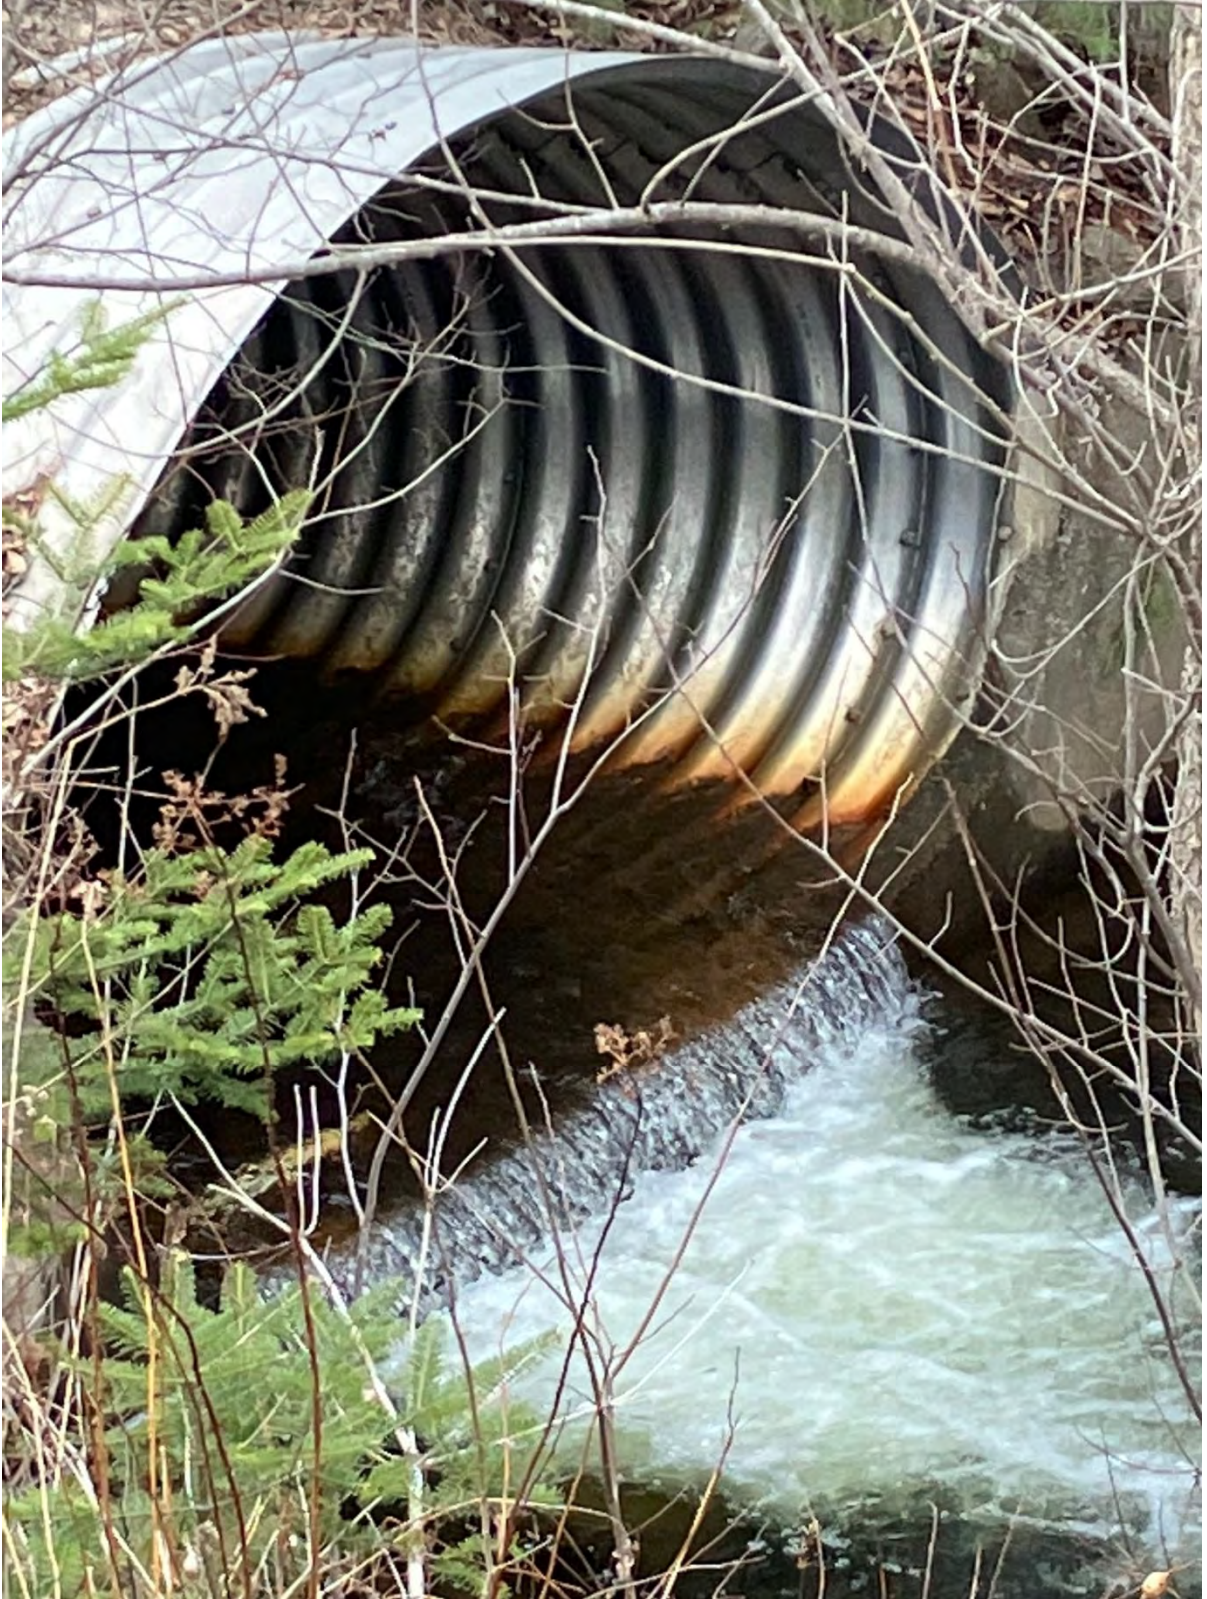
*Culvert outlet slightly perched*

- The current culvert is overall in good condition. Just a little rust on the bottom. The existing culvert was installed in 1999 by Grenier Engineering.

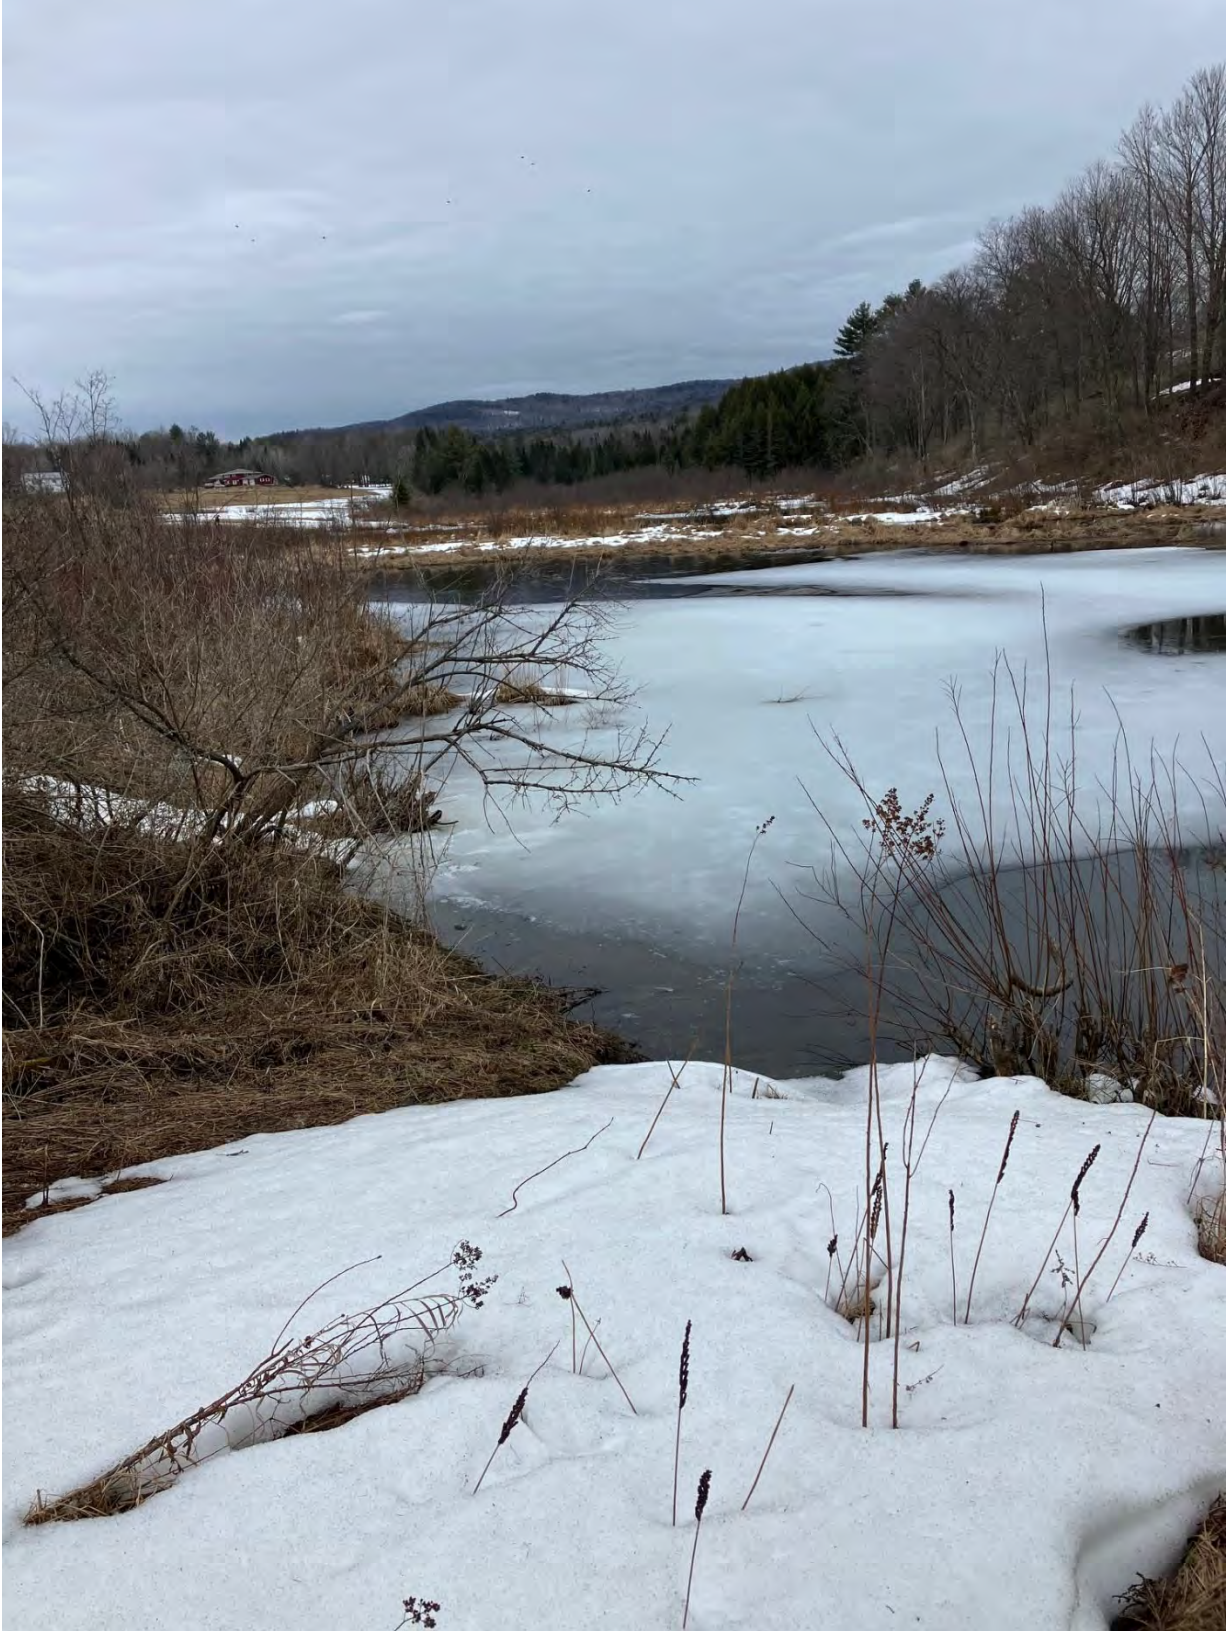
*View of wetland area*

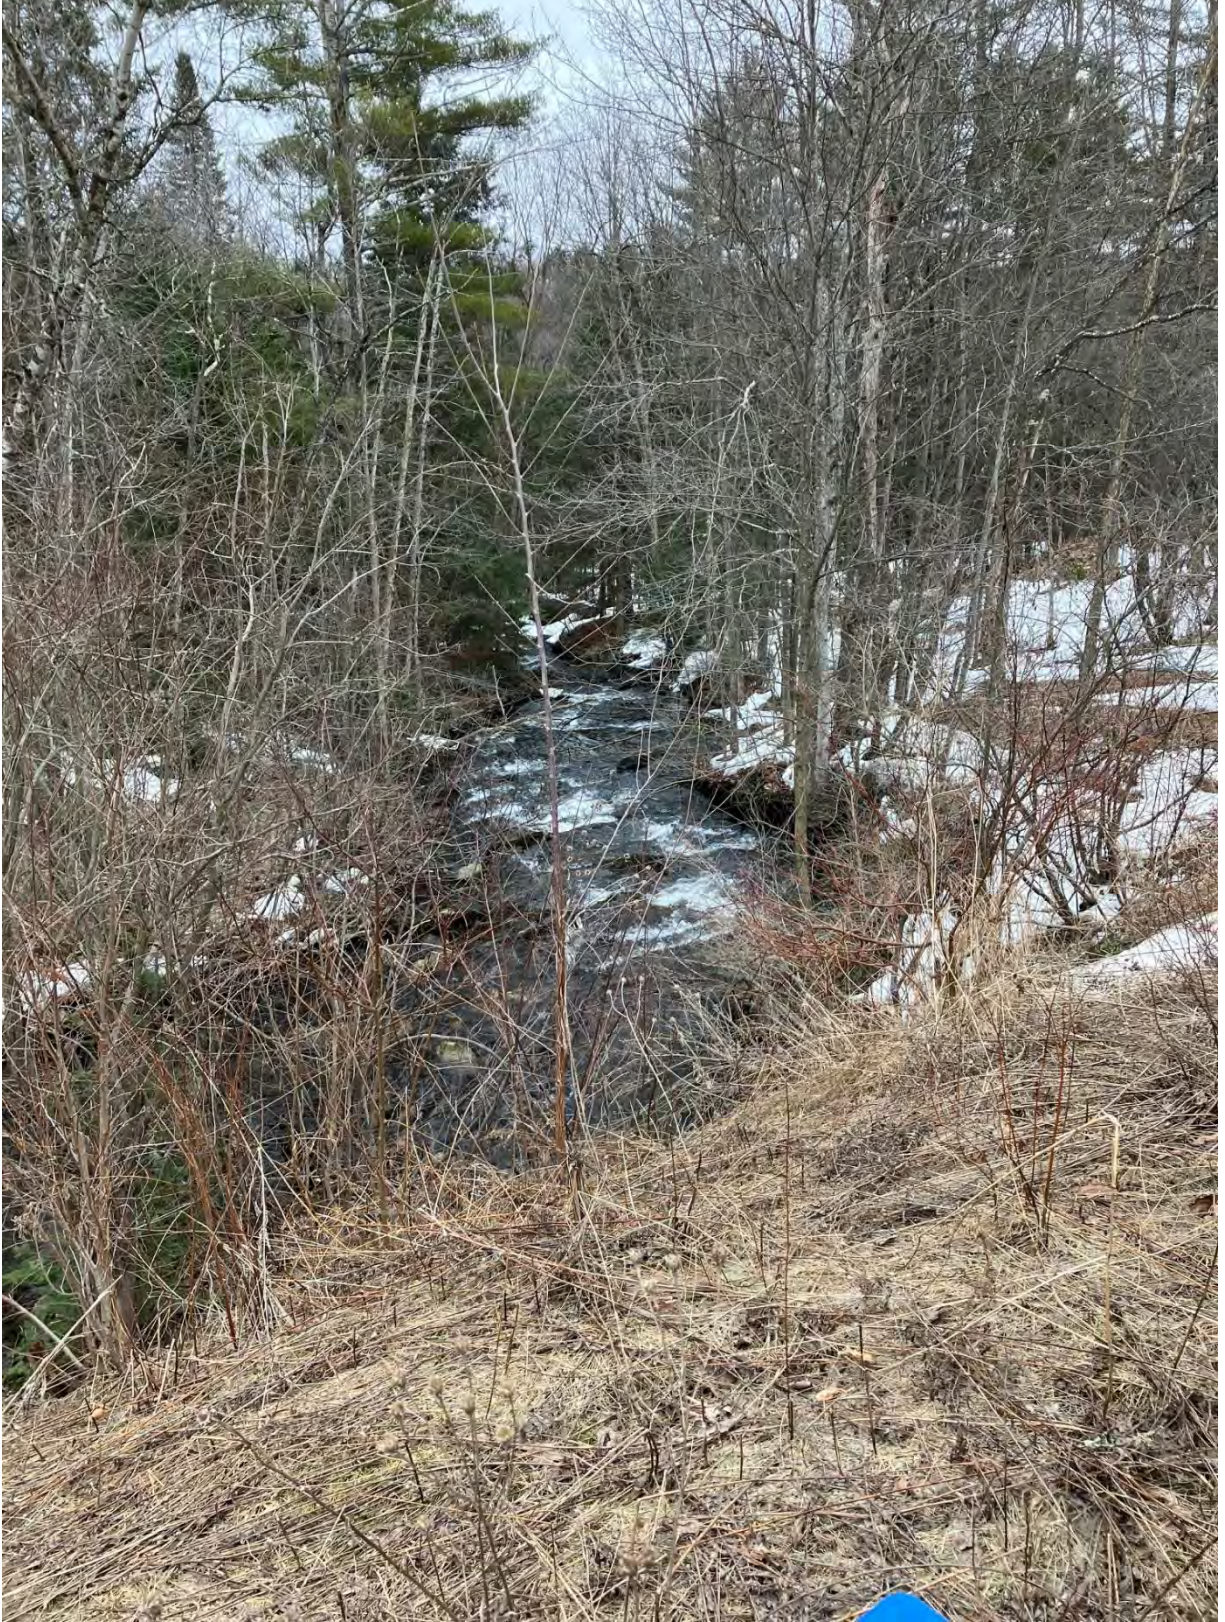
*Looking downstream*

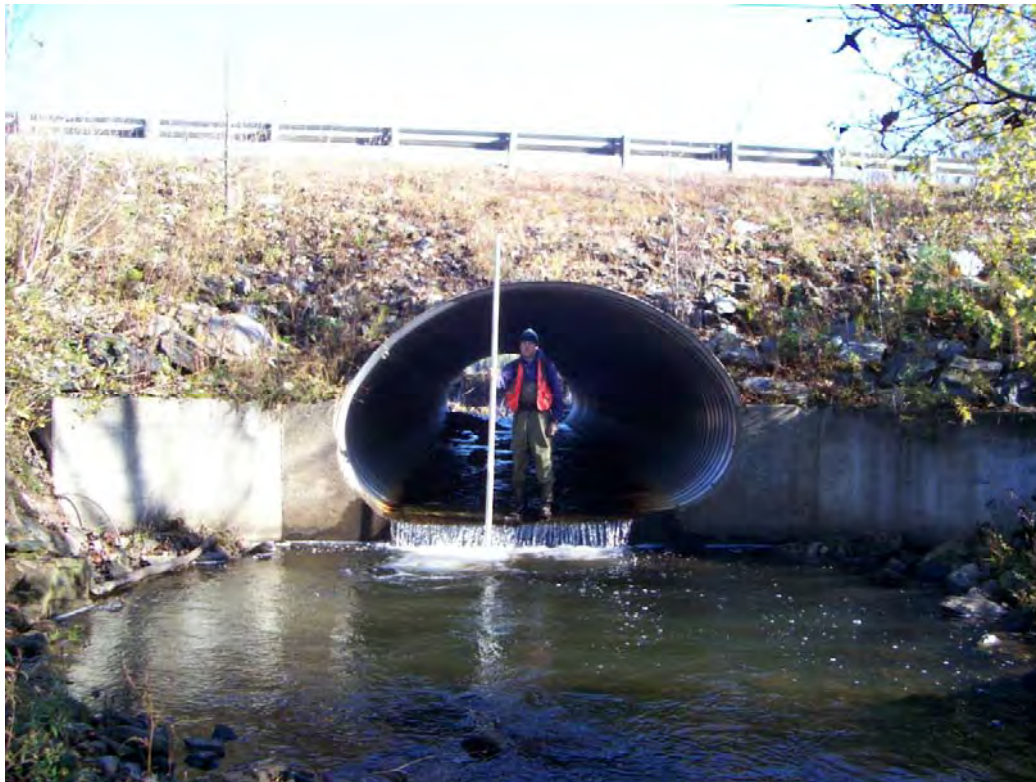
**Figure 10. Culvert at Centerville Road in reach R15.07-B was flagged as “No Aquatic Organism Passage” using the Vermont Culvert Aquatic Organism Passage Screening Tool (Milone and MacBroom, Inc, 2008)**

None of the culverts had sediment throughout the structure and were flagged as having reduced aquatic organism passage. The culvert crossing at Centerville Road in reach R1507-B is freefall with an outlet drop of 1 foot (see Figure 10). Using the VT Organism Passage Coarse Screen (Milone and MacBroom 2008) this culvert was flagged as no AOP for all aquatic organisms including adult salmonids. This structure is a high priority for replacement or retrofit.

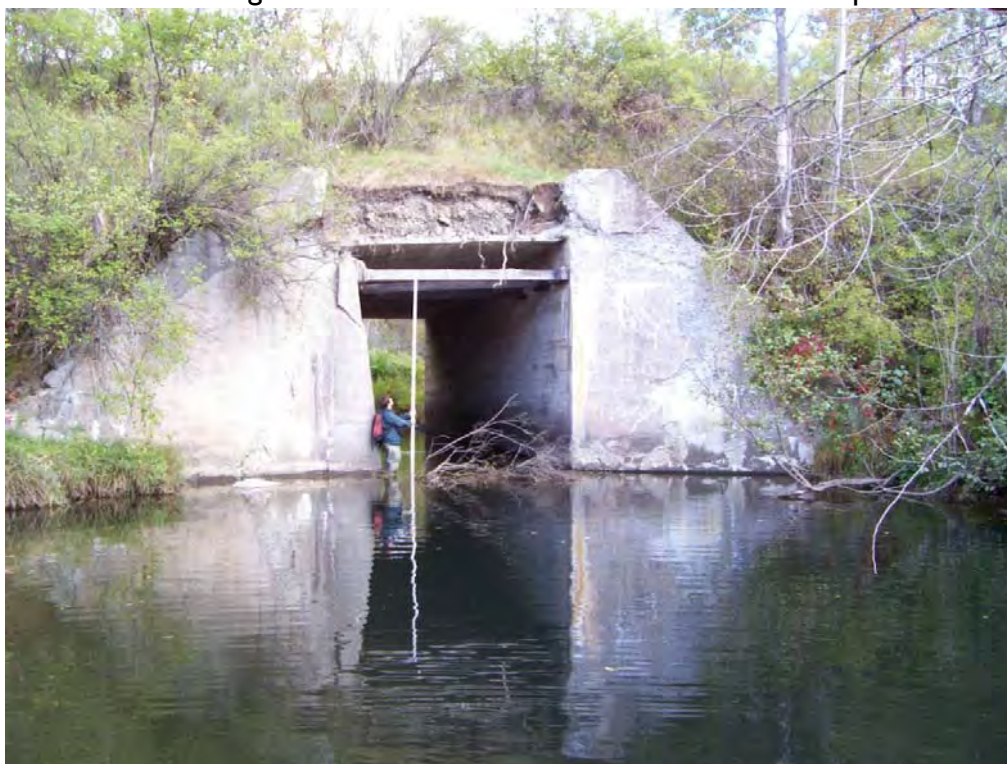
**Figure 12. Rail to trail crossing in reach R15.02 has bank erosion above the outlet. This structure is undersized relative to the bankfull channel width and is recommended for replacement.**

The bridge in reach R15.02, which crosses the Rail to Trail network, is undersized relative to the bankfull width and was noted to cause localized geomorphic instability due to sediment transport and alignment. As shown in Figure 12, the bank above the outlet of this structure is eroding. It is recommended that this structure be replaced.

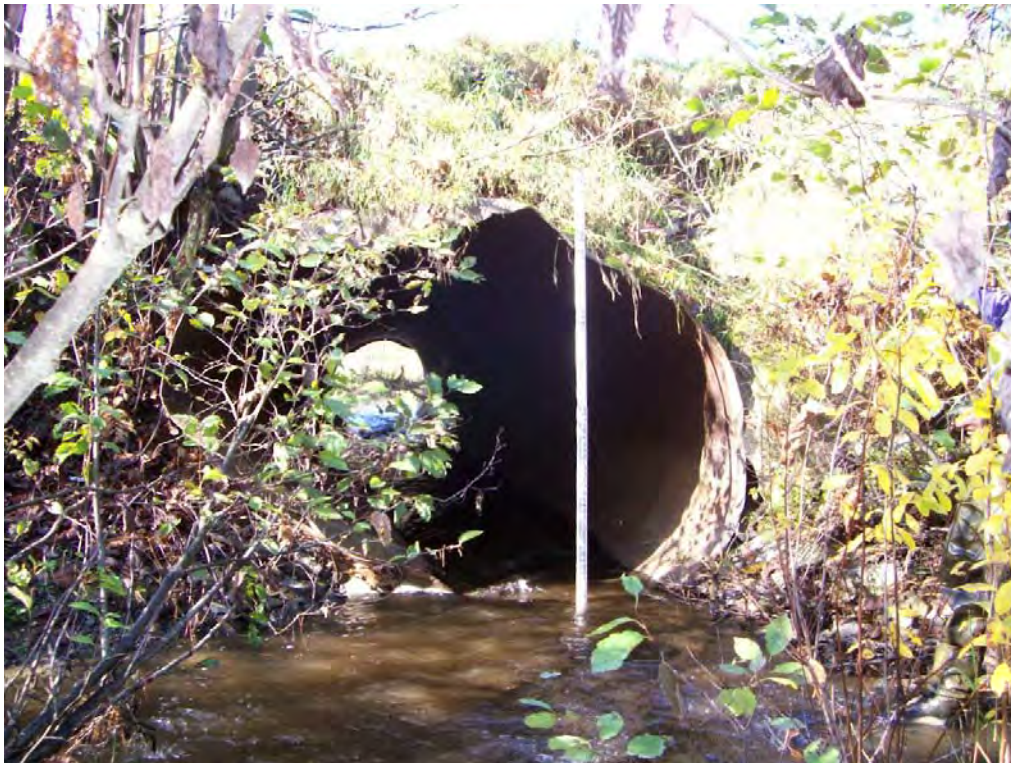
**Figure 13. Brook Road culvert crossing in reach R15.07-A is undersized and impeding sediment transport. The culvert is in poor condition and has the potential to reduce AOP.**

The farm crossing in reach R1506-A is also undersized, but is rated low priority for replacement at this time. The structure is located in a wetland and floodwaters have access to the floodplain. The culvert crossing at Brook Road (Figure 13) is undersized and was given a moderate to high priority to replacement due to sediment transport problems; reduced AOP and the poor condition of the culvert.

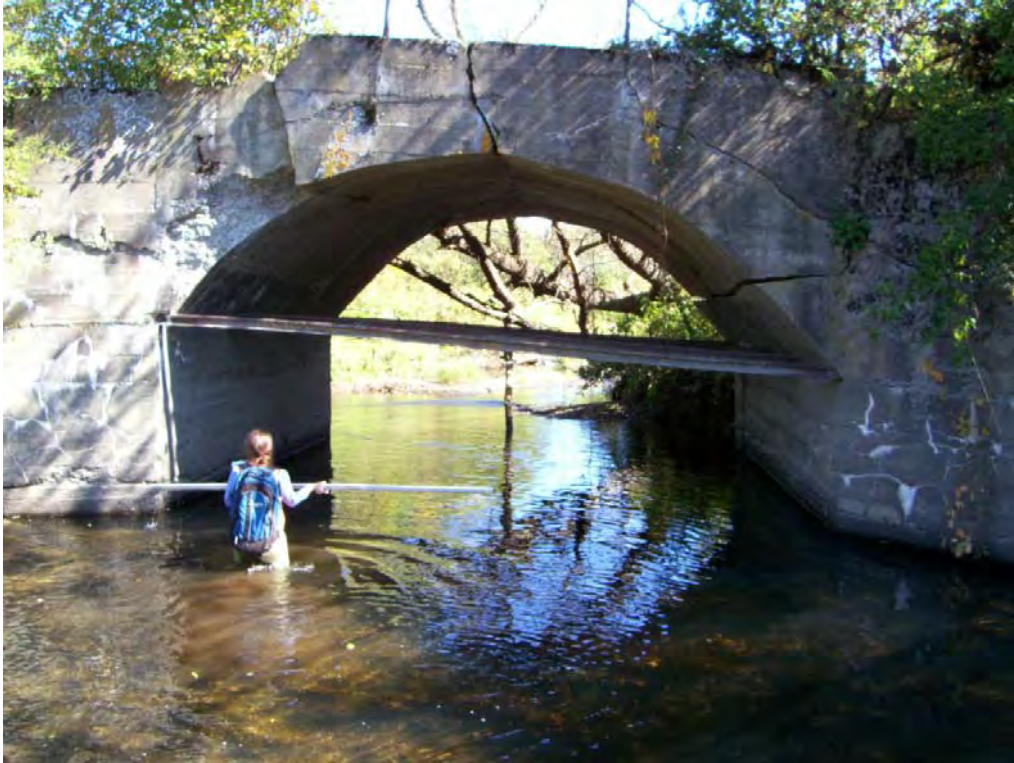
**Figure 14. Farm bridge in reach RI5.01-A that is structurally unsound and is causing localized geomorphic instability.**

The farm bridge in reach R1501-A does not have a span which is less than 50% of the bankfull width, but was nonetheless rated as moderate to high priority for replacement. This span of this structure is 50% of the bankfull width and was noted to be causing sediment transport problems (deposition above, deposition below, score above, scour below) and was poorly aligned. The structure is in poor condition as shown in Figure 14.

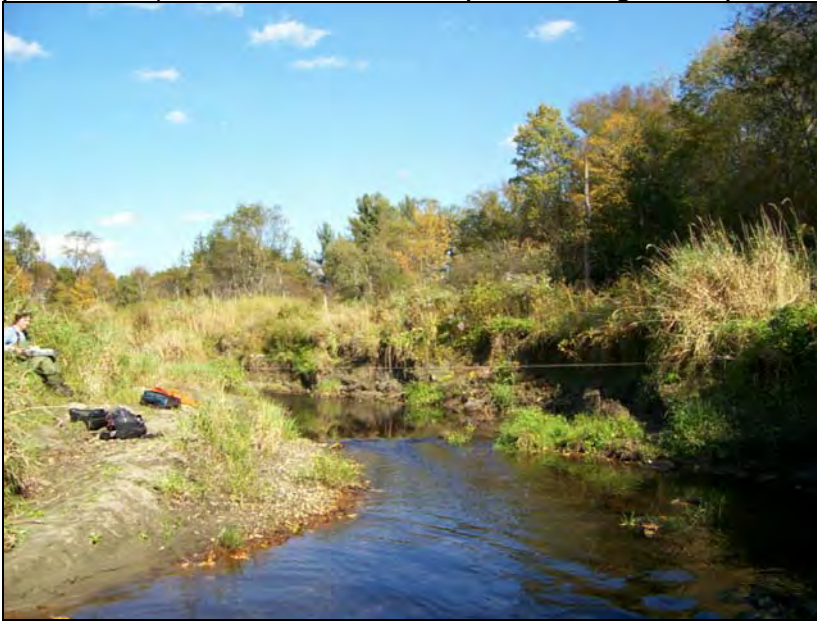
**Centerville Brook segment R15.01-A is an “E” type channel that has undergone a stream type departure and major existing channel adjustment.**

reach. The reference stream type is an “E” channel; however, due to major adjustment the channel is a “C” riffle-pool bedform undergoing major widening and extreme planform adjustment as a new floodplain is being developed.

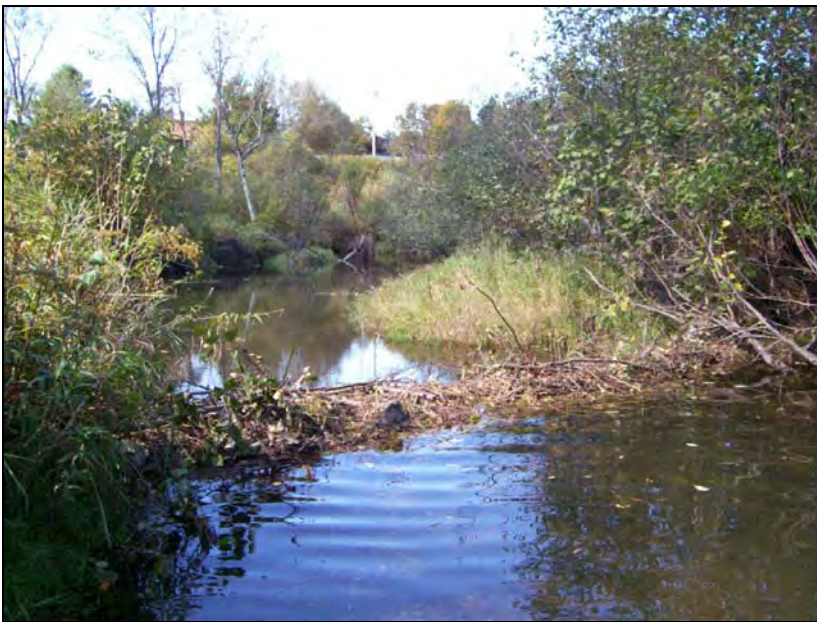
**Centerville Brook R15.01-B has been dammed by beavers in numerous locations.**

Centerville Brook segment R15.01-B flows through abandoned agricultural lands east of Hyde Park village. The stream in this reach has been impounded by several beaver dams. A complete geomorphic assessment was not conducted in this segment due to the influence of these dams.

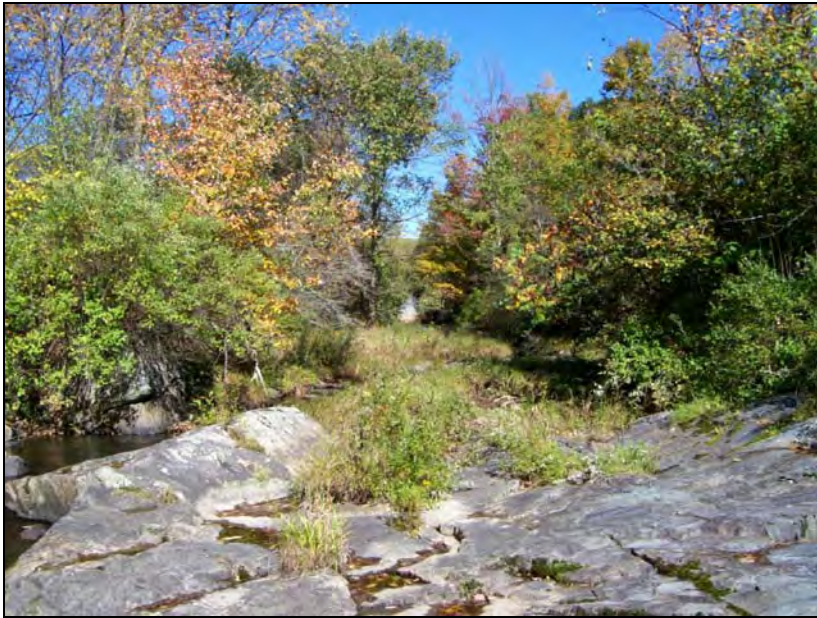
**Centerville Brook segment R15.03 is a bedrock dominated channel.**

Centerville Brook segment R15.03 is a bedrock gorge between the Route 15 and Main Street crossings east of Hyde Park village. In accordance with ANR protocol, only a partial assessment was conducted on this reach.

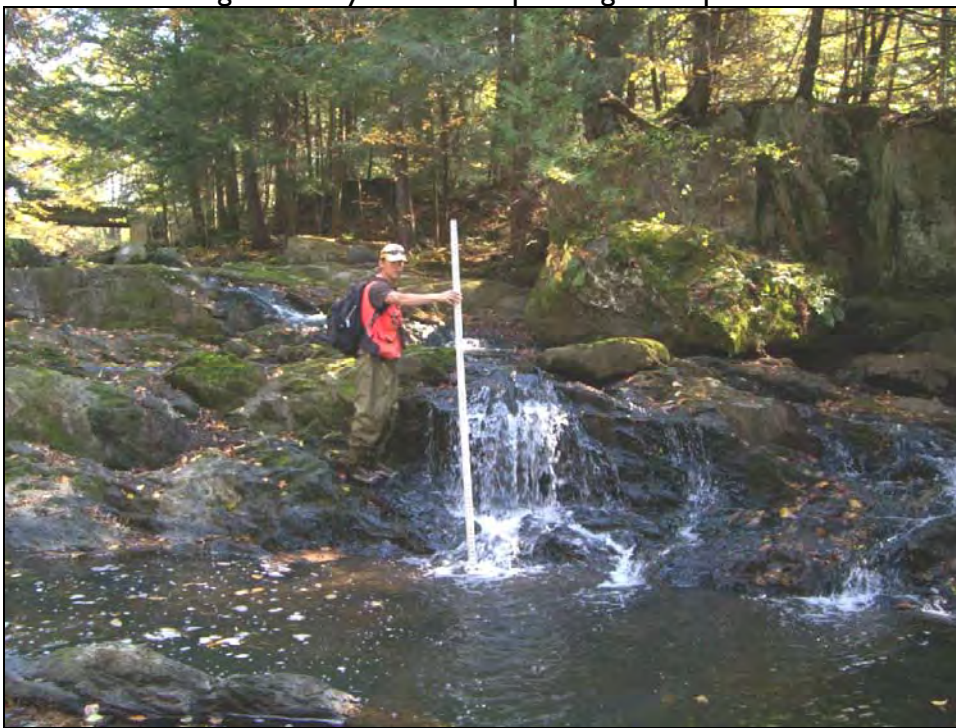
**Segment R15.05-A is a bedrock dominated channel with several small waterfalls.**

Centerville Brook R15.05-A begins just upstream from the private Pair Farm Road bridge where a very broad valley becomes confined and where the Centerville Brook encounters a bedrock dominated channel and a series of small waterfalls. Due to these waterfalls this segment only received a partial geomorphic assessment.

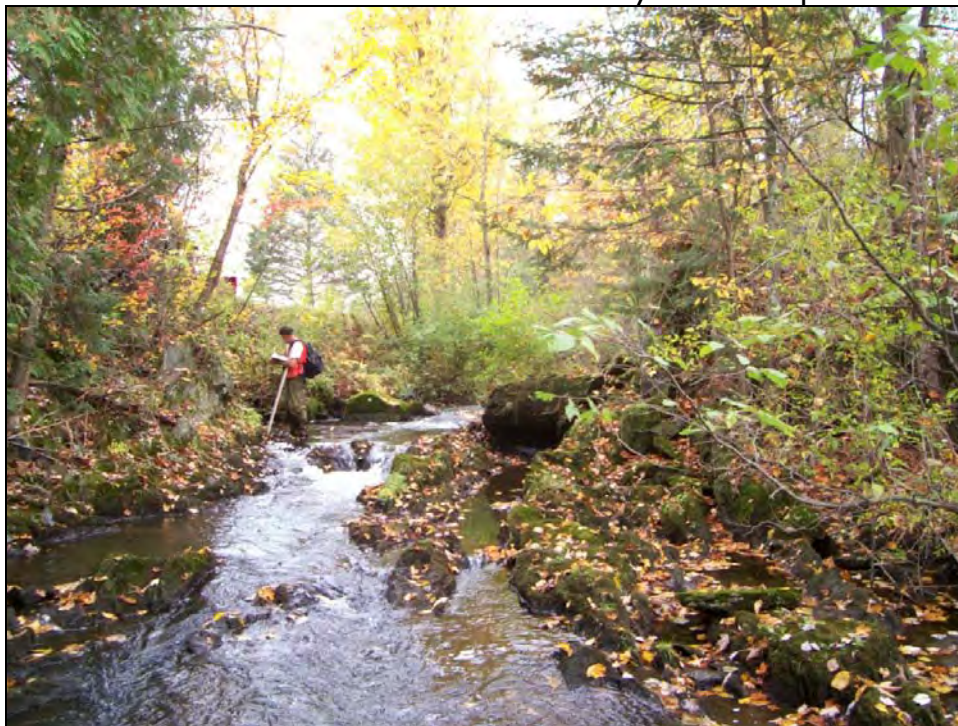
**Centerville Brook segment R15.05-D is controlled by bedrock on the bed and banks.**

Centerville segment R15.05-D is a short (600 ft.) section of channel that begins where bedrock grade controls appear in the channel near the upper pastures of a dairy farm and ends at the culvert under Frost Road. The stream in this segment is controlled by bedrock on the bed and banks and therefore only received a partial Phase 2 assessment.

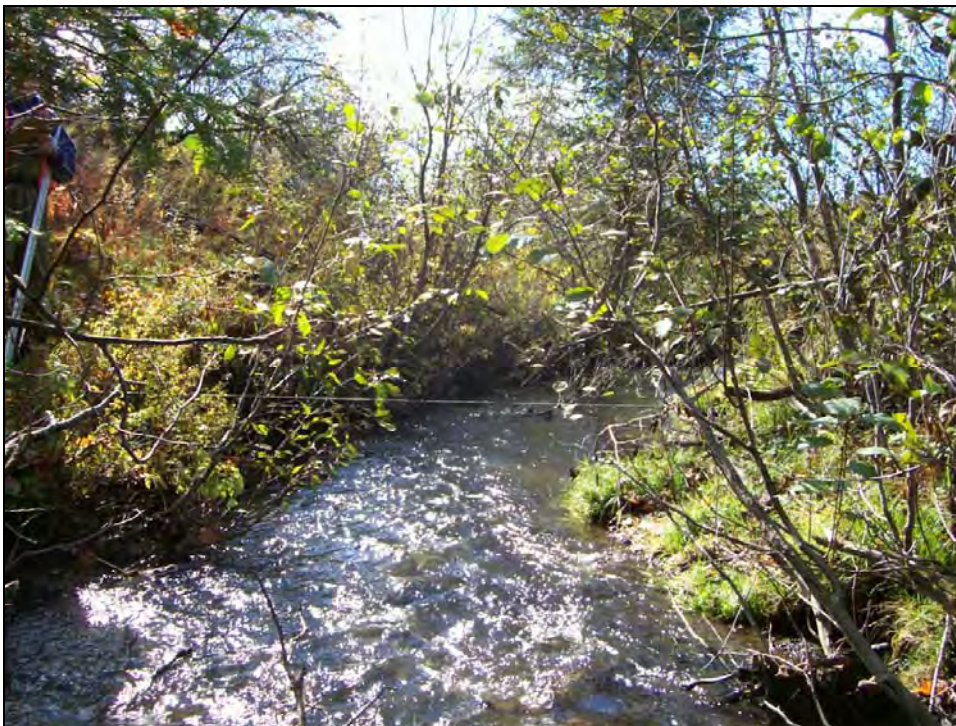
**R15.07-A is an “E” channel with alder vegetation and active pasture on both banks.**
