# Montgomery Flood Hazard Mitigation Study

**Montgomery, Vermont  
Franklin County Natural Resources Conservation District**

**SLR International Corporation**

December 27, 2024

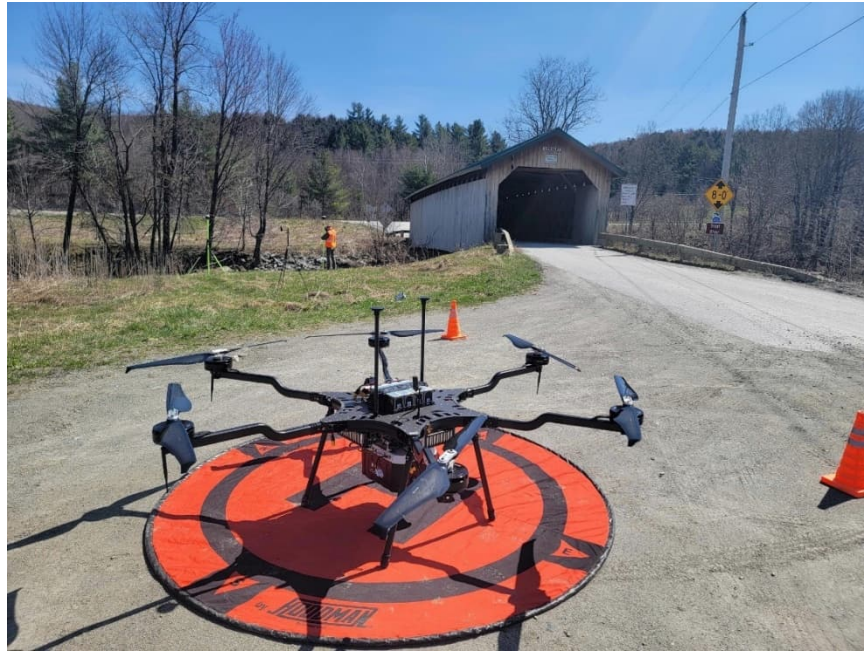
SLR contracted with Whiteout Solutions to perform survey using unmanned aerial systems (UAS). During late April and early May 2024, Whiteout staff conducted eight flights with a Harris Aerial H6 HL drone equipped with a Reigl VQ 840 GL topobathymetric light detection and ranging (LiDAR) sensor (Figure 1). The sensor is capable of collecting 200 points per square meter with up to two centimeters vertical accuracy. Topobathy LiDAR uses two lasers – one near infrared to map the land and water surface and one green to penetrate the water surface and characterize the streambed. The green LiDAR laser is capable of mapping up to 15 meters or 2.5 times Secchi disk depth underwater. The UAS equipment collected millions of data points within the Montgomery survey area, including below the water surface of the Trout River and tributaries. A point cloud was generated with points classified by return as ground, high vegetation, building, roads, utility, bridges, and water (Figure 2).

**Figure 1.** Topobathymetric LiDAR enabled UAS at the Longley Covered Bridge.

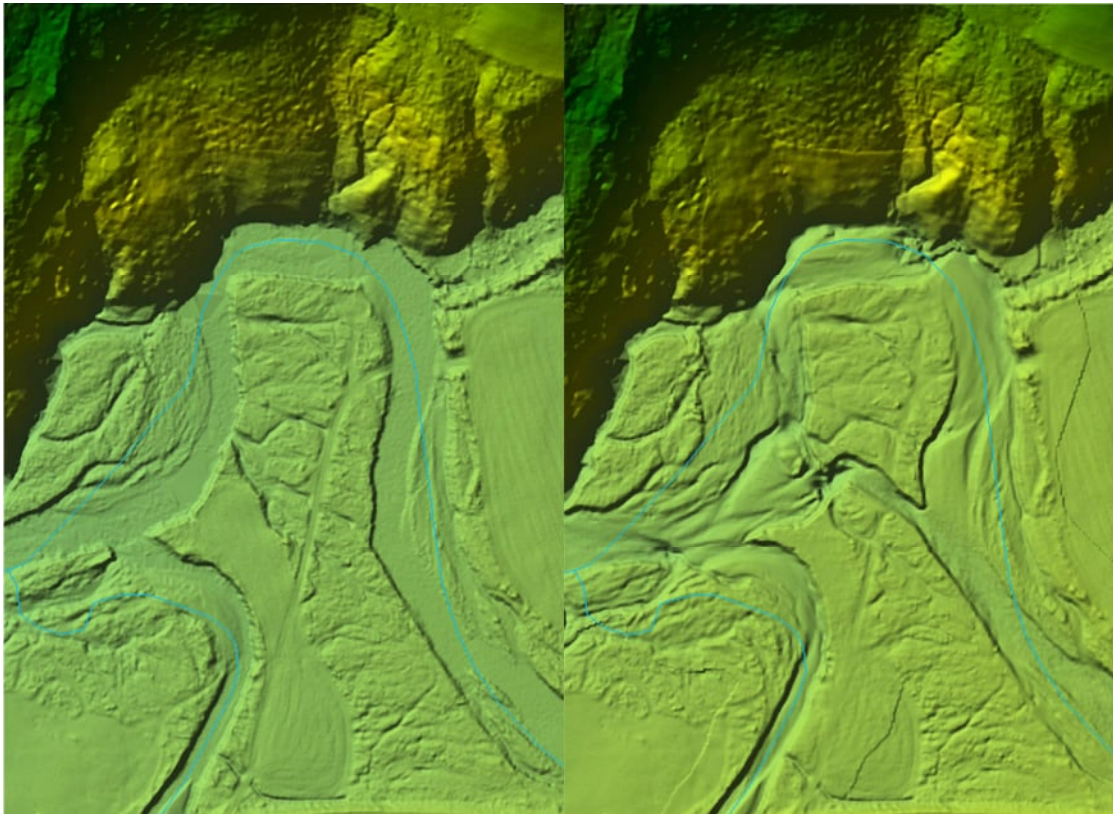
**Figure 3.** 2017 LiDAR only (left) 2017 LiDAR with 2023 UAS survey added (right) shows the streambed beneath the water surface and channel migration not reflected in LiDAR data

The post-correction product provides extremely high-resolution terrain data, which was used in the hydraulic model to reflect existing conditions at the site (Figure 3). The topobathy DTM covers the stream channel and banks; 2017 LiDAR was used for all other areas within the model extent.

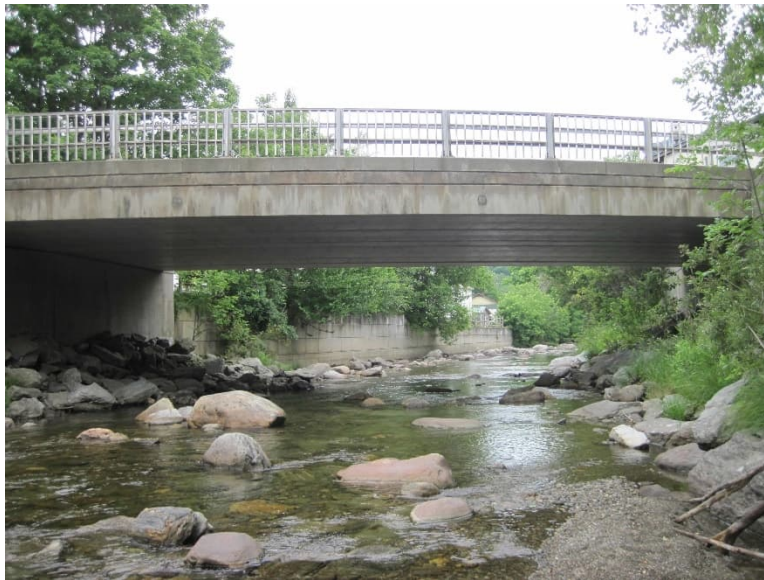
North Main Street (Route 118) crosses the Trout River in Montgomery Center between Mountain Road and Hazens Notch Road. The bridge was destroyed during the flood of 1997 and a new bridge was built the same year. The structure has a concrete deck with concrete abutments with a 60-foot span and a 13.5-foot rise (Figure 4).

**Figure 4.** North Main Street Bridge in Montgomery Center.

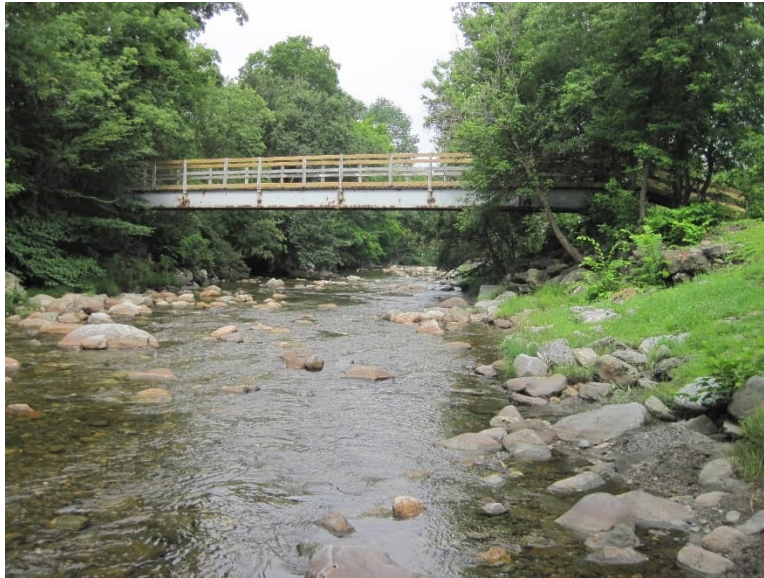
Approximately 550 feet downstream of the North Main Street Bridge, a snowmobile bridge crosses the Trout River, connecting from River Street to agricultural lands on the south side of the river. The bridge is part of the Vermont Association of Snow Travelers (VAST) trail network. The bridge is comprised of two steel I beams with a timber deck and stone abutments and has a 100-foot span and 12.8-foot rise (Figure 5).

**Figure 5.** Snowmobile bridge in Montgomery Center.

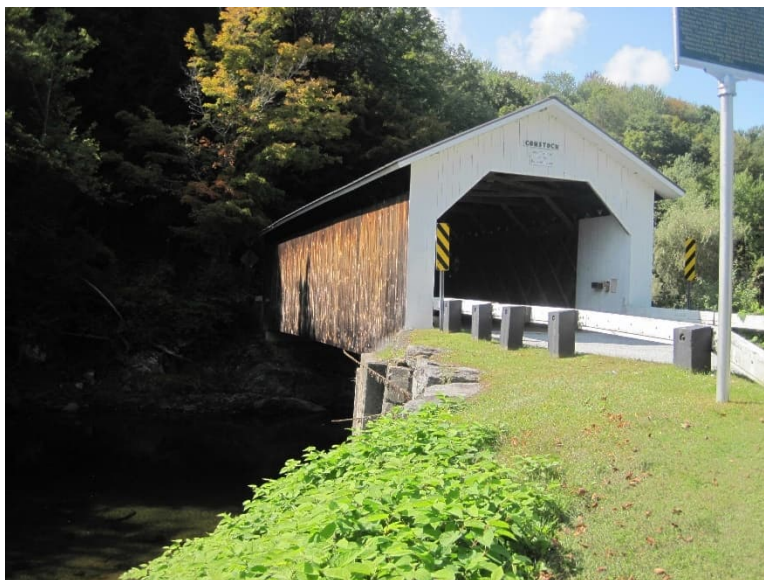
Just west of Montgomery Village, Comstock Bridge Road crosses the Trout River approximately 500 feet upstream of Route 118. The bridge is a historic covered bridge originally built in 1883 and reconstructed in 2003. The covered bridge is constructed of wood and has a 58-foot span (Figure 6).

**Figure 6.** Comstock Covered Bridge.

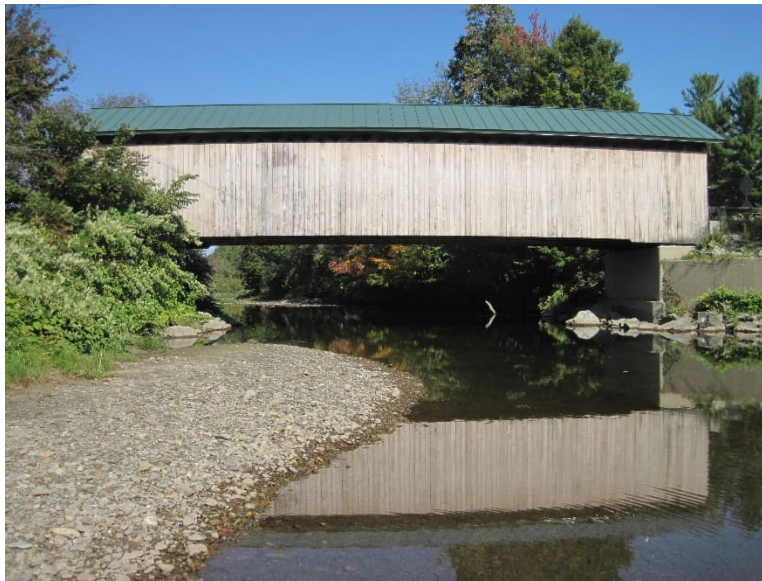
Just west of the intersection of Longley Bridge Road with Route 118, a historic covered bridge crosses the Trout River. The bridge was built in 1863 and was reconstructed in 2017. The covered bridge is constructed of wood and has a 66-foot span (Figure 7).

**Figure 7.** Longley Covered Bridge.

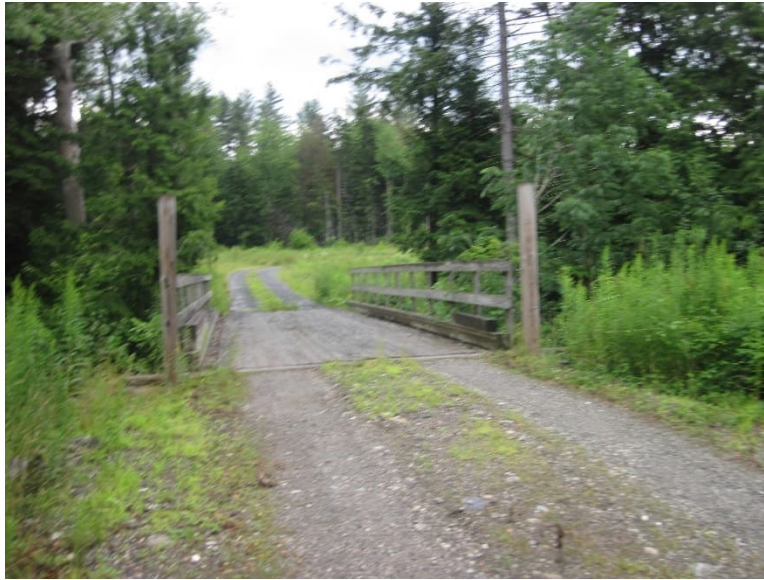
A bridge over Hannah Clark Brook connects the home at 768 to Mountain Road. The bridge is single lane, comprised of steel beams, has concrete abutments, and has a timber deck. The bridge has a span of 35 feet and a rise of 11 feet (Figure 8).

**Figure 8.** Driveway bridge to 768 Mountain Road.

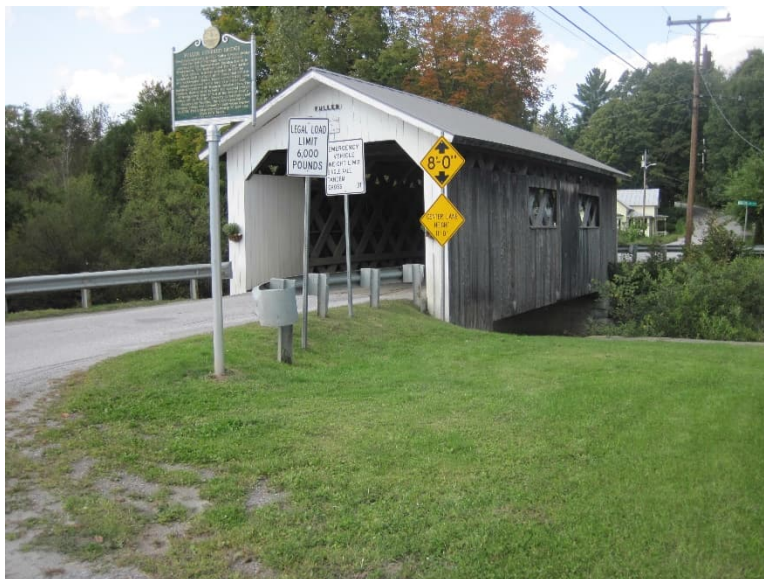
In Montgomery Village, Fuller Bridge Road crosses Black Falls Brook between the intersections of Brook Road and Black Falls Road. The structure is a historic covered bridge built in 1890 and reconstructed in 2000. The wooden covered bridge has a span of 42 feet (Figure 9).

**Figure 9.** Fuller Covered Bridge.

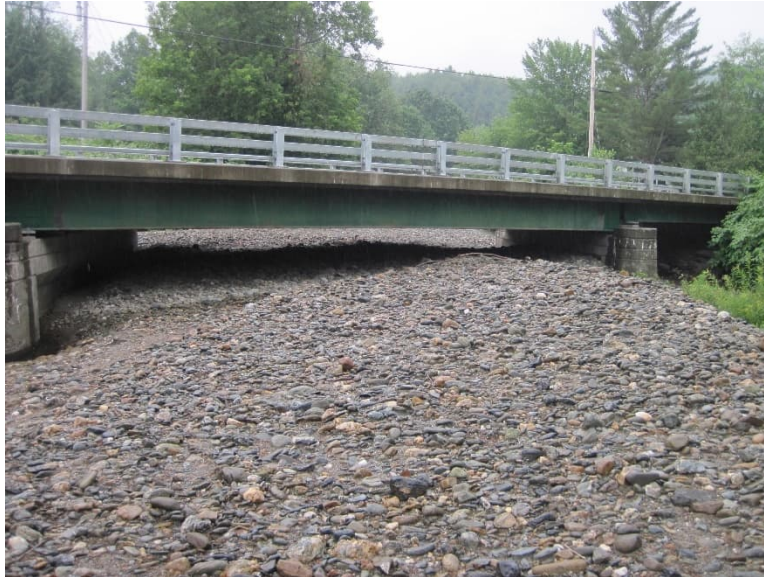
Route 118 (North Main Street) crosses West Hill Brook between the intersections of West Hill Road and Hill West Road. The bridge has a 120-foot span with two piers. The rise varies from 2.6 feet to 6.4 feet with significant accumulation of sediment throughout the structure (Figures 10 and 11).

**Figure 10.** Sediment accumulation at West Hill Brook bridge.

Replacement of undersized bridges was considered in the alternatives analysis to reduce river-road-conflicts. Four bridge replacement projects were included in the alternatives analysis. The Route 118 Bridge over West Hill Brook has a history of flood damages and is located in a depositional setting. The bridge was rehabilitated in 2022 and requires regular sediment removal to reduce flood risk. One component of Alternative 2 includes replacement of the bridge with a new structure that has a longer span and higher clearance. The existing bridge is located near the confluence of West Hill Brook and the Trout River and just downstream of a major break in channel slope and change in valley width. Sediment and debris accumulate at the bridge during floods and have caused overtopping and damage to Route 118 and adjacent properties. In this alternative, the existing 160-foot bridge would be replaced with a 220-foot bridge that is raised 4 feet above the height of the current structure. The land just upstream and downstream of the bridge on the east side would be lowered to create an inset floodplain. The new structure would also only have one pier, while the current structure has two. The bridge replacement alternative also includes removal of accumulated sediment from just upstream of the bridge through the bridge to downstream where the wedge of accumulated sediment ends. Hydraulic modeling indicates that overtopping of Route 118 is reduced in the 100-year event, primarily because a section of the road would need to be raised to achieve the four-foot higher bridge deck. Depth of floodwaters in the model results is reduced upstream of the bridge by 1.5 to 2 feet, but effects do not carry far enough upstream to impact the homes along West Hill Brook (Appendix F, page 15). A new structure would greatly reduce the potential for blockage of the bridge with sediment and debris during flooding.

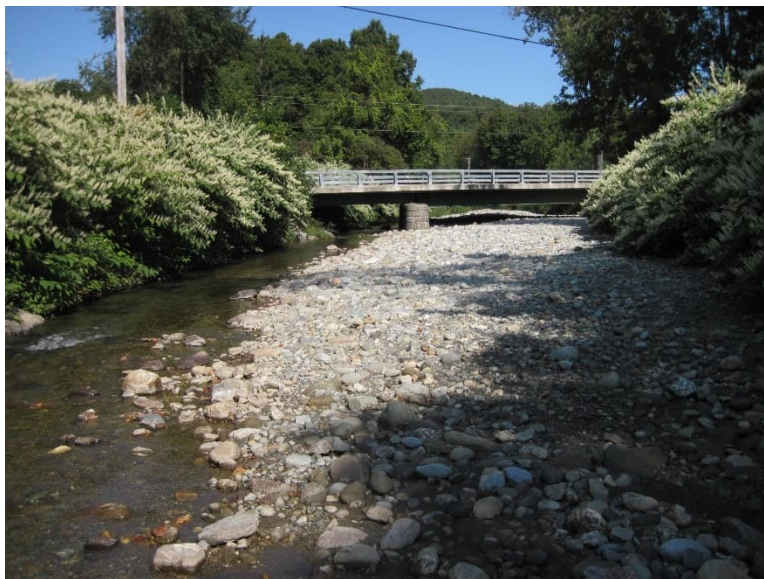
**Figure 11.** West Hill Brook bridge from upstream.

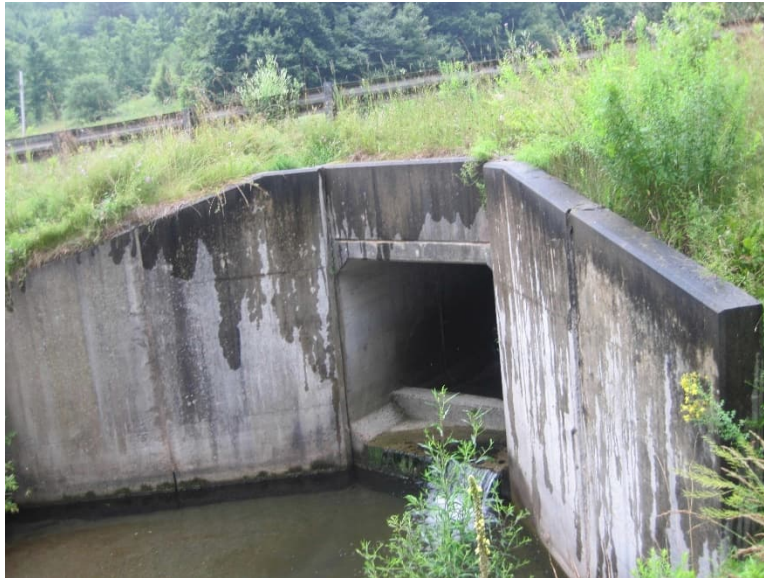
placement throughout the structure. At the time of field data collection, an outlet drop of 1 foot exists from the culvert floor to the water surface of the downstream pool (Figures 12 and 13).

**Figure 12.** Longley Bridge Road tributary culvert outlet.

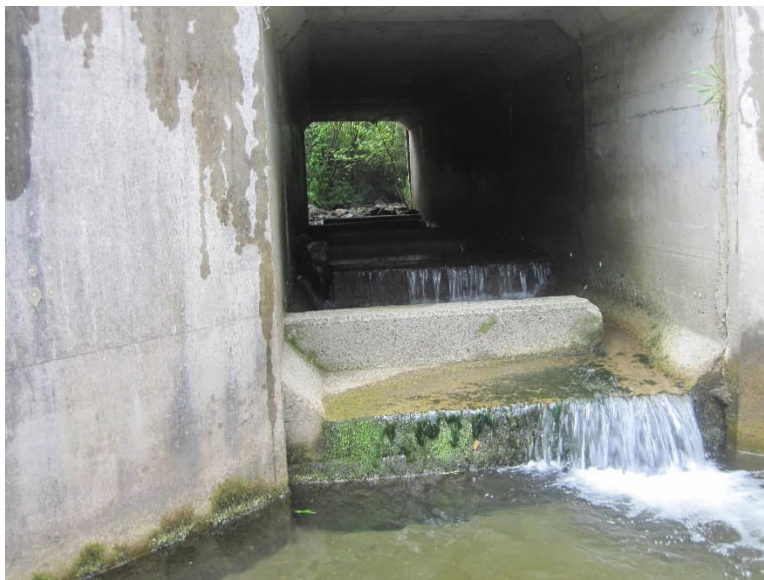
**Figure 13.** Longley Bridge Road tributary culvert outlet.

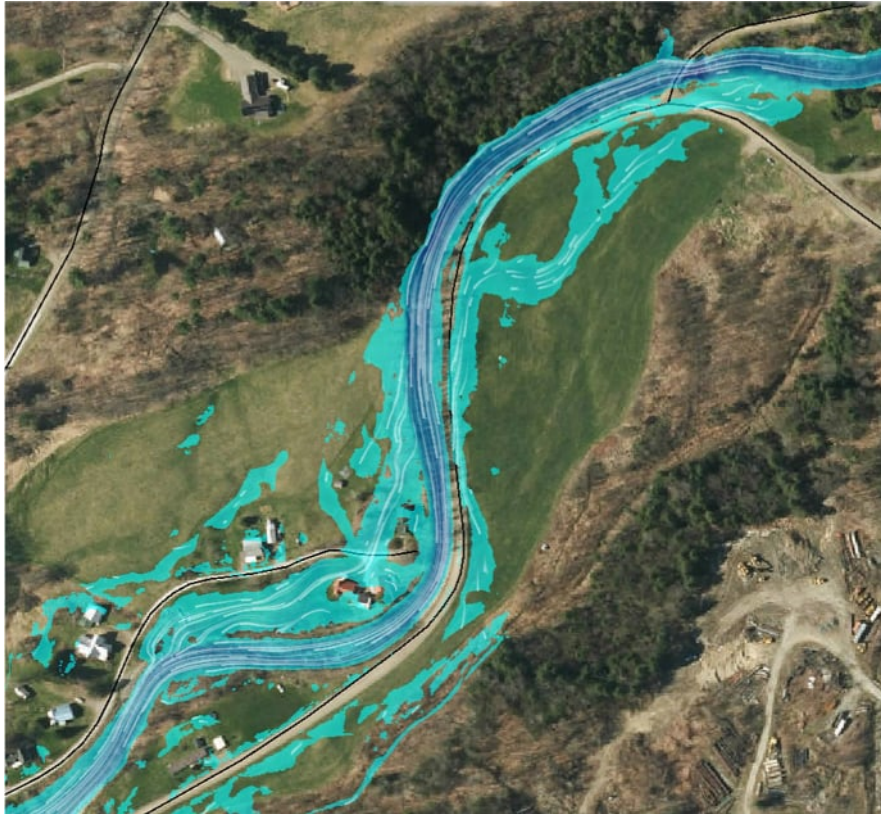
**Figure 16.** Modeling shows floodwaters from Black Falls Brook flowing down Black Falls Road during the 50-year event.

Two specific damage locations were used to evaluate and validate hydraulic model results. The project worksheet for Longley Bridge Road describes damage to 600 linear feet of roadway immediately west of the covered bridge due to overtopping by floodwaters. The length of road overtopping on this section of road was reviewed in the hydraulic model and showed good agreement between the model results in this location and observed damages. The project worksheet for damage to Black Falls Road, which runs parallel to Black Falls Brook on the southern bank, was reviewed and compared to the hydraulic model. During Tropical Storm Irene floodwaters overtopped the banks of Black Falls Brook and flowed down Black Falls Road causing 1,200 linear feet of roadway damage. Hydraulic model results for the 50-year event show floodwaters flowing down an 1,100-foot section of Black Falls Road in the same location as the project worksheet, providing further agreement between modeled and documented conditions (Figure 16).

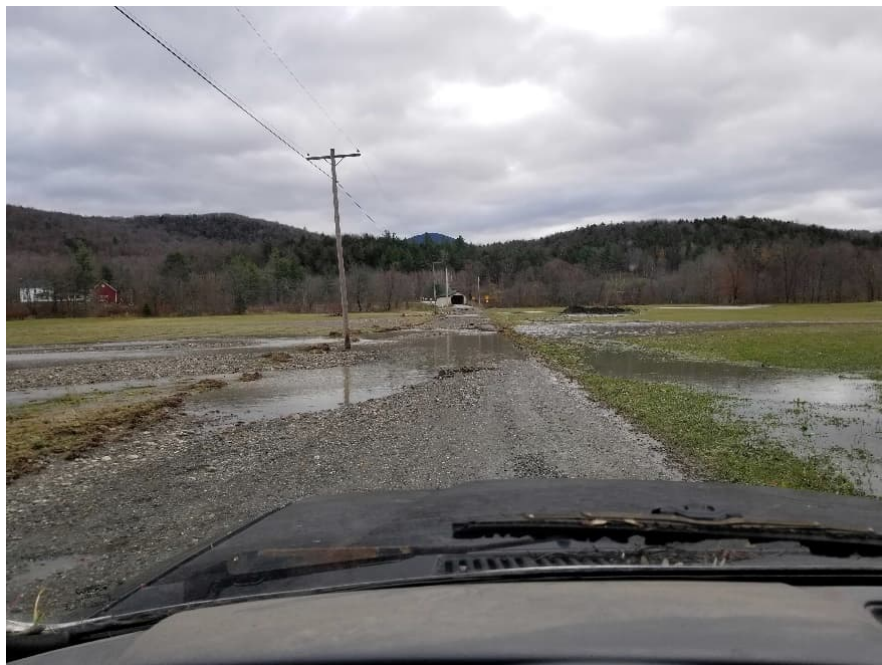
**Figure 18.** Longley Bridge Road looking east toward the covered bridge at the damaged section of roadway following the Halloween 2019 flood.

For the Halloween 2019 flood, flow data were not recorded on the Trout River. Damage data reported for Longley Bridge Road state that 630 linear feet of roadway washed out just west of the covered bridge (Figures 17 and 18). Hydraulic model results show this level of overtopping between the 10-year and 50-year events. Photos from the Halloween 2019 flood show floodwaters exiting the channel of West Hill Brook just upstream of the Route 118 Bridge on the west bank (Figures 19 and 20). The model shows overtopping in this location beginning in the 50-year storm.

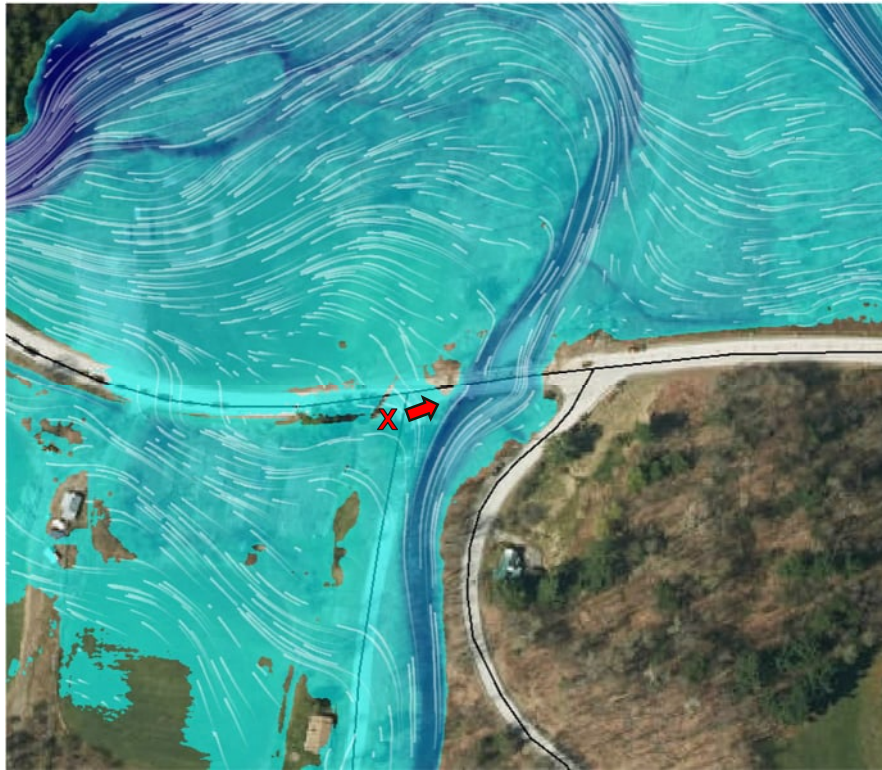
**Figure 19.** Modeling shows floodwaters from West Hill Brook flowing out of the channel upstream of the Route 118 Bridge on the west bank during the 50-year event. Damage photo viewpoint denoted with red X.

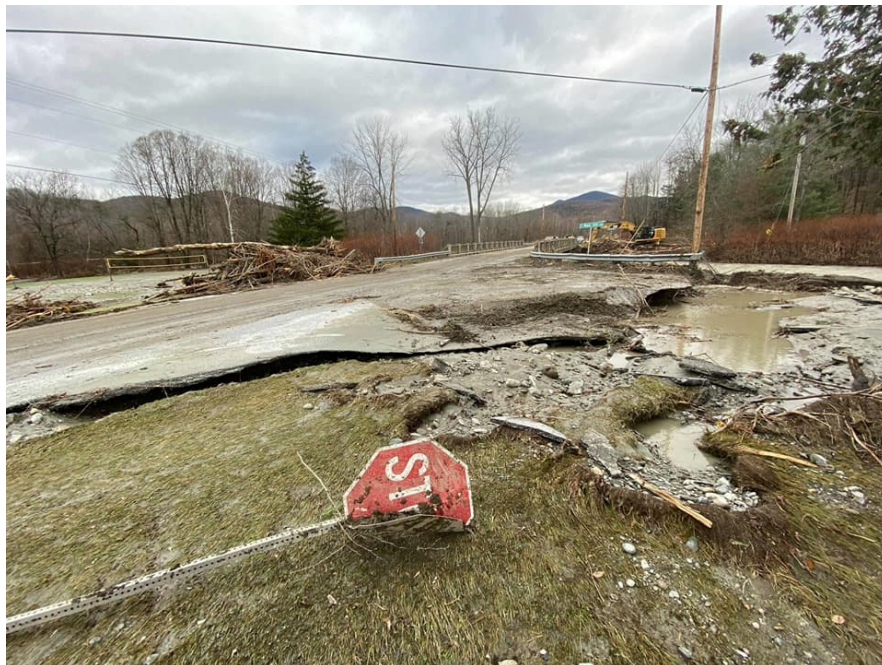
**Figure 20.** Route 118 Bridge over West Hill Brook from intersection with West Hill Road following Halloween 2019 flood.

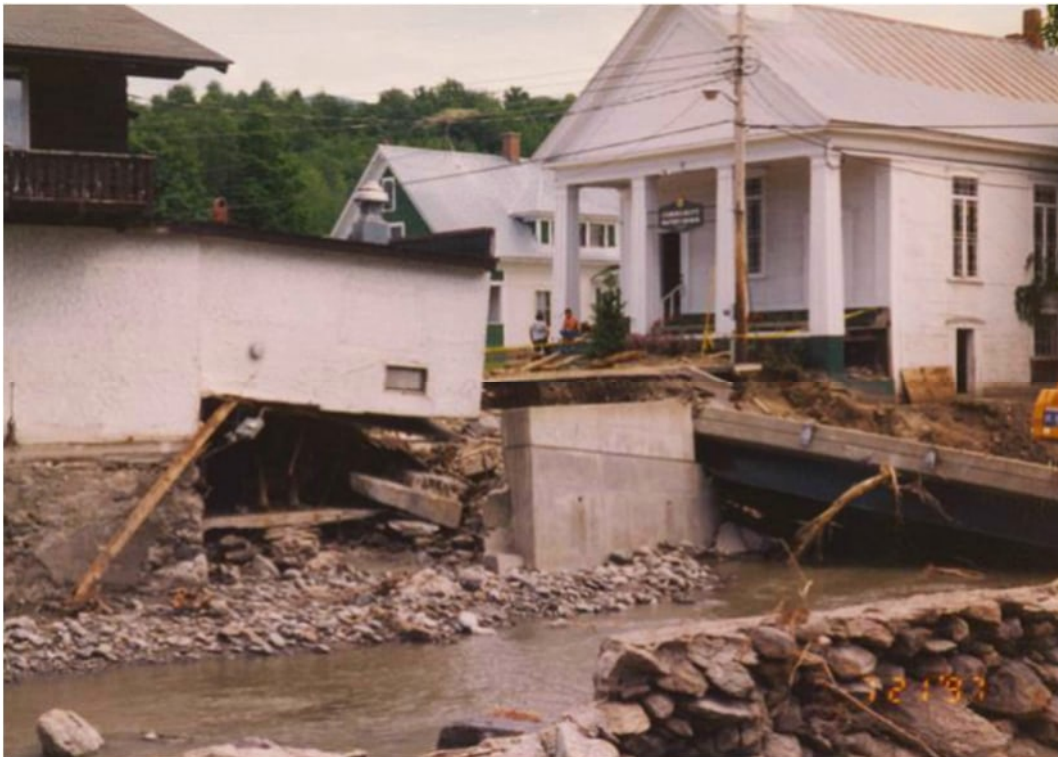
**Figure 21.** Looking northeast at the destroyed North Main Street Bridge in Montgomery Center following the 1997 flood.

A National Weather Service report on the July 15, 1997 flood in Montgomery provides anecdotal information on flood damages as well as damage photos (National Weather Service). Extensive damages were reported throughout Montgomery and this flood remains the largest in recent decades. Montgomery Center reported major damages including flooding of homes and businesses all along North Main Street and the destruction of the North Main Street Bridge (Figures 21 and 22). Floodwaters appear to have exited the Trout River upstream of the North Main Street Bridge and flowed down North Main Street and across properties on Begnoche Farm Road (Figure 22). These flooding patterns best match the model results for the 500-year flood, which shows a substantial amount of water in the eastern portion of the Center. Photos from the 1997 flood show major damage on Longley Bridge Road just west of the covered bridge where floodwaters are known to overtop the roadway (Figure 23). Modeled flood depth mapping and flow vectors show floodwaters exiting the channel of the Trout River just upstream of the North Main Street Bridge and flowing westerly through the Center (Figure 24).

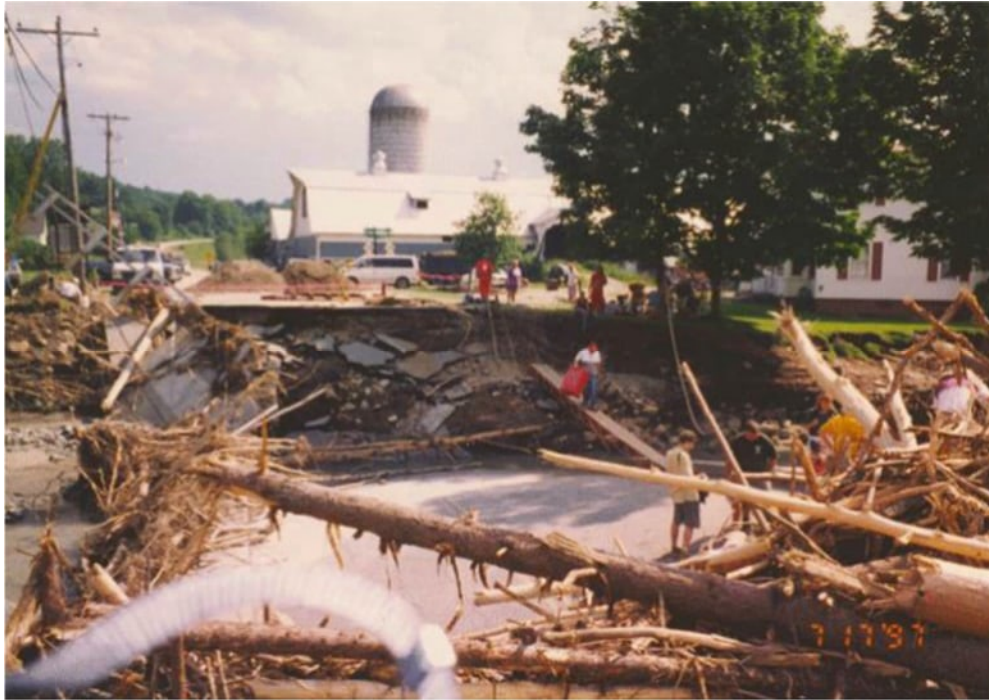
**Figure 22.** Looking south across the destroyed North Main Street Bridge following the 1997 flood.

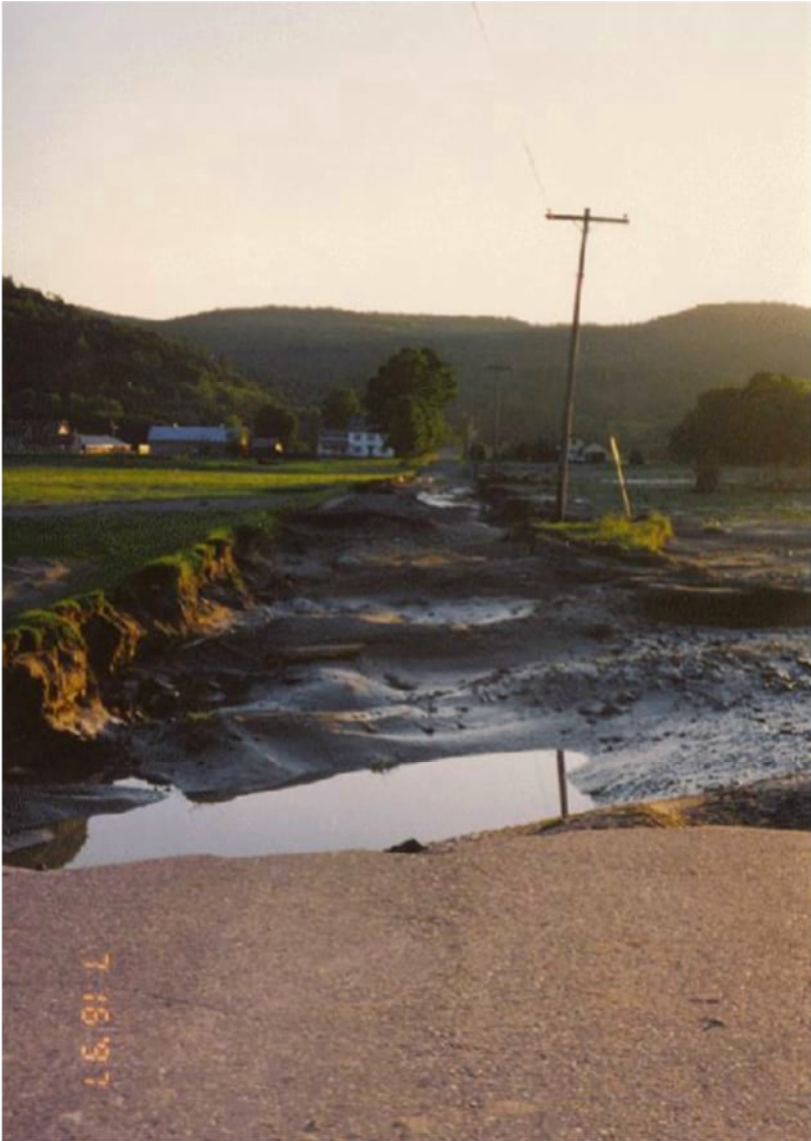
**Figure 23.** Looking west at damage to Longley Bridge Road following the 1997 flood.

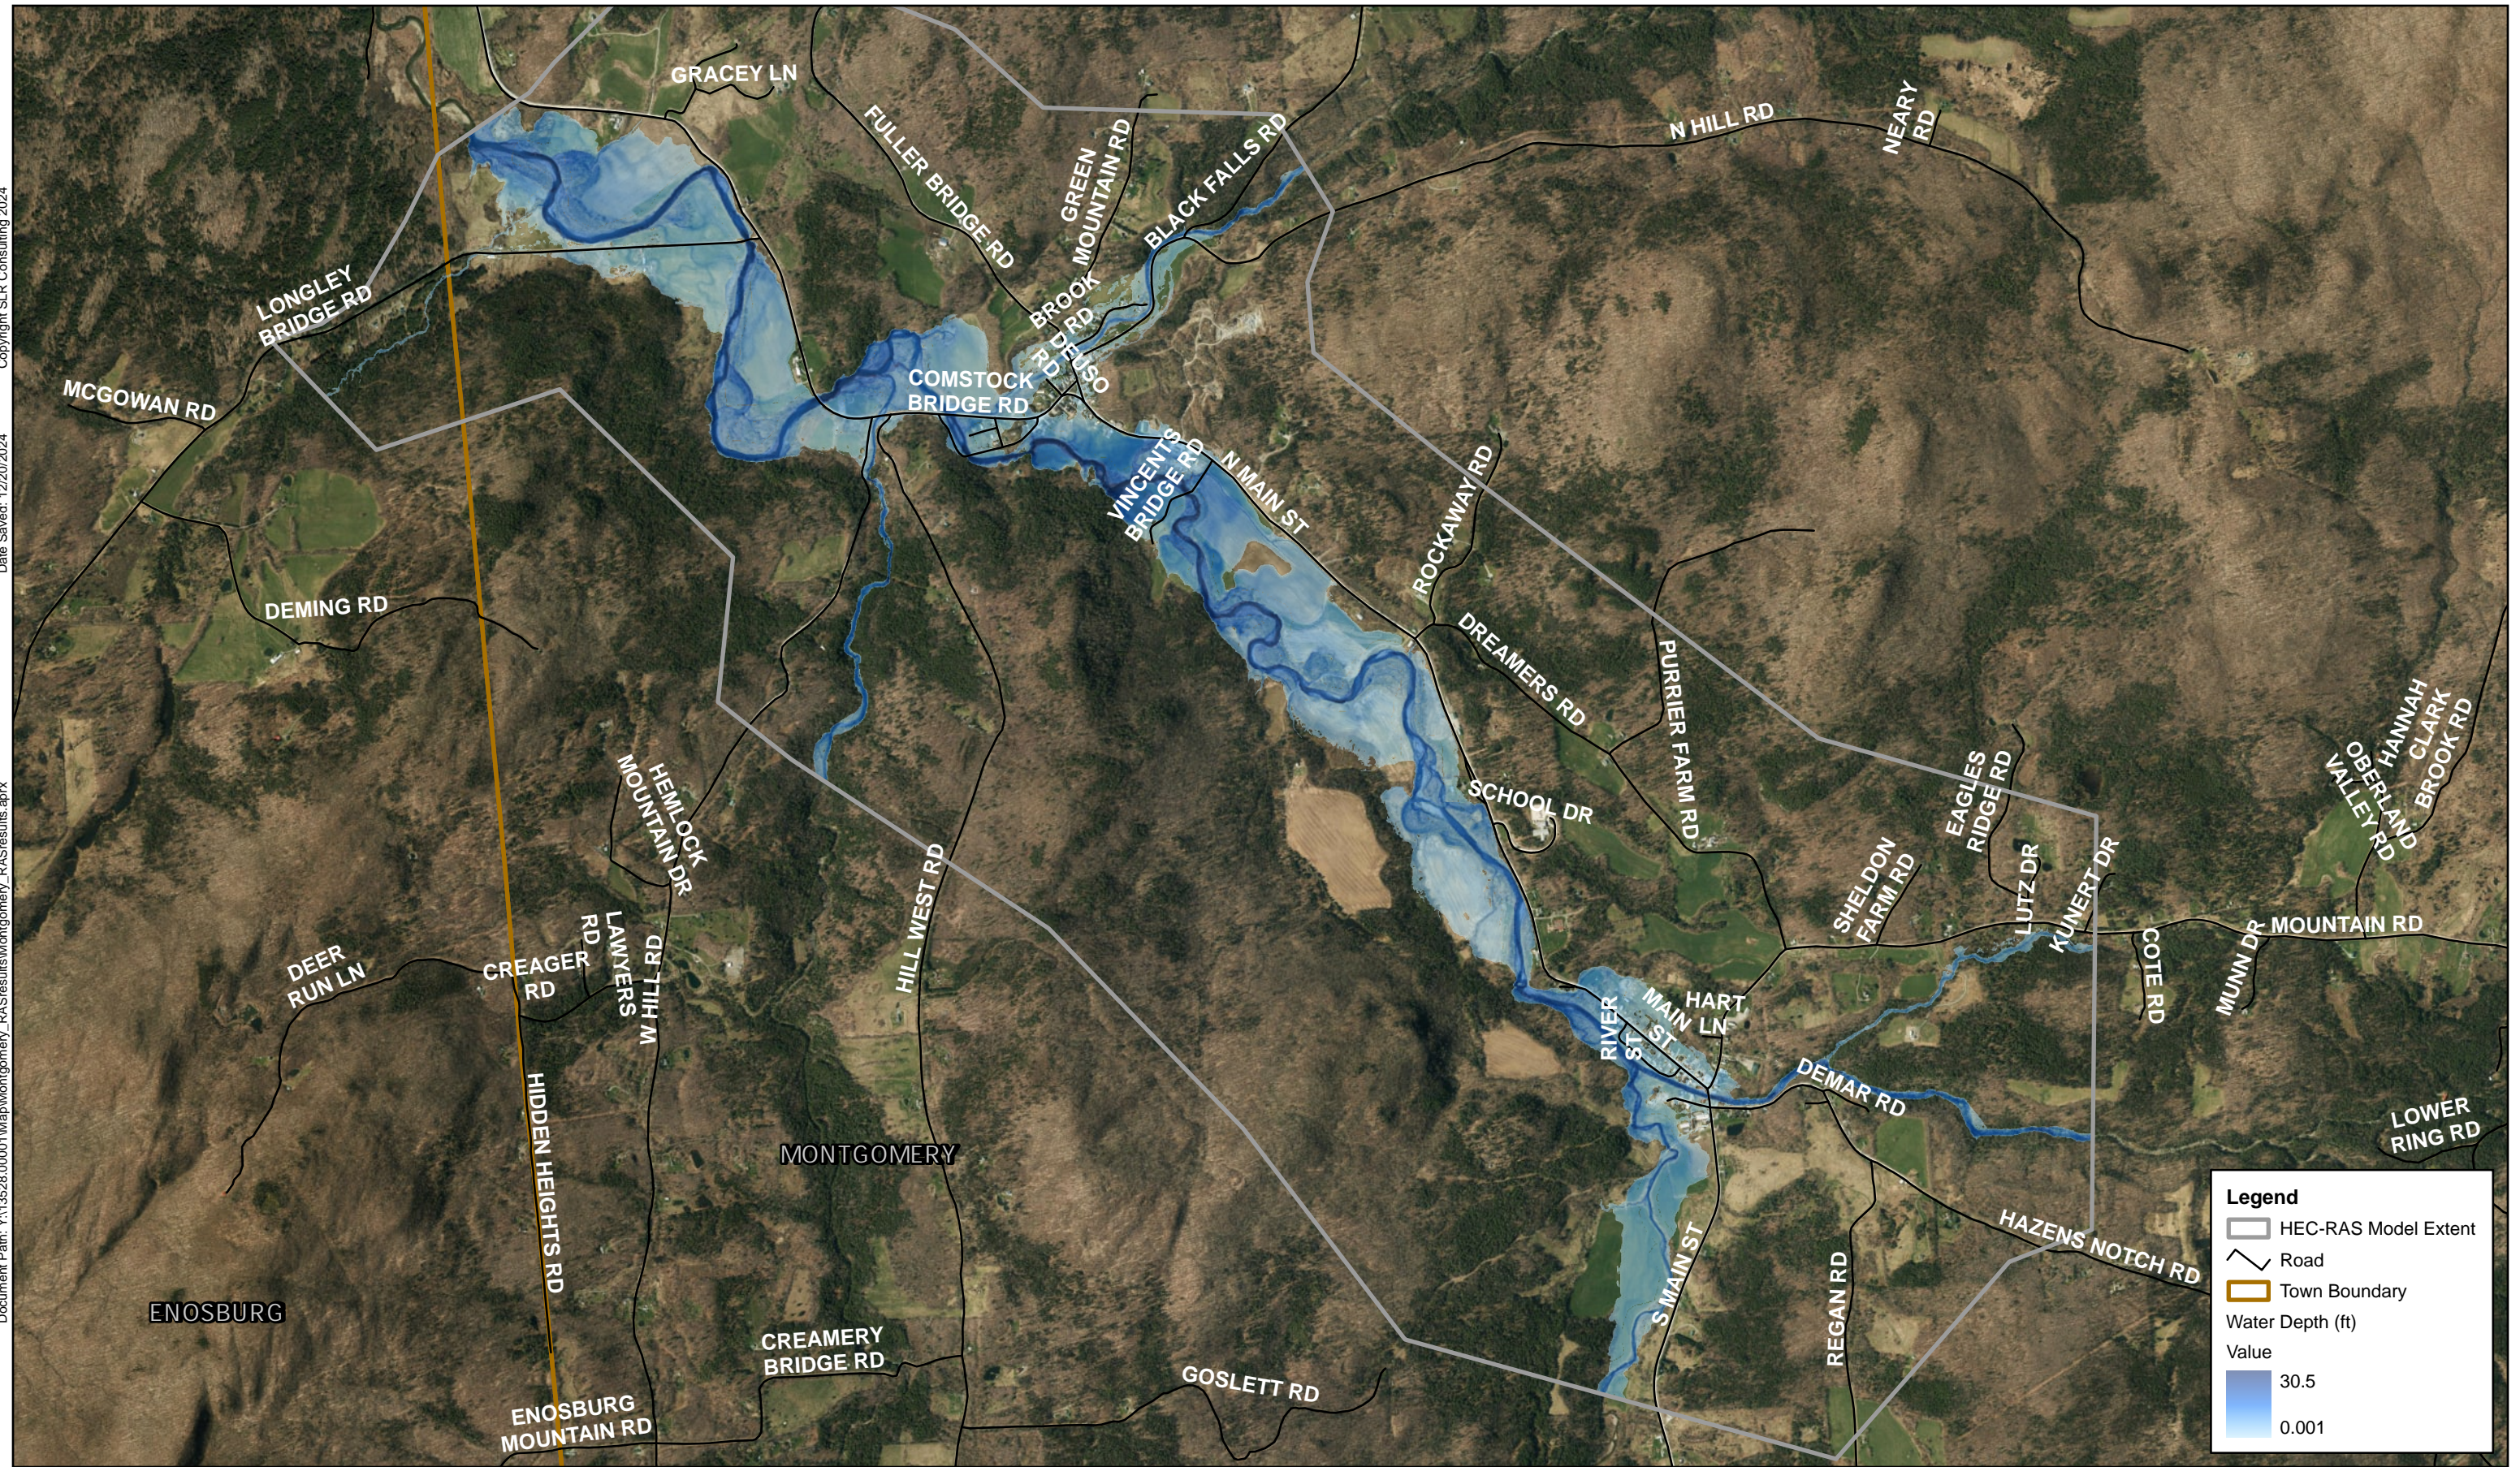
**EXISTING CONDITIONS - 500-YEAR FLOOD**  
 MONTGOMERY FLOOD HAZARD MITIGATION STUDY  
 FRANKLIN COUNTY NATURAL RESOURCES CONSERVATION DISTRICT

For the 500-year flood, existing conditions modeling shows that floodwaters remain in the channel of the Trout River until just upstream of the Montgomery Center for the Arts in Montgomery Center. Floodwaters exit the channel on both banks in this location and flow down North Main Street around homes and businesses, inundating most of the Center. Depth mapping from the model shows 1 to 3 feet around homes and businesses east of Mountain Road, 0.5 to 2 feet around businesses and homes in the eastern portion of the Center, with locally deeper water up to 4 feet around the houses closest to the river on River Street. The western portion of the Center has greater 100-year flood water depths of 1 to 6 feet around homes and businesses. The entire length of North Main Street within the Center is overtopped by 0.5 to 4 feet of water. Homes and businesses on the southern side of the Trout River in the Center are also shown to be surrounded by 0.5 to 4 feet of water.

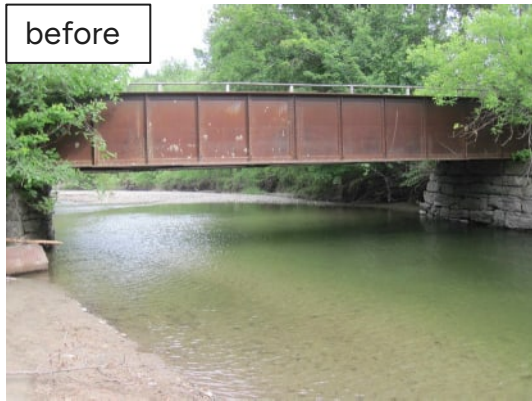
before

## Removed constriction

- An undersized bridge and unused abutments were removed
- Larger bridge installed
- Opened up floodplain under bridge

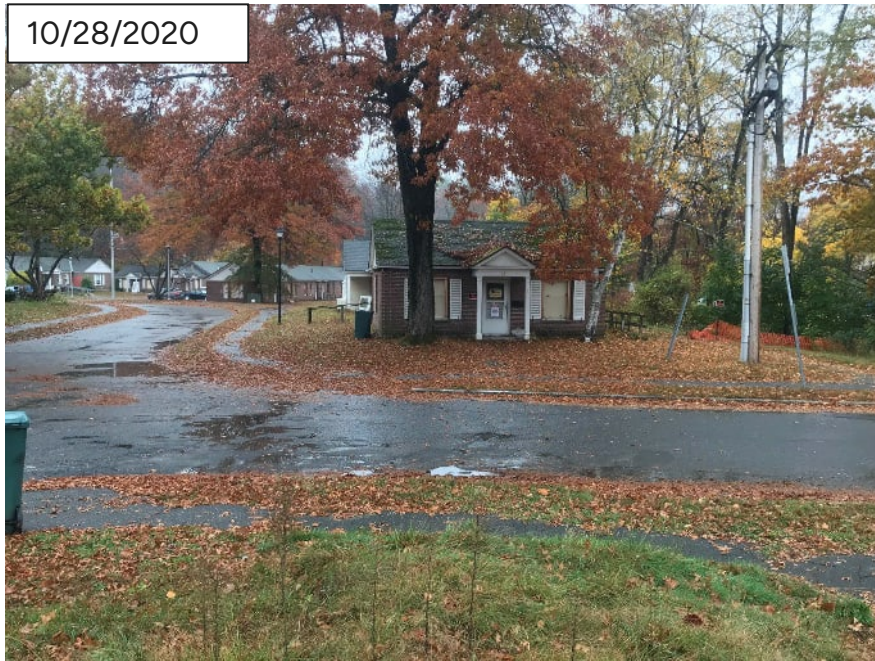
# Melrose Terrace, Brattleboro – Overflow culvert at bridge

Pre-construction

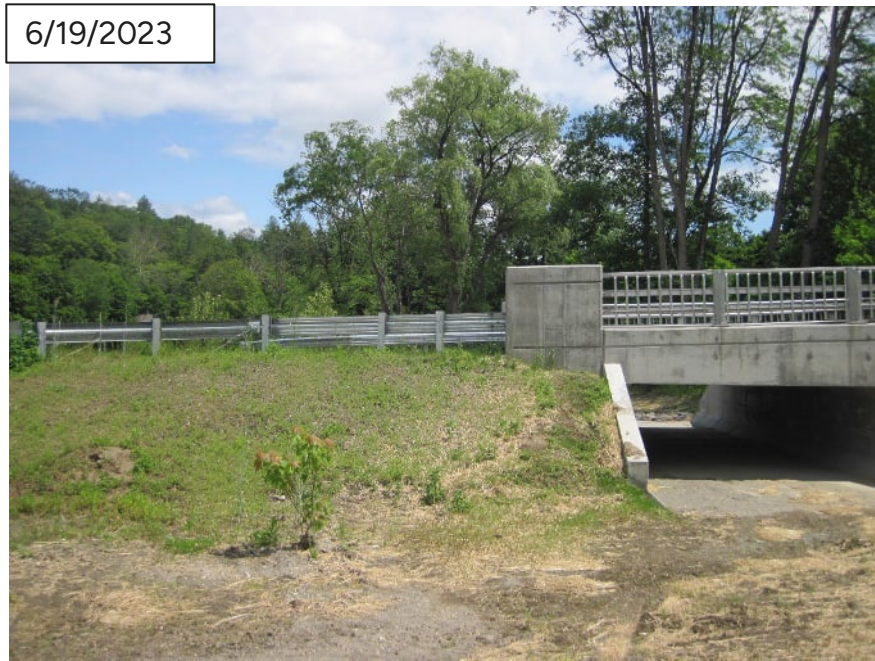
Post-construction

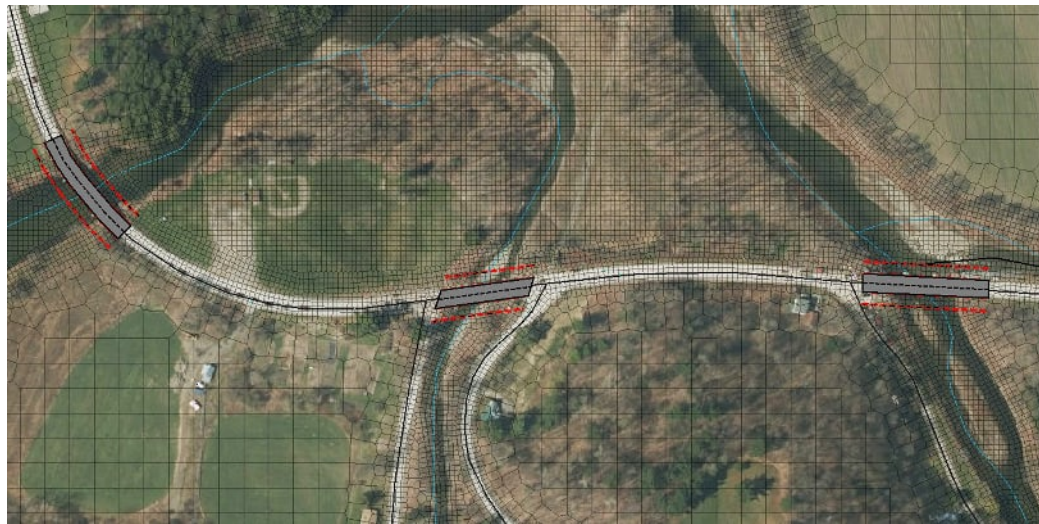
- Model mesh refined to accurately show berms, road edges, channel
- Bridges and culverts inserted using survey data, collected LiDAR, and high accuracy GPS data

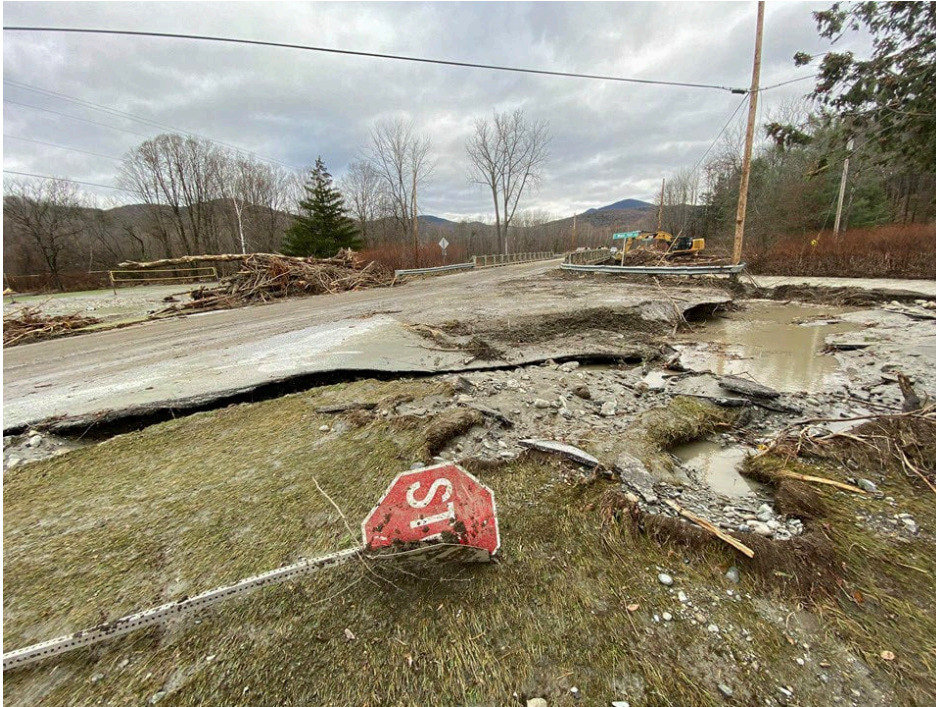
North Main and West Hill Road  
Following Halloween 2019 Flood

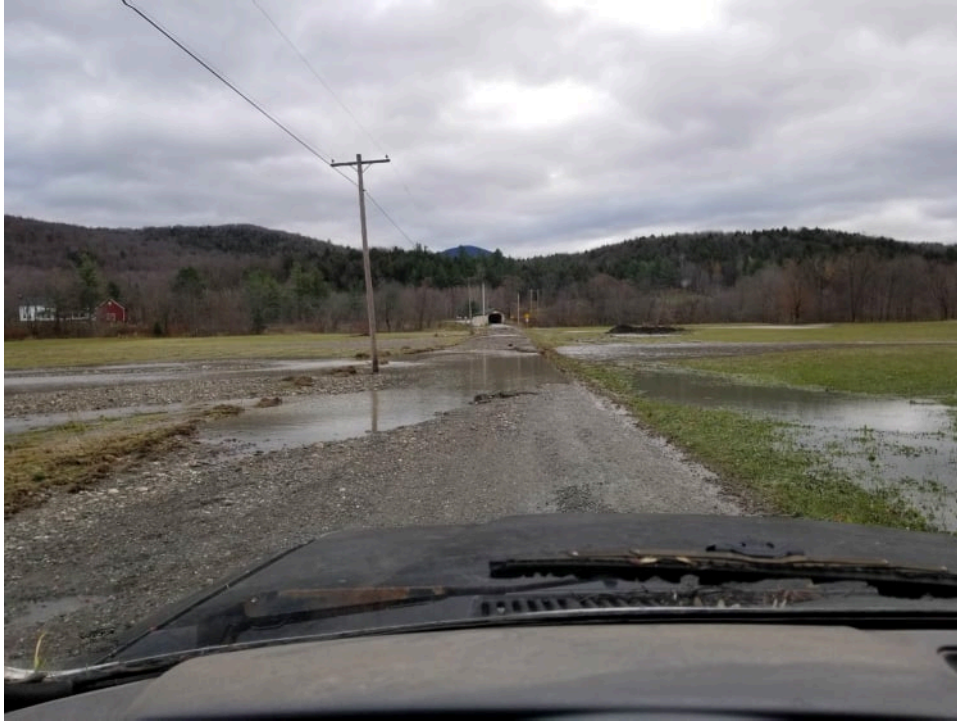
Longley Bridge Road  
Following Halloween 2019 Flood

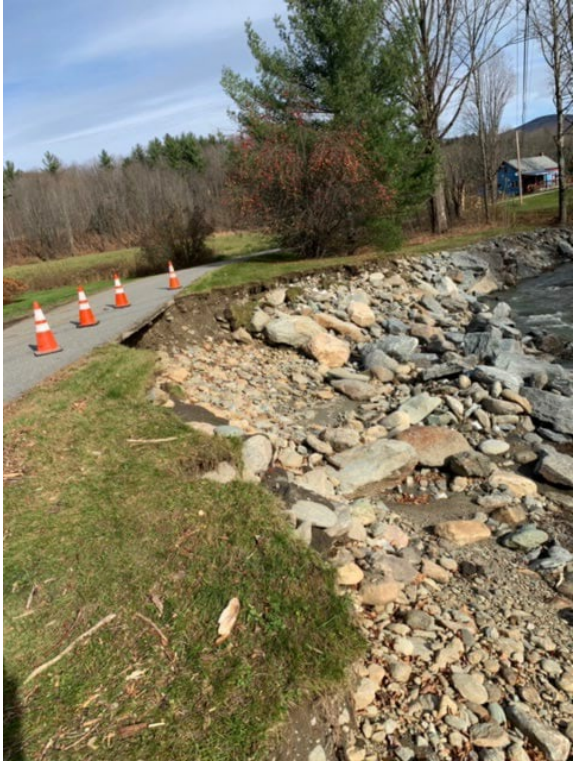
Brook Road  
Following Halloween 2019 Flood

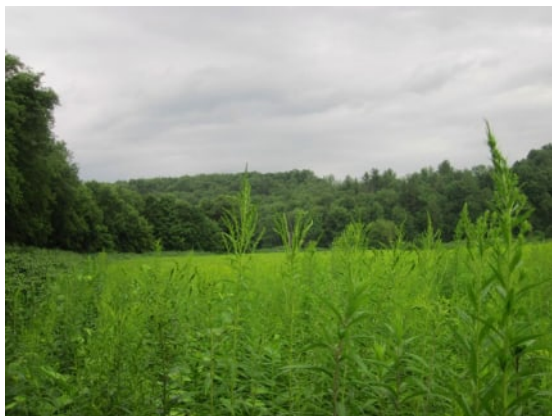
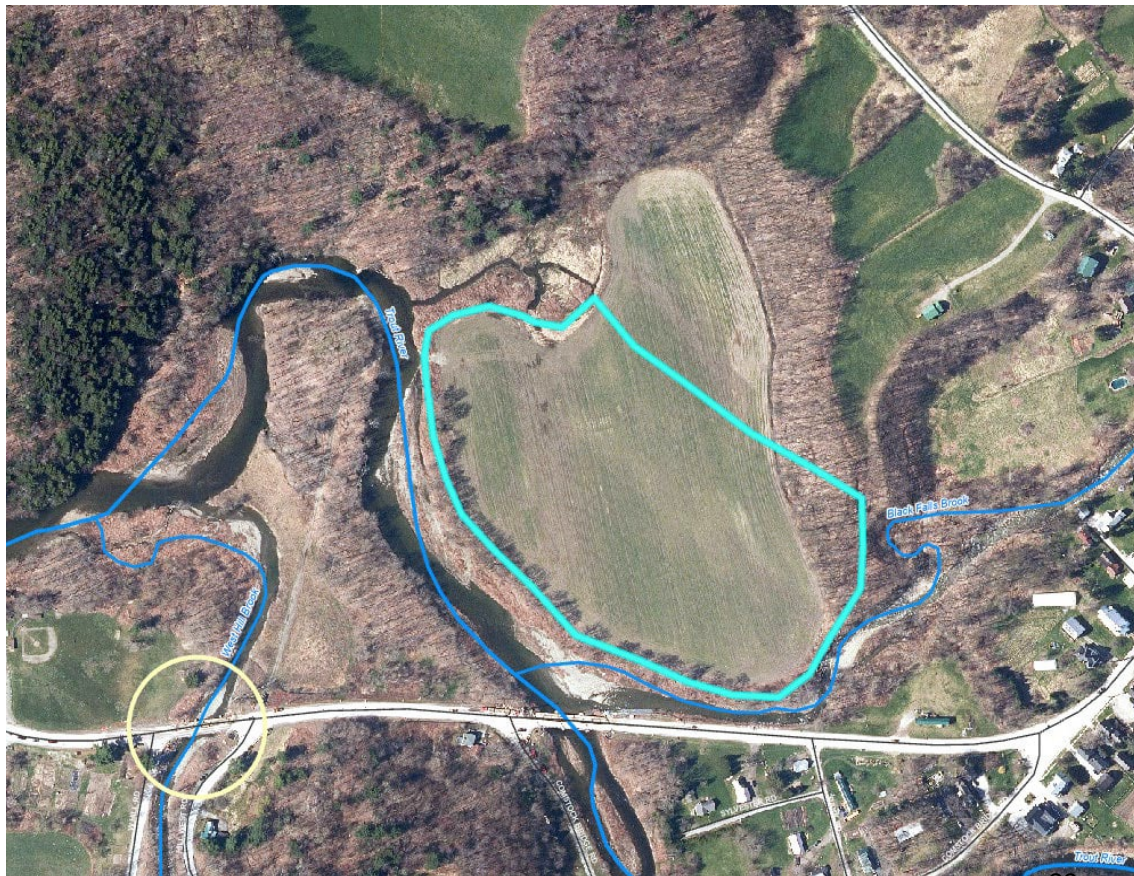
# Alternative 1

- Floodplain and Wetland Restoration at 251 Fuller Bridge Road
- Various size footprints and flood storage options
- Black Falls Brook Confluence

- Floodplain and Wetland Restoration at 251 Fuller Bridge Road
- Minimal change in flood extent
- Reduction of in-channel velocities from 10-13 ft/s to 4-9 ft/s along road embankment
- Small footprint recommended
