# Montgomery Flood Hazard Mitigation Study

**Montgomery, Vermont  
Franklin County Natural Resources Conservation District**

**SLR International Corporation**

December 27, 2024

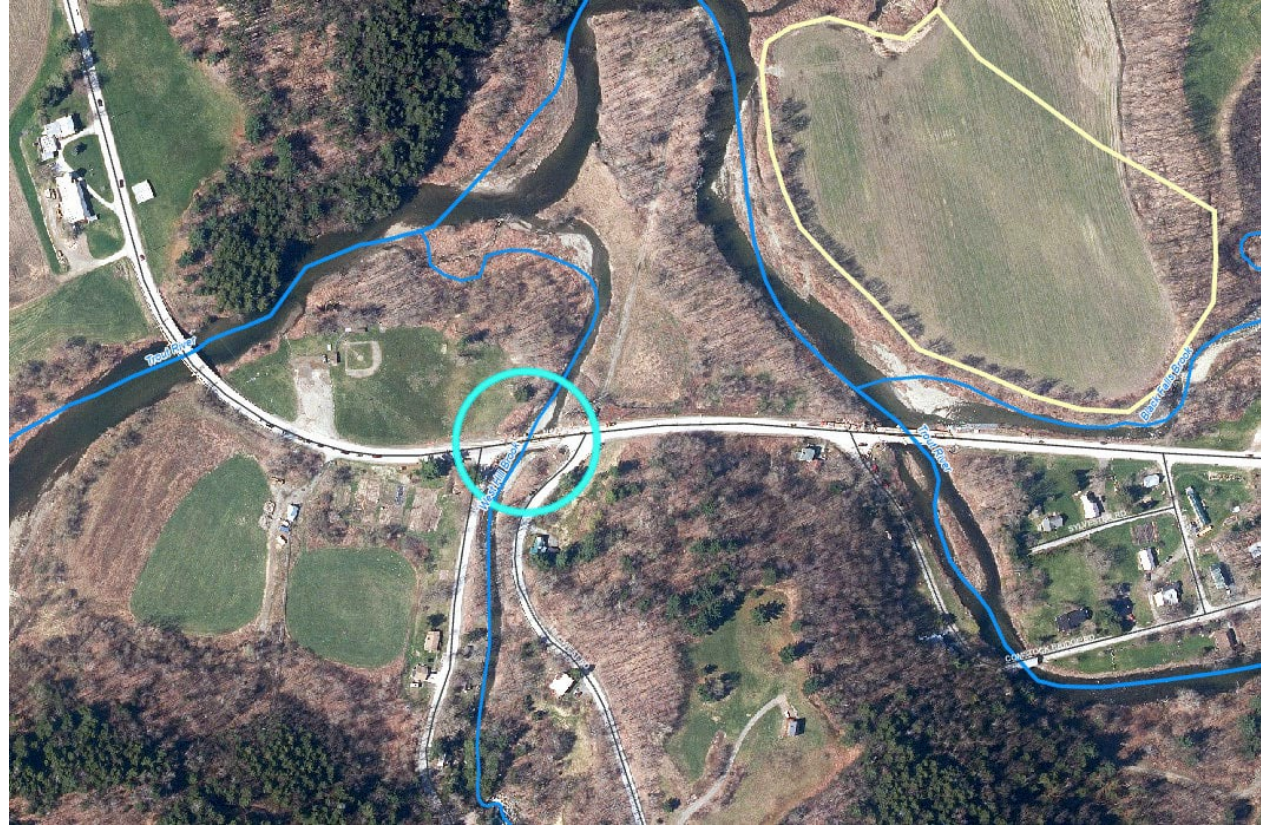
# Alternative 2

- Route 118 at West Hill Brook

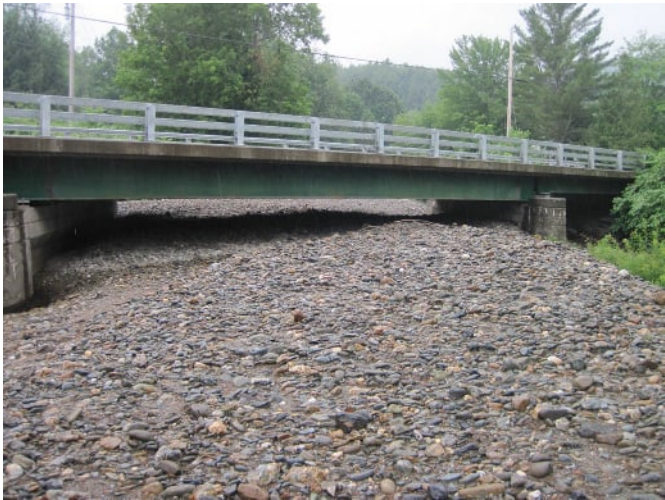
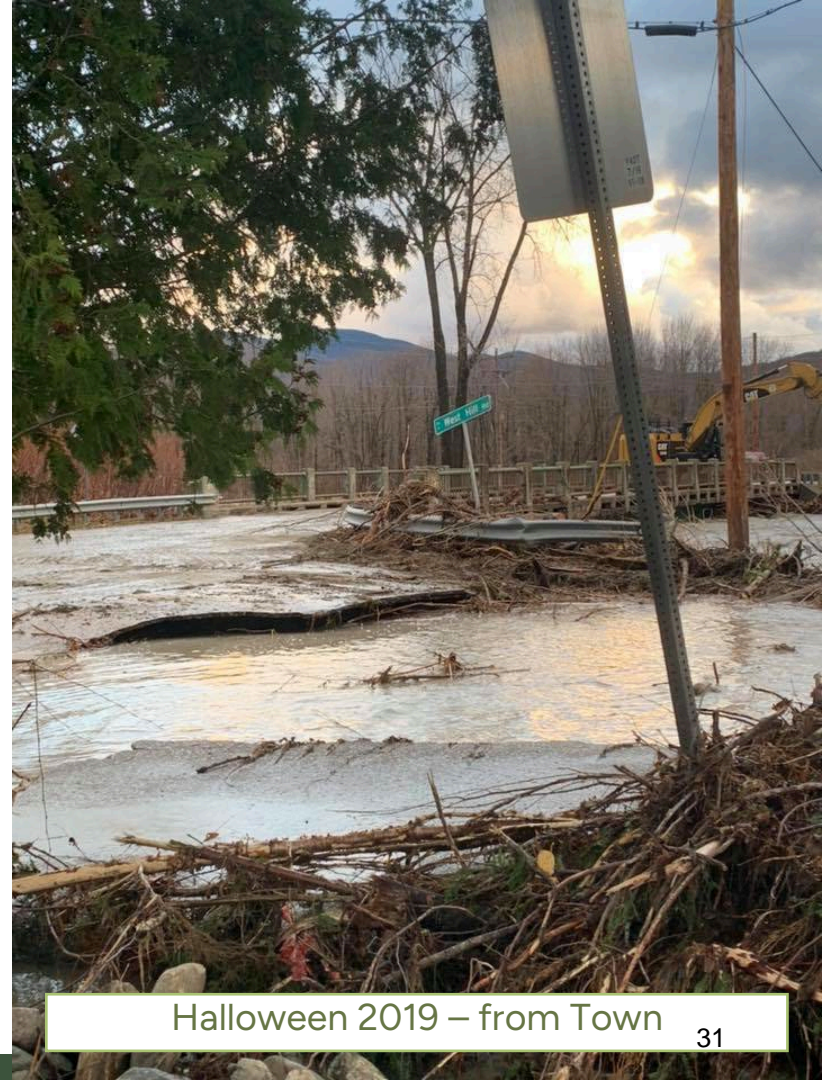
# Alternative 2

- Route 118 at West Hill Brook
- Bridge Replacement
- Sediment and debris management
- Increase transport

- Replace bridge with 220-ft span
- Overtopping of Route 118 reduced but not eliminated
- Benefits do not extend upstream to location of homes
- Benefits not substantially better than overflow culvert

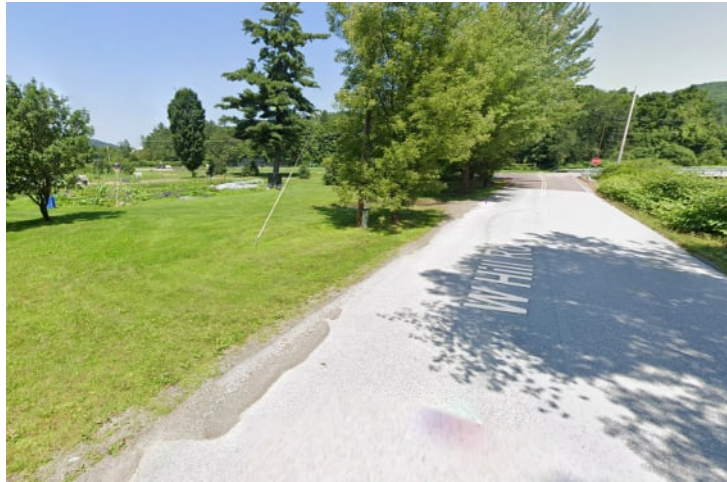
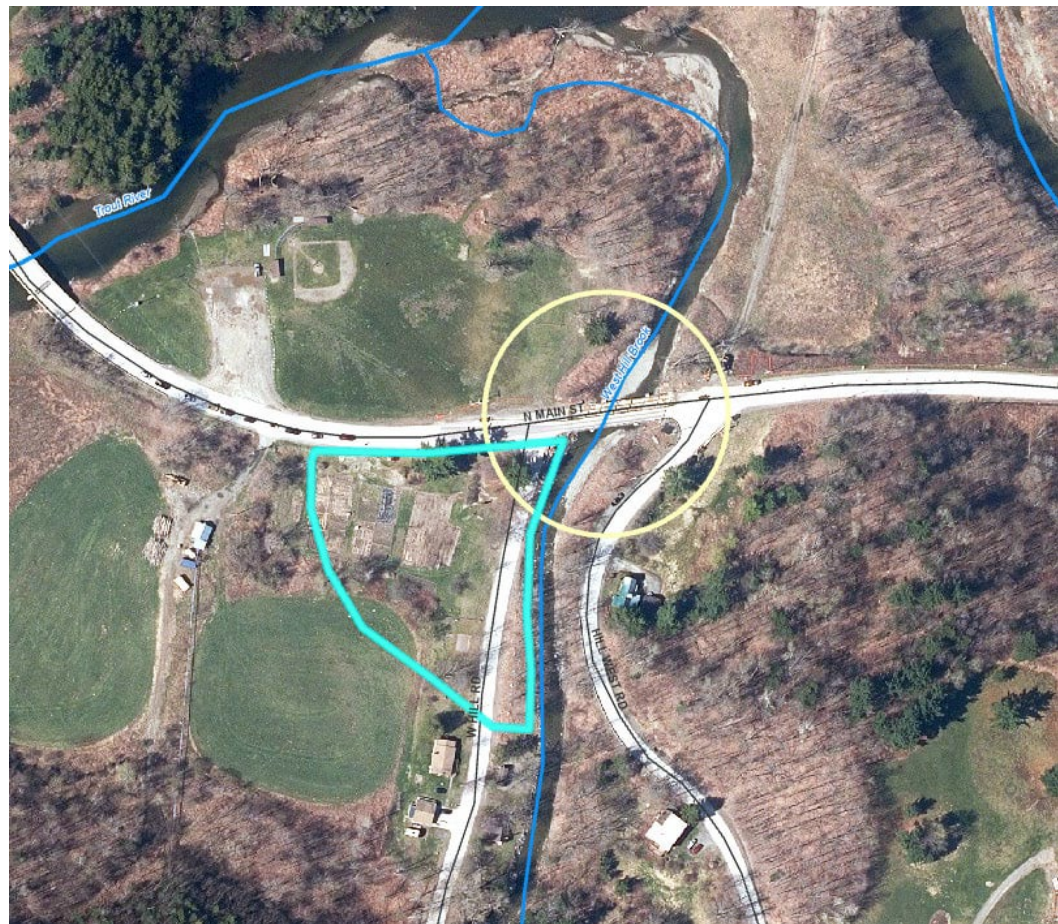
# Alternative 3

- Realign West Hill Road farther to West at West Hill Brook
- Floodplain Restoration to lower land at gardens (prior buyouts)

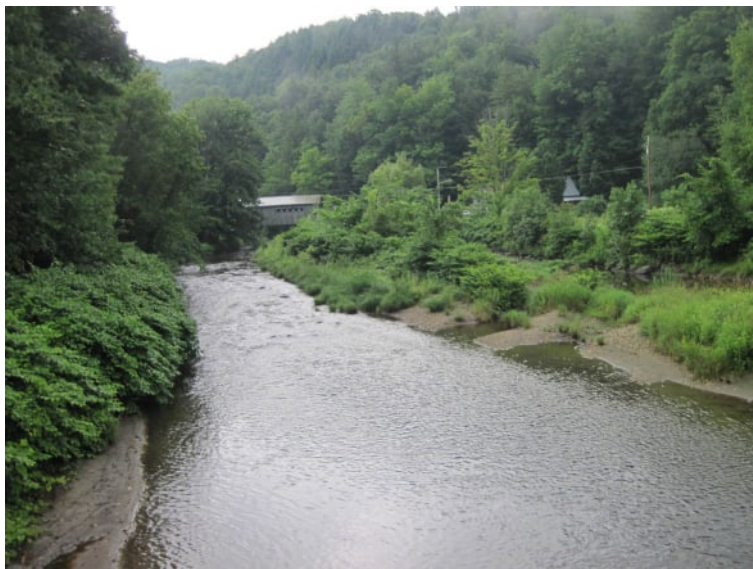
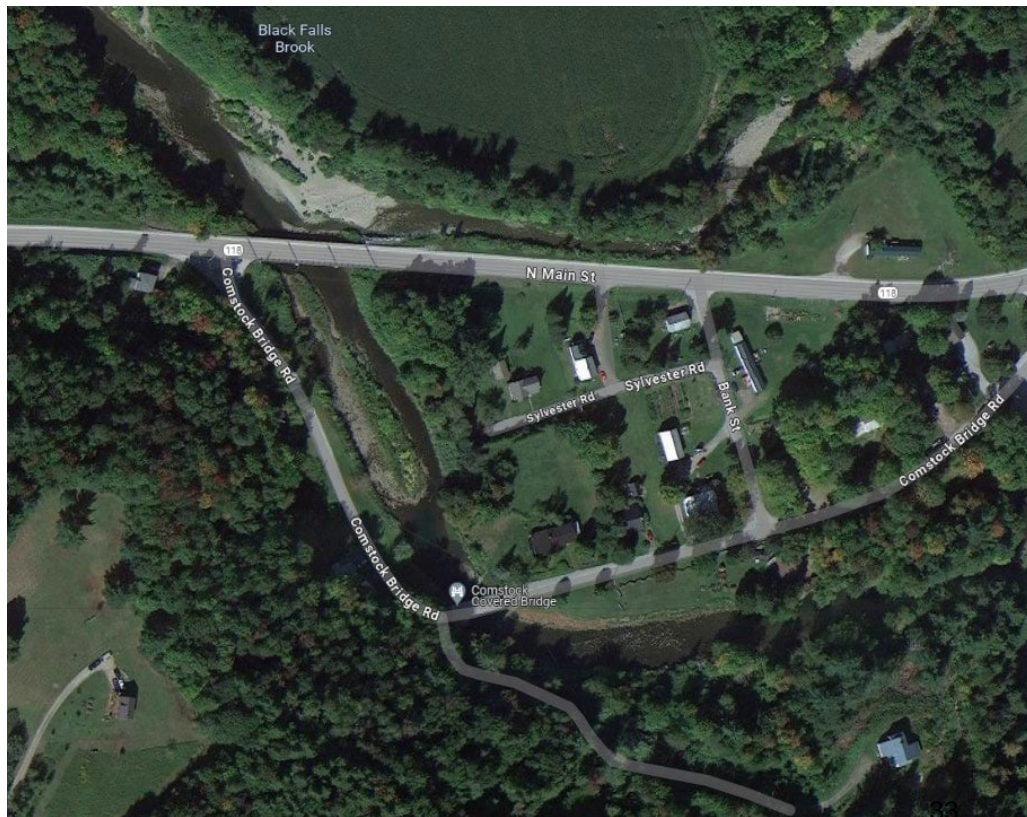
# Alternative 4

- Comstock Bridge at Trout Brook
- Bridge Replacement
- Reinforced Overflow

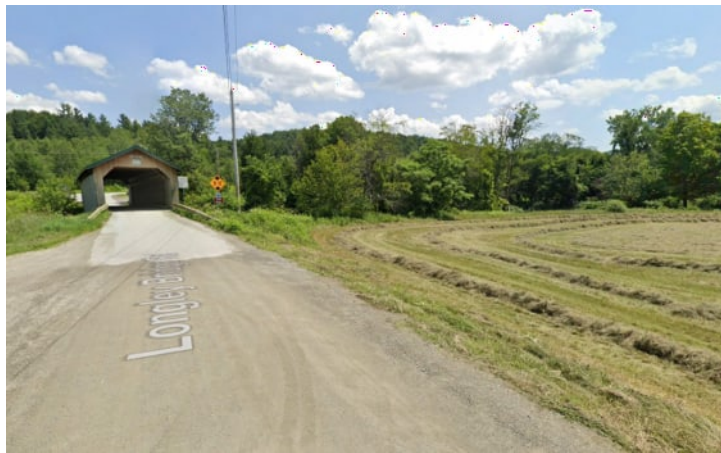
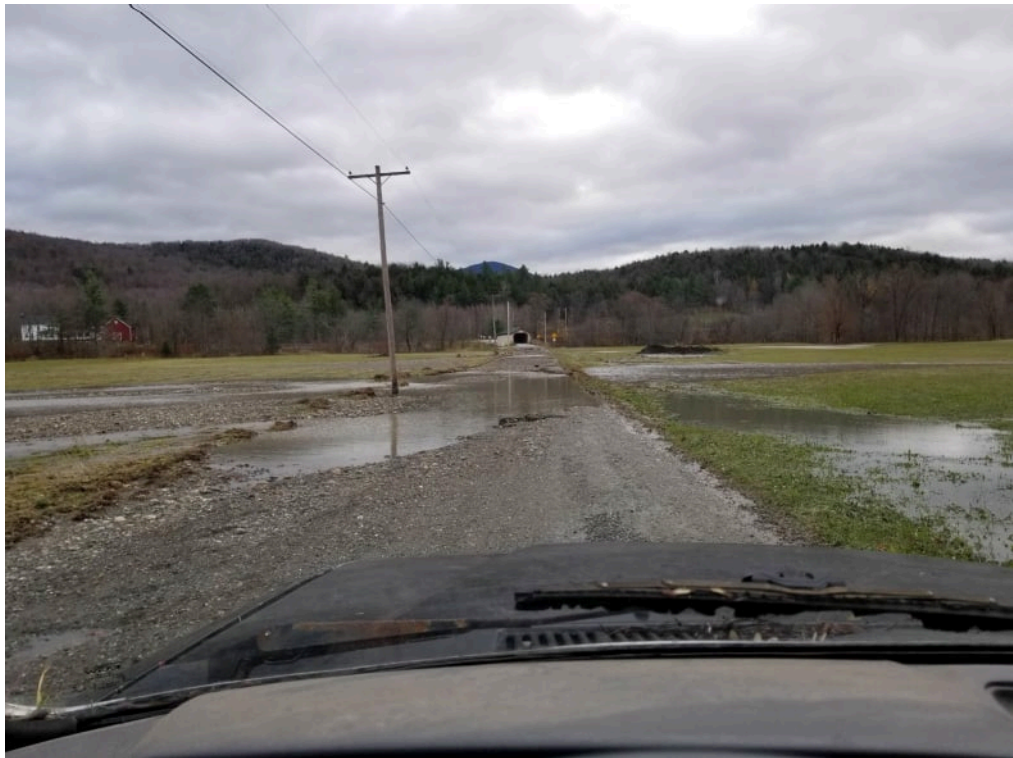
# Alternative 6

- Longley Bridge Road at Trout Brook
- Reinforced Overflow
- Historic Bridge
- Road damage at Irene

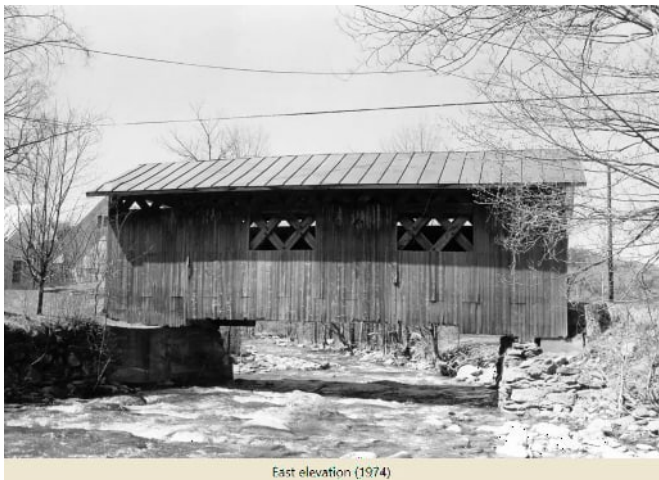
East elevation (1974)

- Fuller Covered Bridge at Black Falls Brook
- Reinforced Overflow
- Historic Bridge
- Road damage multiple times

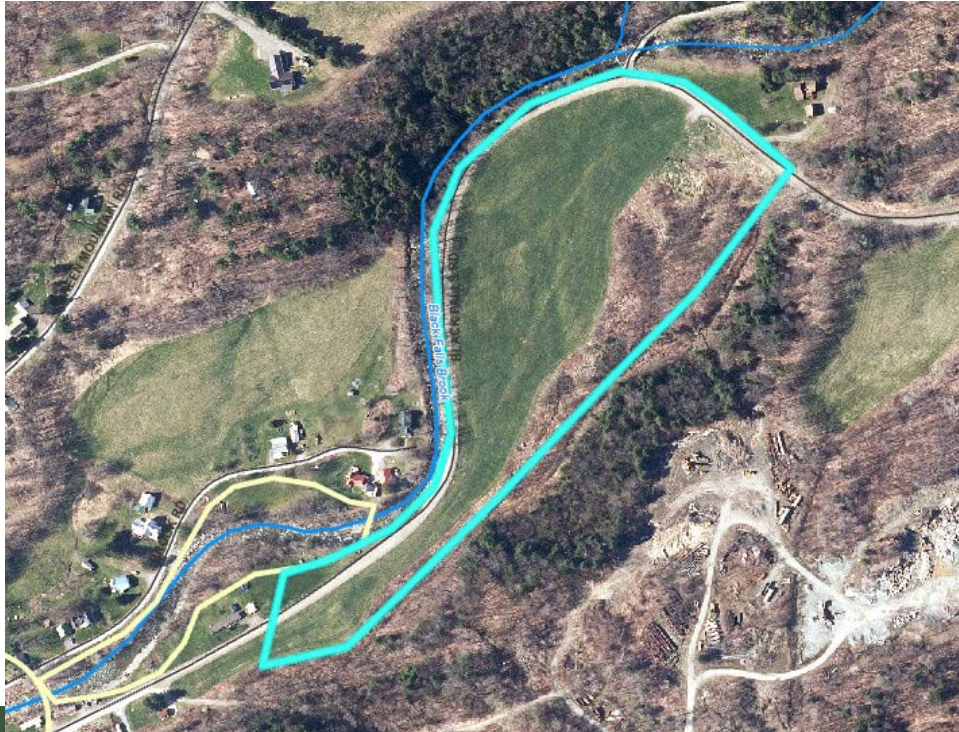
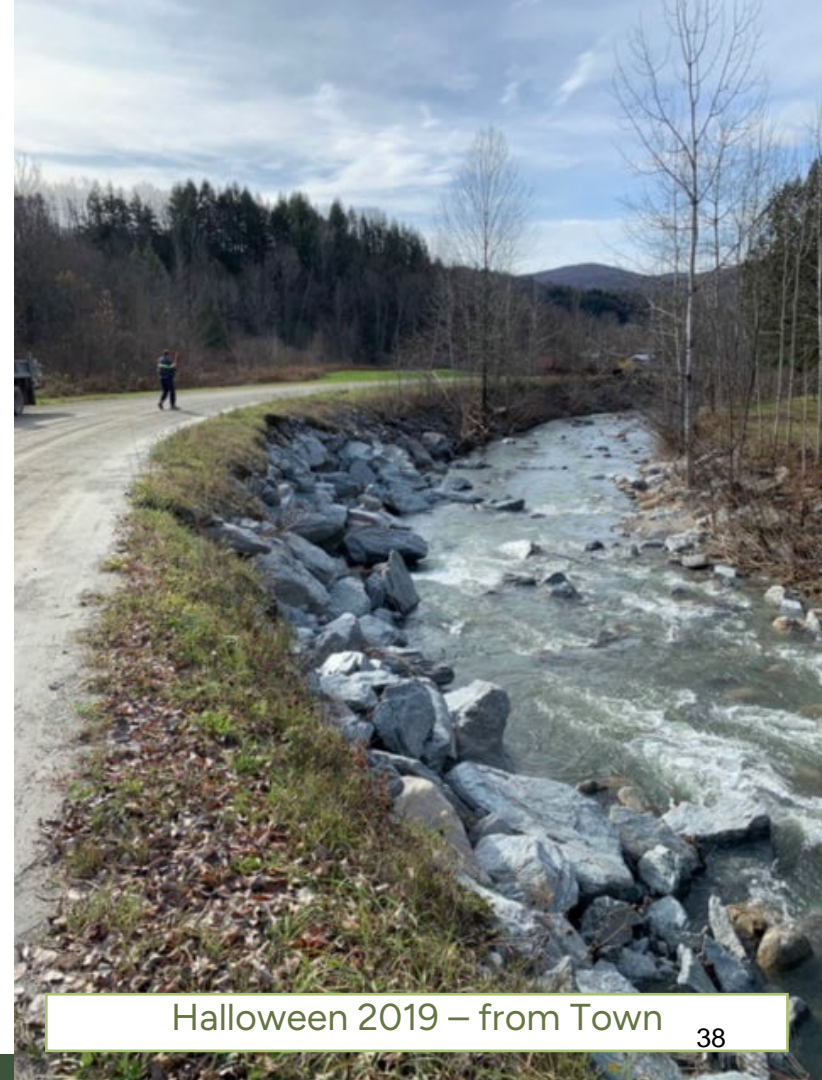
# Alternative 9

- Black Falls Brook is confined along Black Falls Road and Brook Road
- Move Black Falls Road & lower floodplain

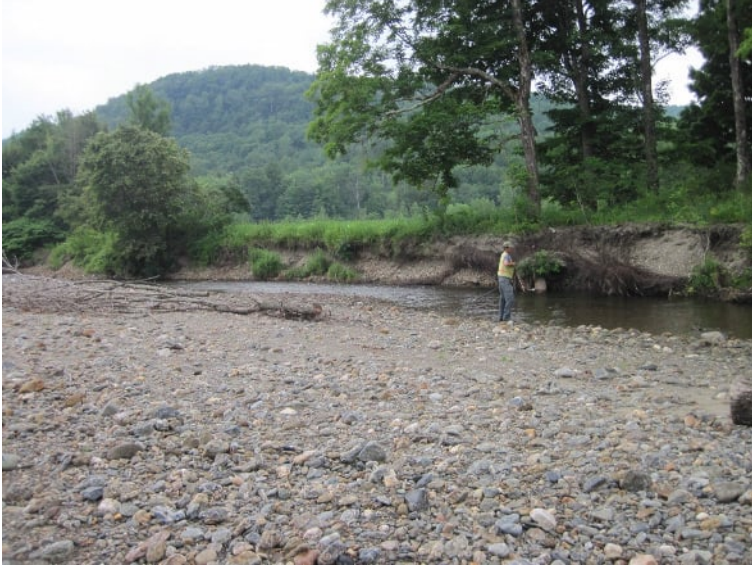
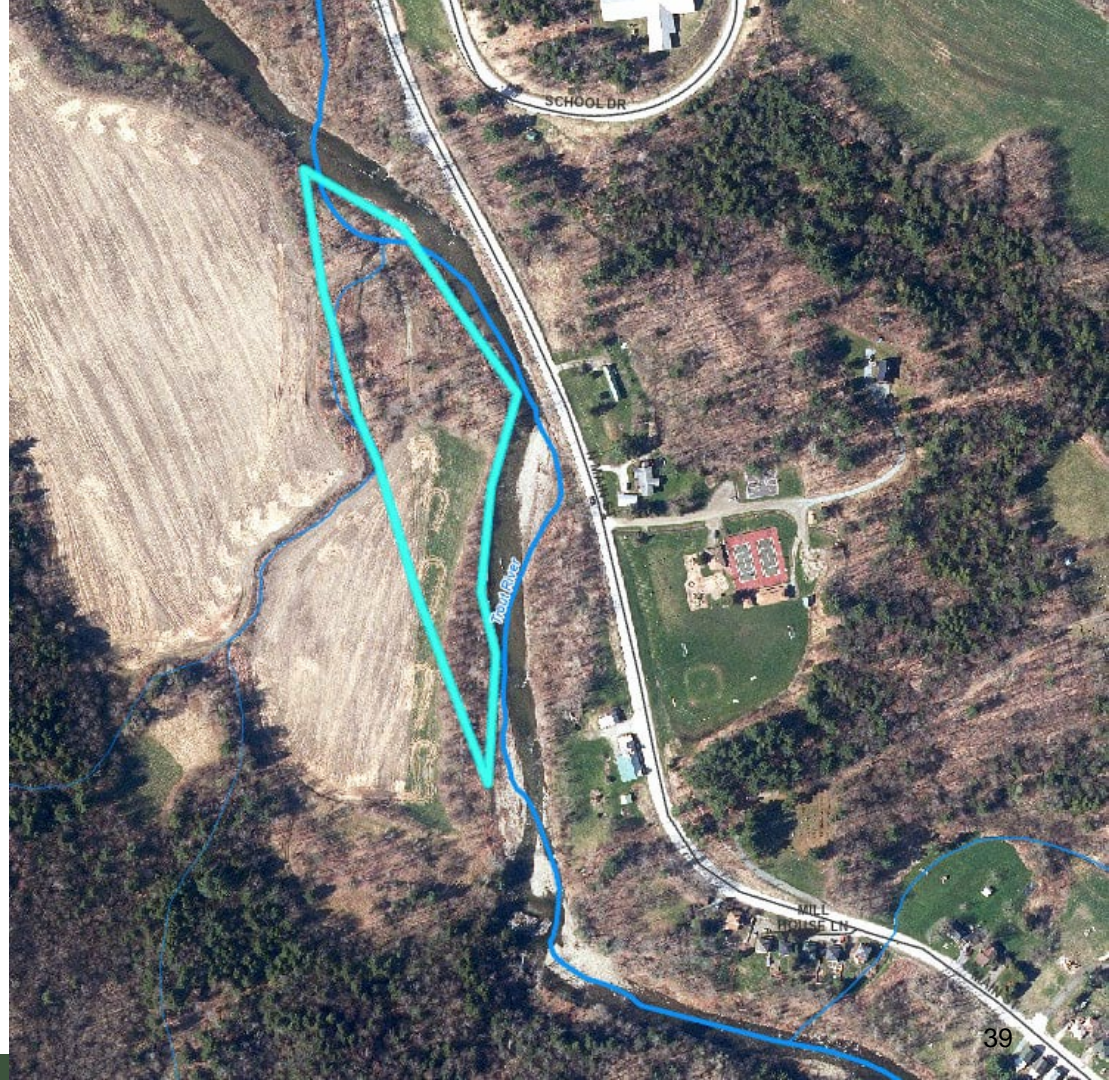
# Alternative 10

- Trout River at Route 118 embankment across from the Rec Center
- Floodplain lowering

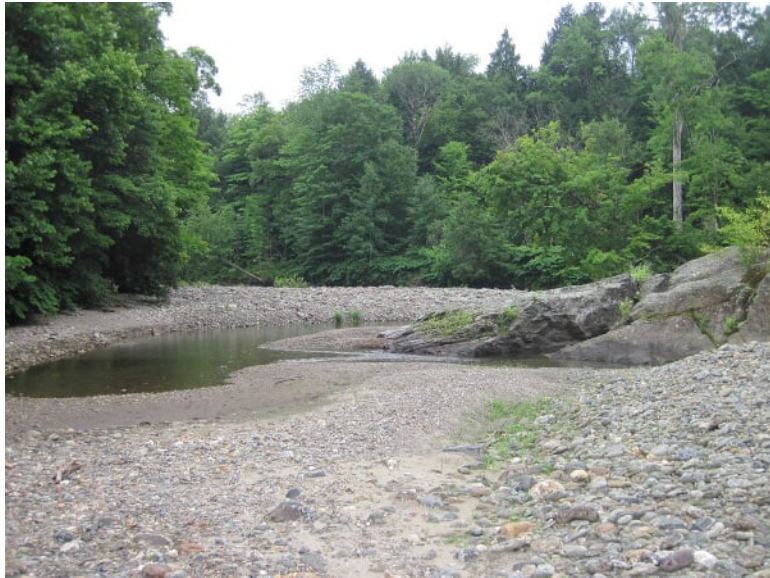
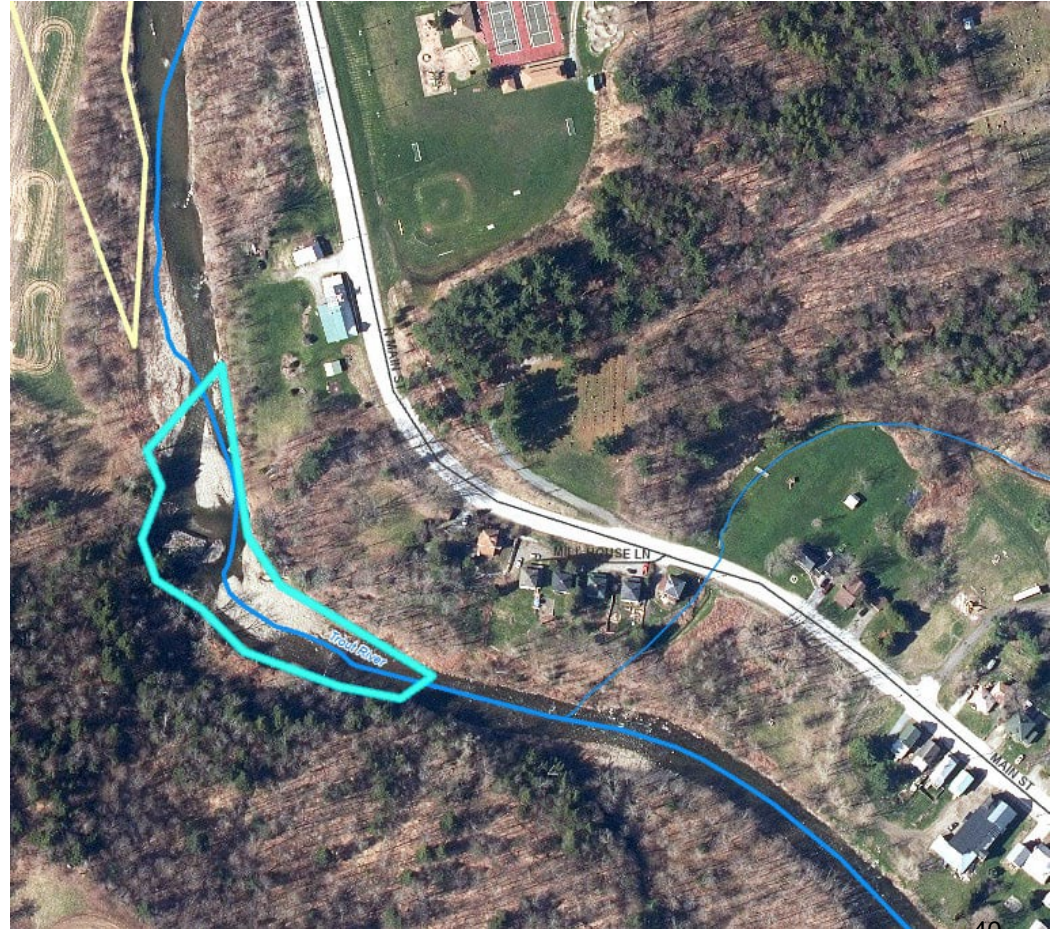
# Alternative 11

- Constriction below Village
- Remove deposition filling channel around bedrock
- Trout River – narrow valley

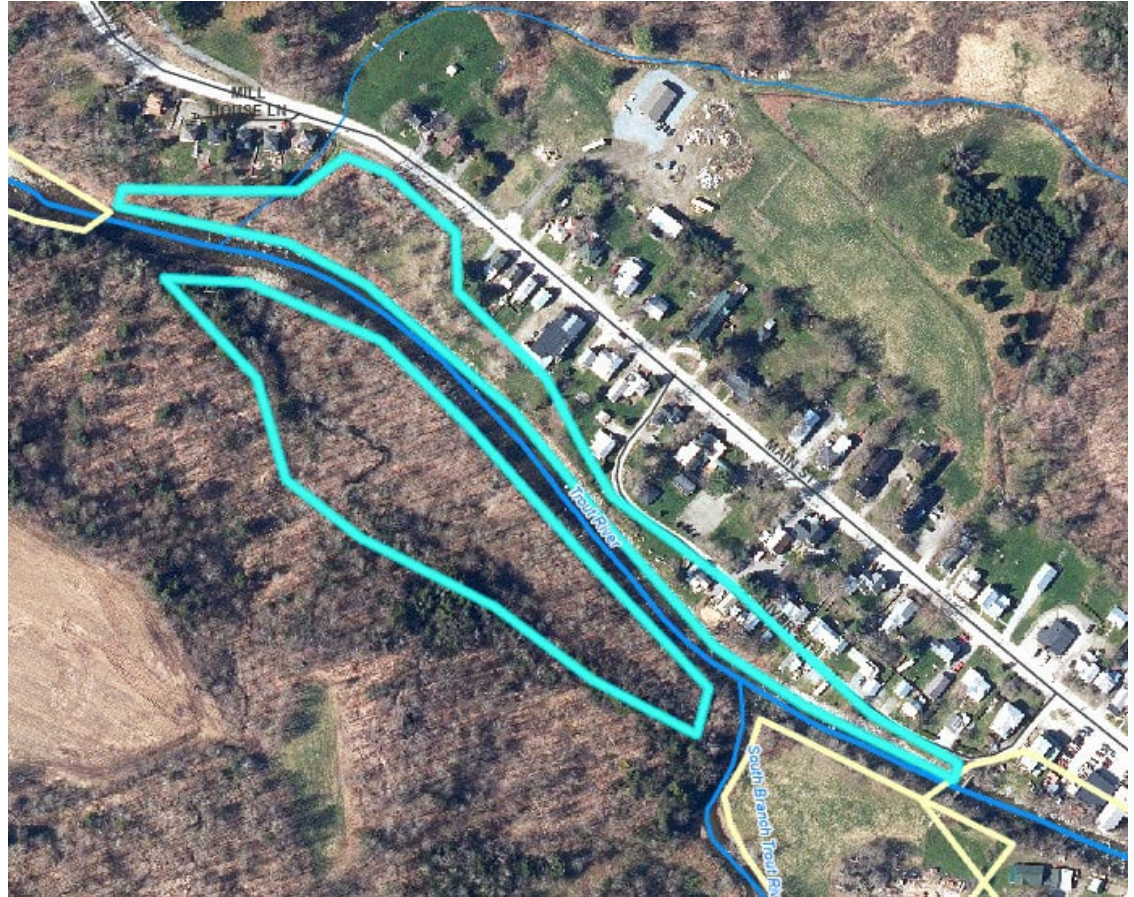
# Alternative 12

- Floodplain access in Center

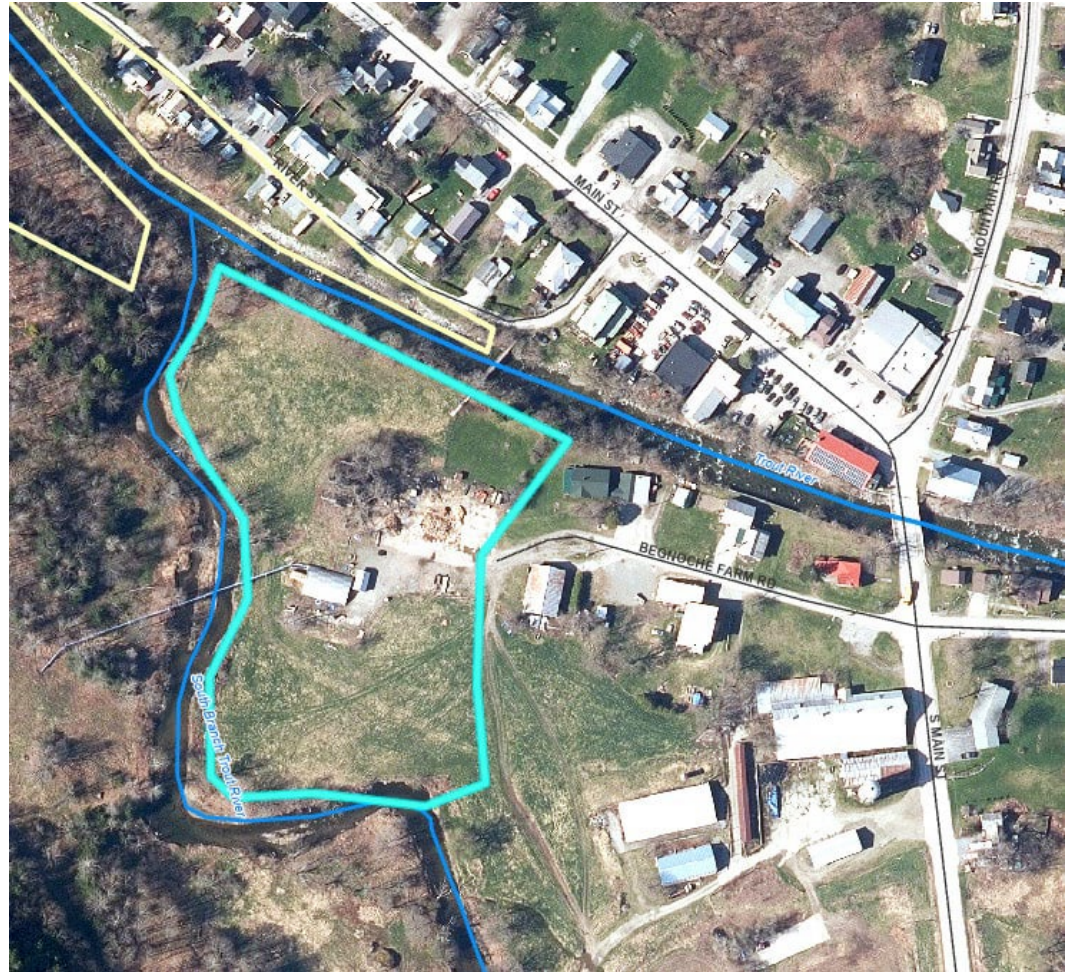
# Alternative 13

- Floodplain access in Center
- South Branch Trout River

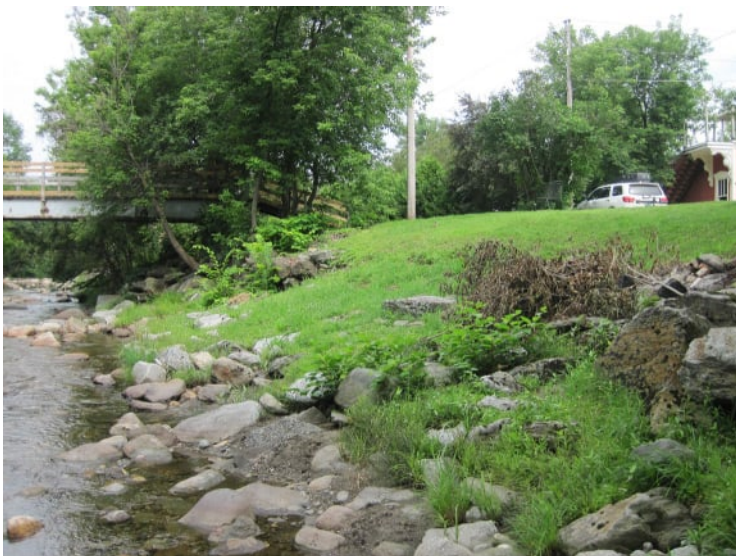
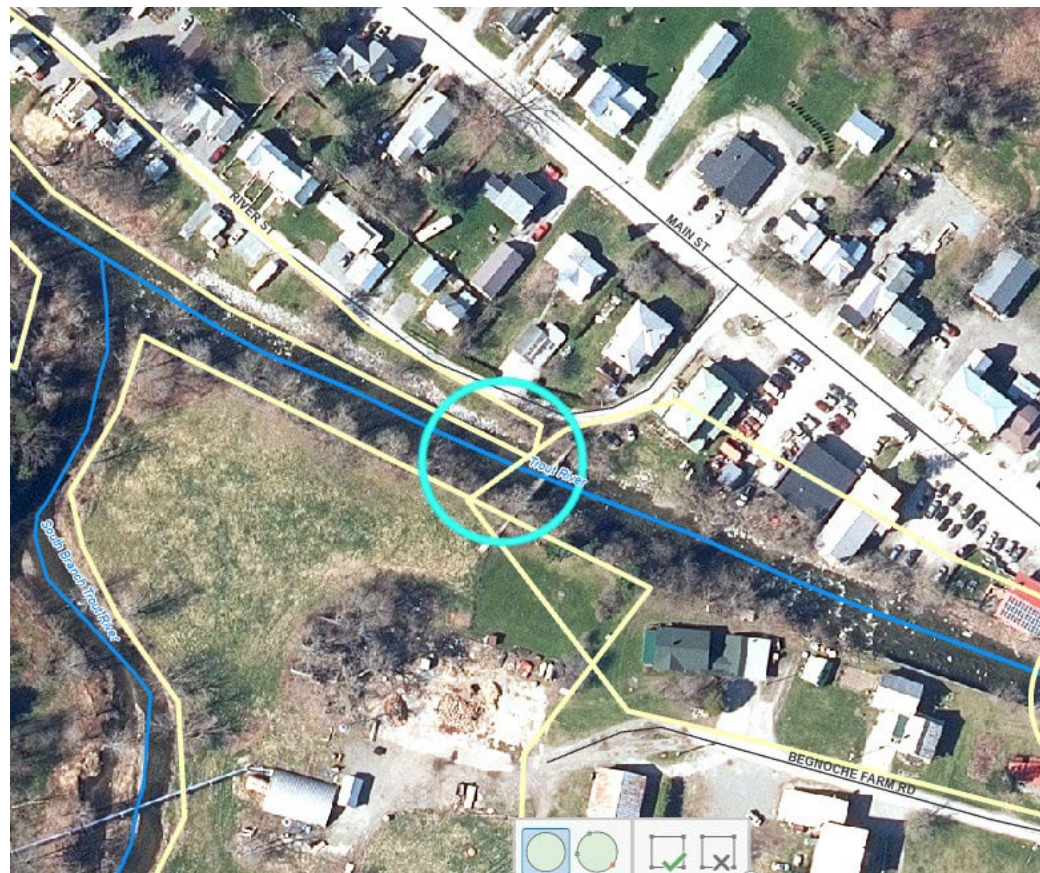
# Alternative 14

- Snowmobile Bridge on Trout River in Center
- Increase conveyance

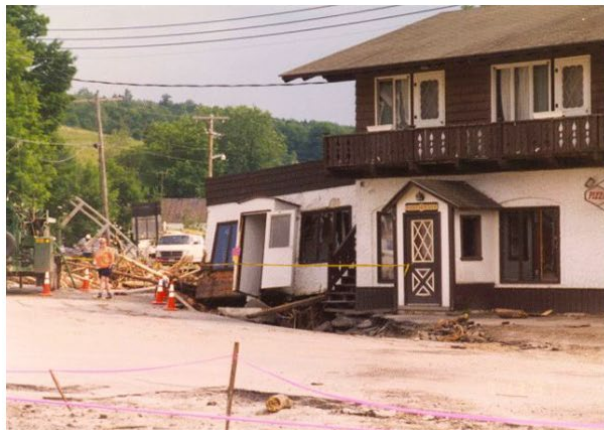
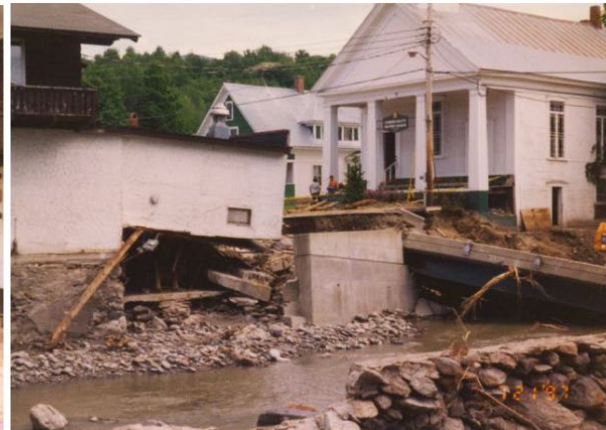
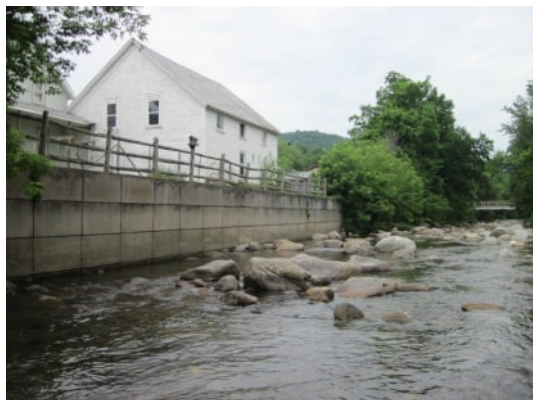
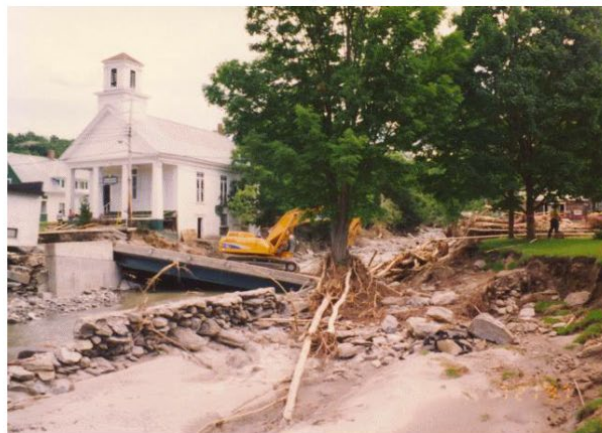
1997 Flash Flood – from Town

- Center Village area has flooded
- River confined by walls and buildings
- Change in slope from steep upstream channel

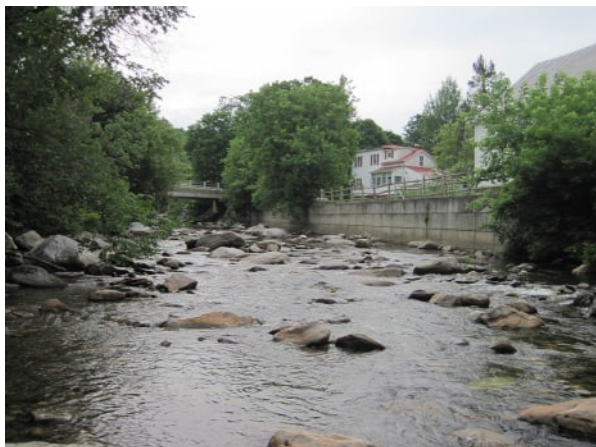
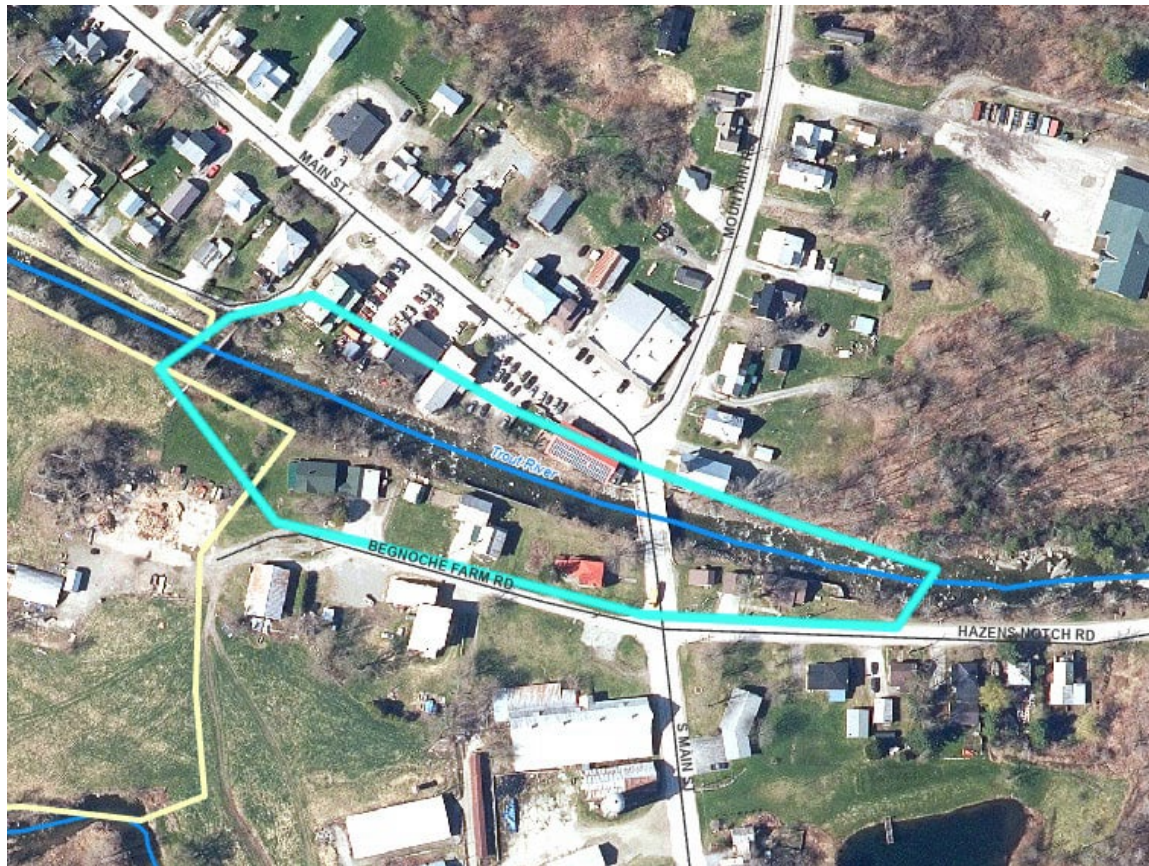
# Alternative 15

- Consider alternatives to increase conveyance
- Increase bridge capacity
- Overflow paths for when walls can not carry flow
- Floodplain access

- Increase capacity through Center with floodplain reconnection, bridge replacement, and sediment management at natural constriction
- Reduction in flood depths through entire Center
- 4-5 feet for 1000' from upstream of South Main Street to just above South Branch

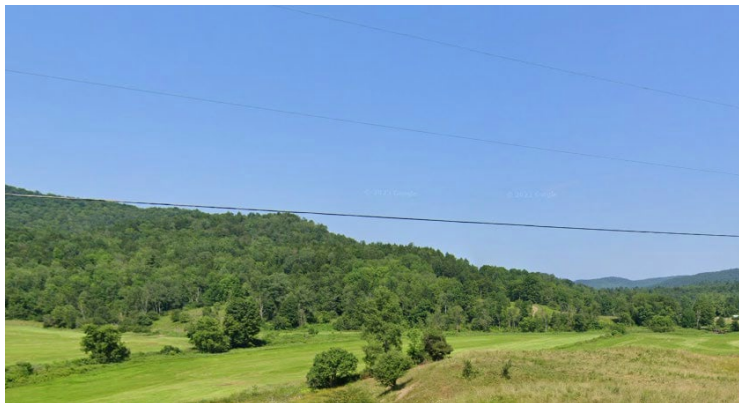
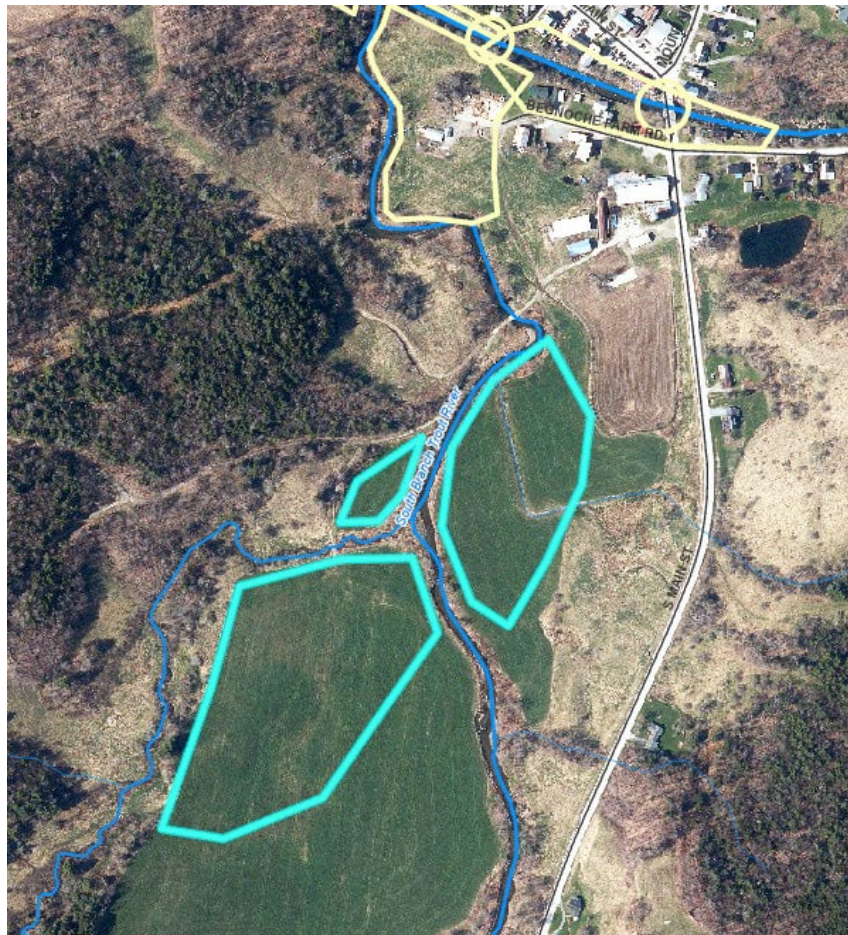
# Alternative 15

- South Branch Trout River
- Flood storage

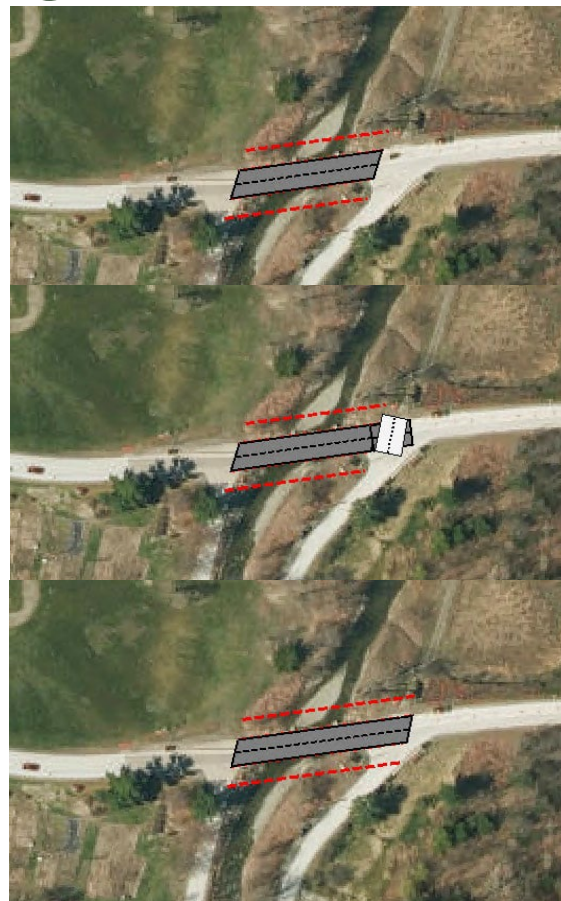
# Alternative 2 – West Hill Brook Bridge

Scenarios – all include dredging of channel through bridge to establish more natural channel profile

- No change to bridge
- No change to bridge, overflow culvert installed with flood bench
- New larger bridge installed, inset floodplain created

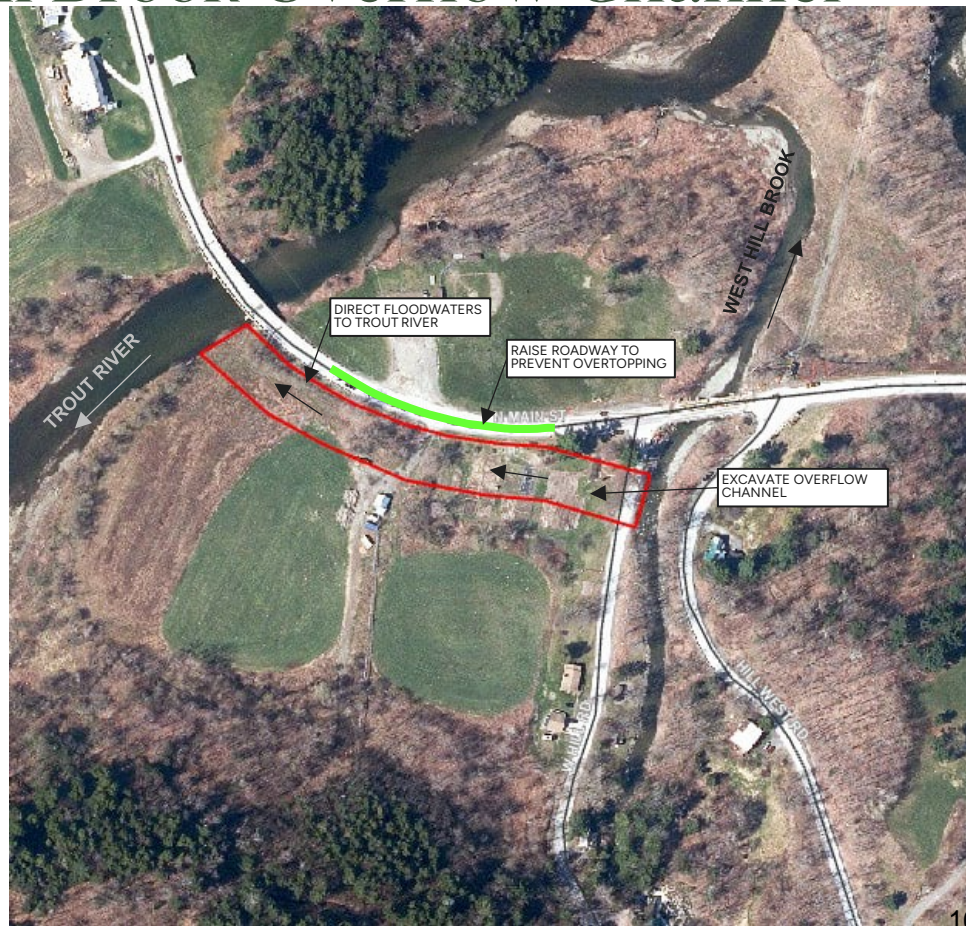
# Alternative 3 – West Hill Brook Overflow Channel

- Create overflow channel to keep floodwaters off Route 118
- Would include new structure on West Hill Road to cross overflow channel and driveway

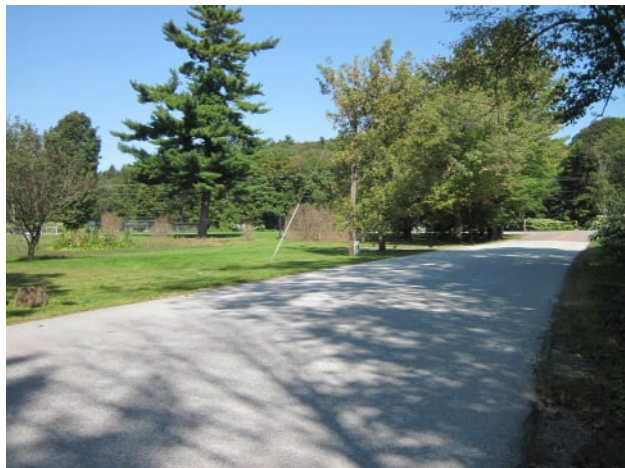
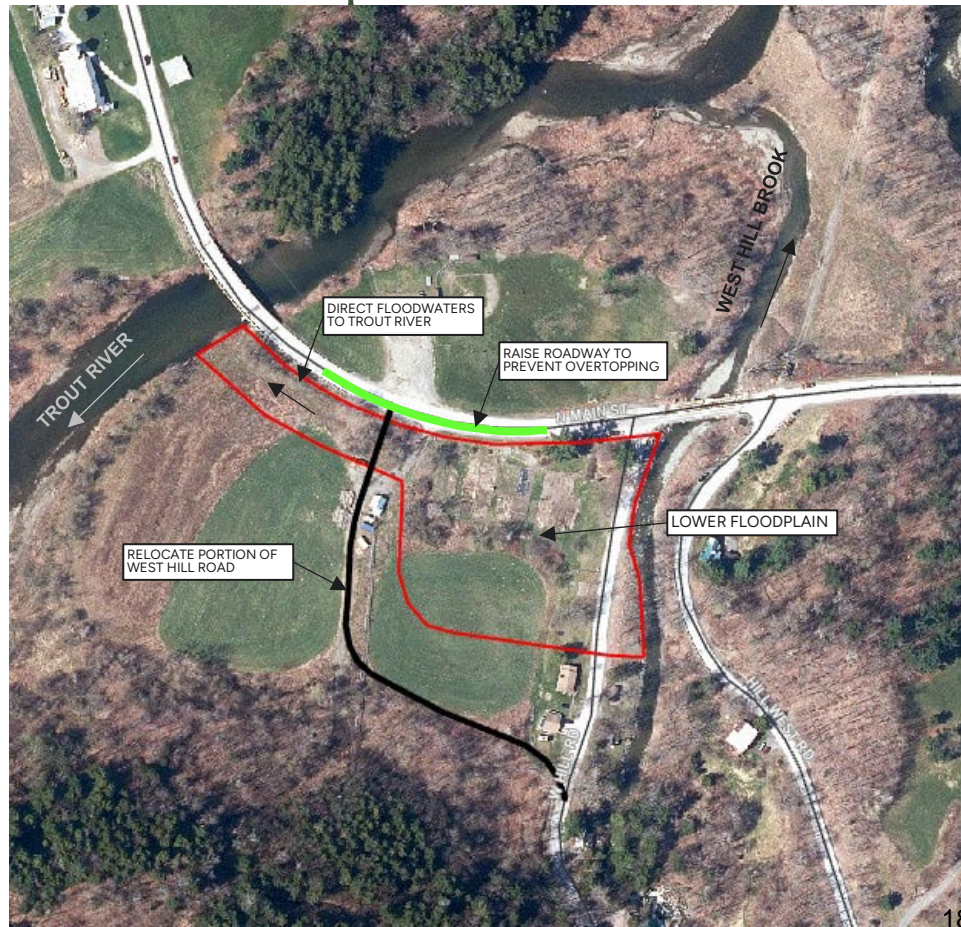
# Alternative 3 – West Hill Brook Floodplain Restoration

- Realign lower West Hill Road away from West Hill Brook
- Floodplain restoration – provide space for floodwater, sediment, and debris
- Would include new structure on West Hill Road to cross overflow channel

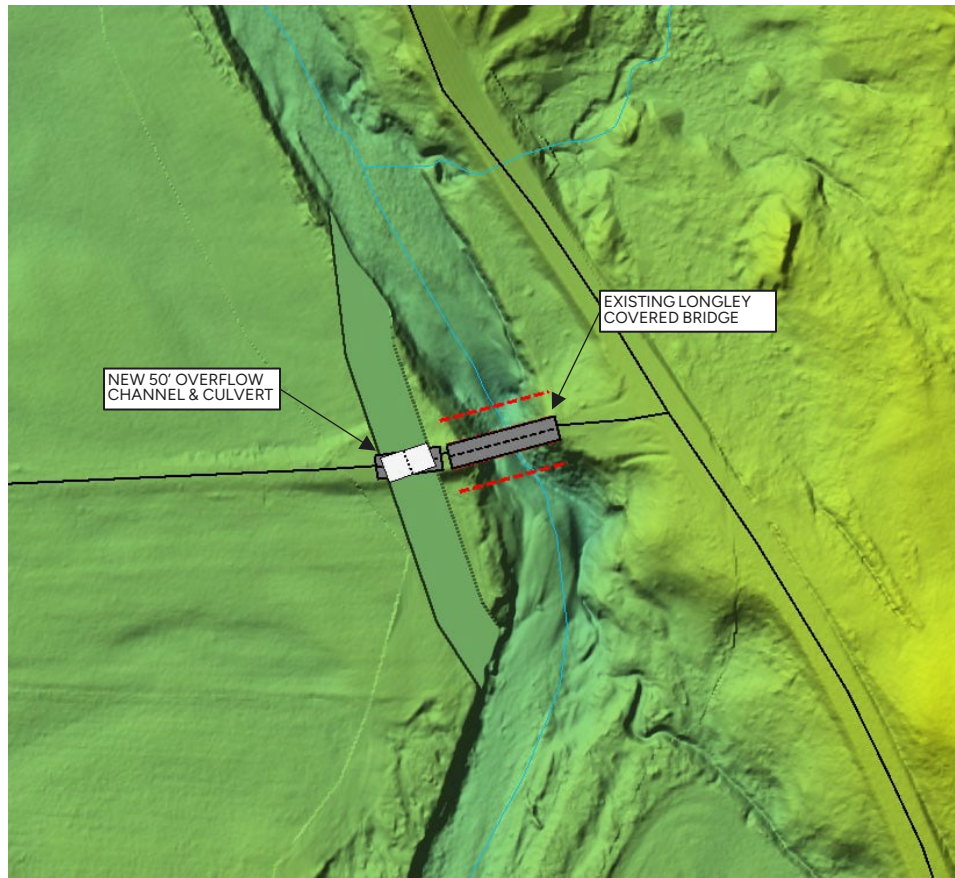
# Alternative 6 – Longley Covered Bridge

- Unable to contain floodwaters
- No substantial reduction in extent of road overtopping, but water depth reduced by 0.5 feet
- May still be beneficial for small floods

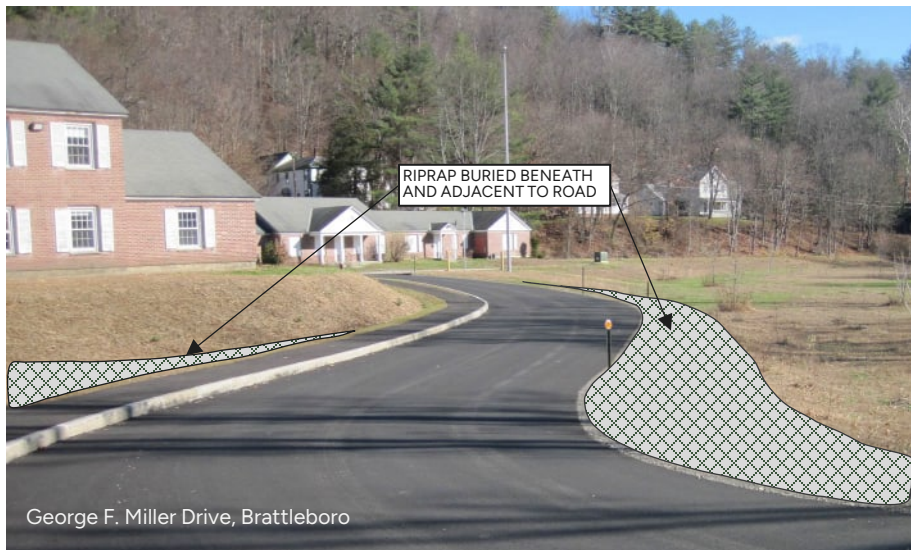
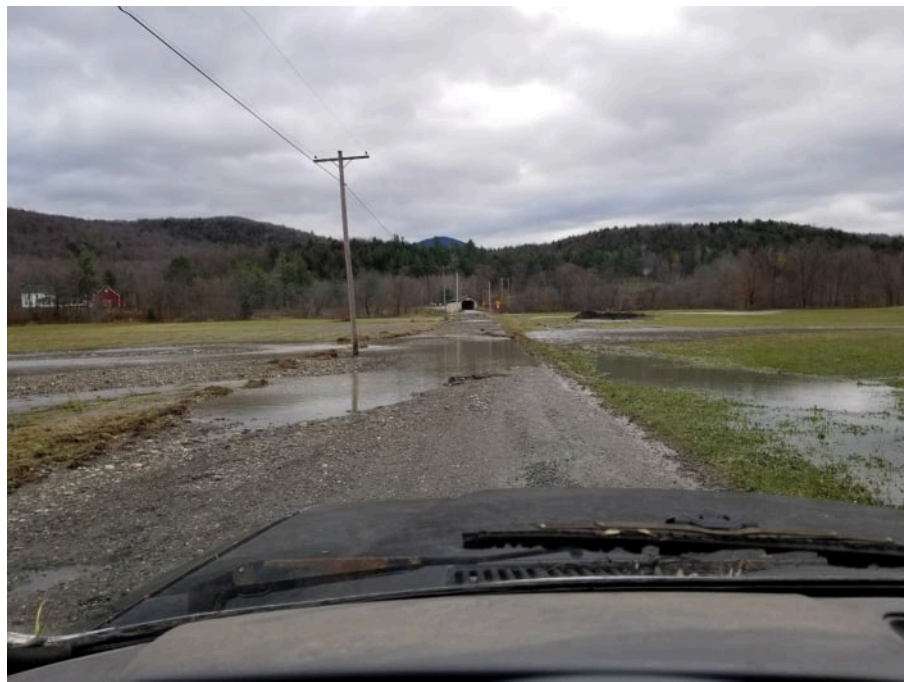
# Alternative 6 – Longley Covered Bridge

- Roadway paving and reinforcement recommended
- Reduce damages from overtopping
