# Montgomery Flood Hazard Mitigation Study

**Montgomery, Vermont  
Franklin County Natural Resources Conservation District**

**SLR International Corporation**

December 27, 2024

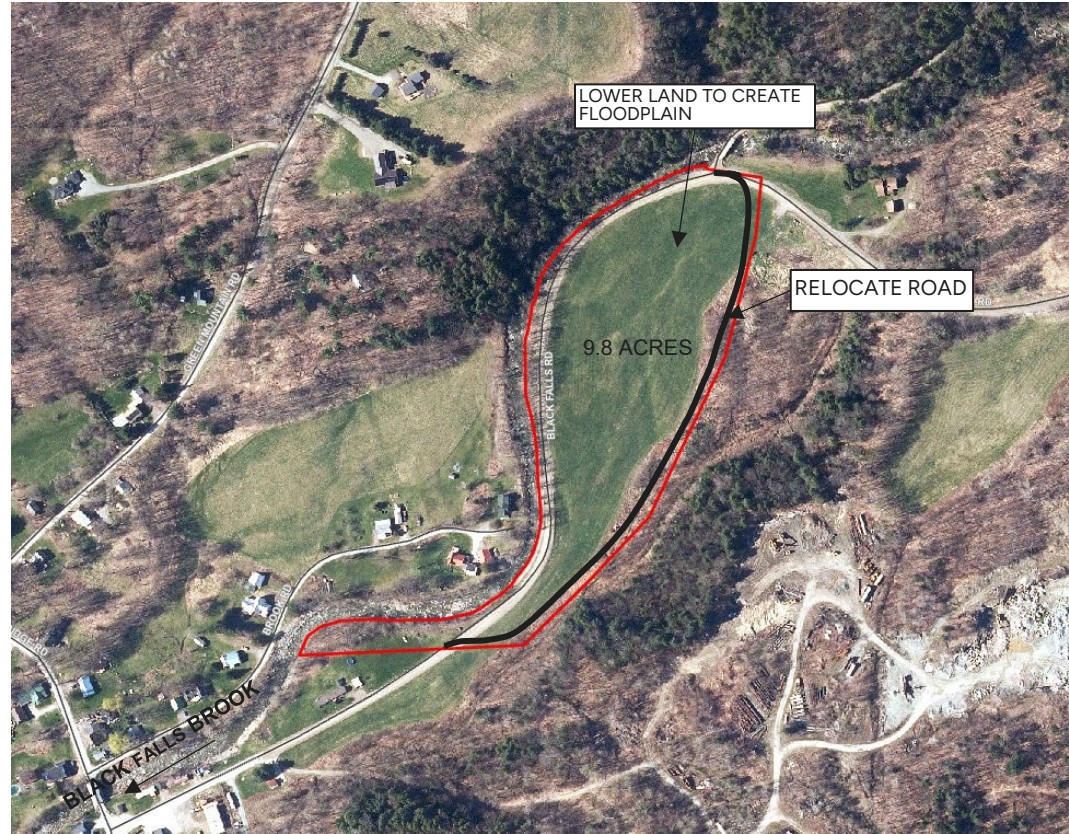
# Alternative 9 – Upper Black Falls Floodplain Restoration

- Prevents water from exiting channel and flowing along road into Village
- Substantial reduction in extent of floodwaters in Village

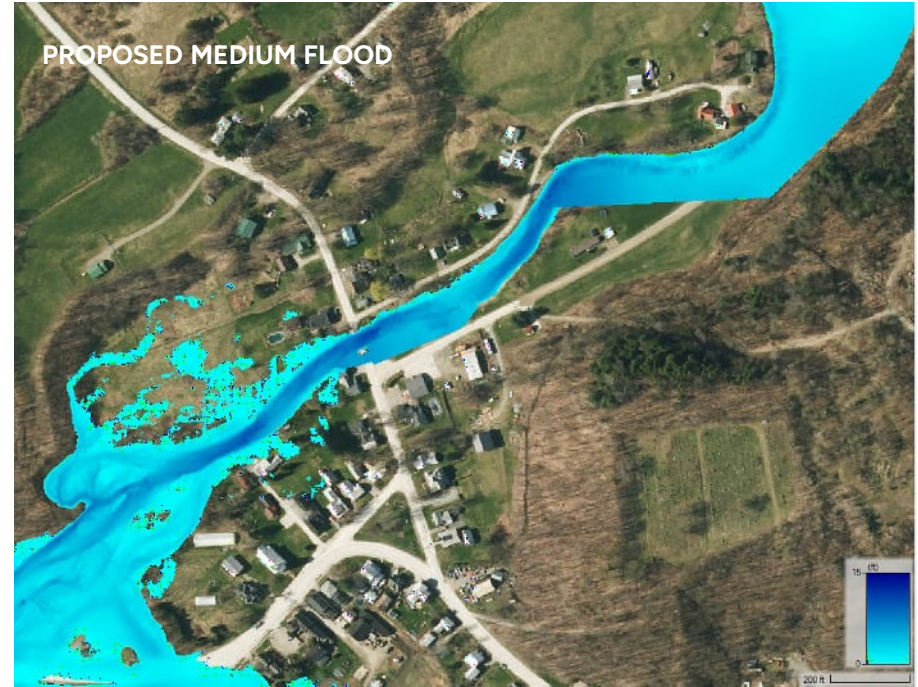
# Alternatives 7 & 9

- Combination of upper floodplain creation and Fuller Covered Bridge overflow culvert

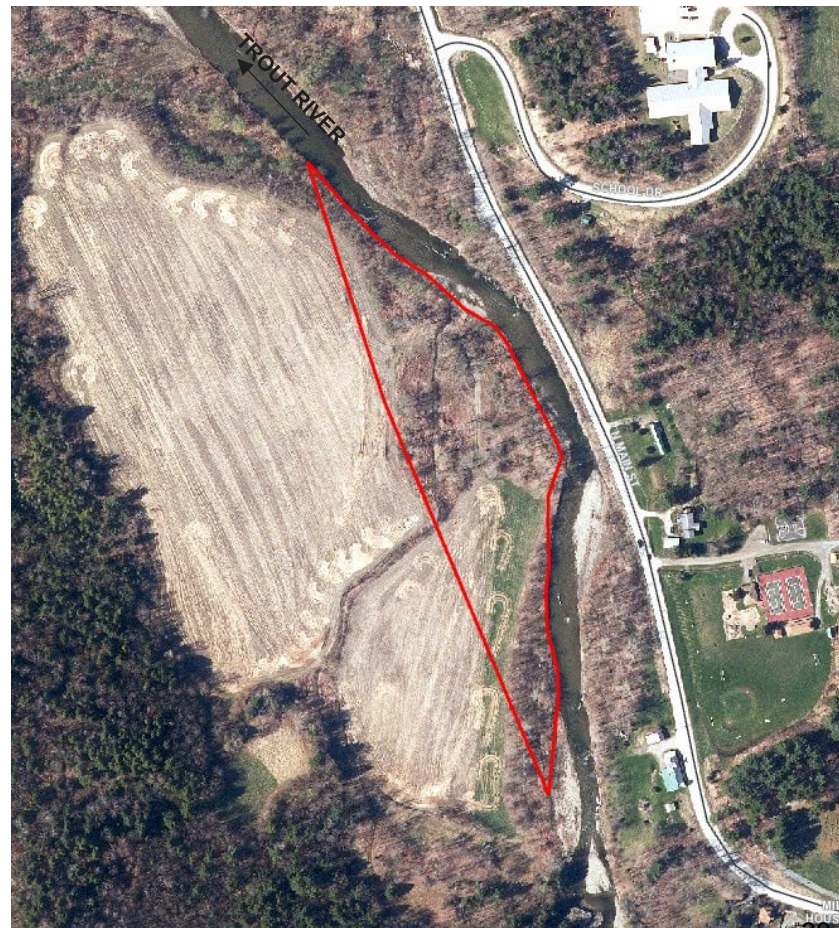
# Alternative 10

- Trout River at Route 118 embankment across from the Rec Center
- Floodplain lowering
- 8-11 ft/s existing, 3-5 ft/s proposed (small flood)

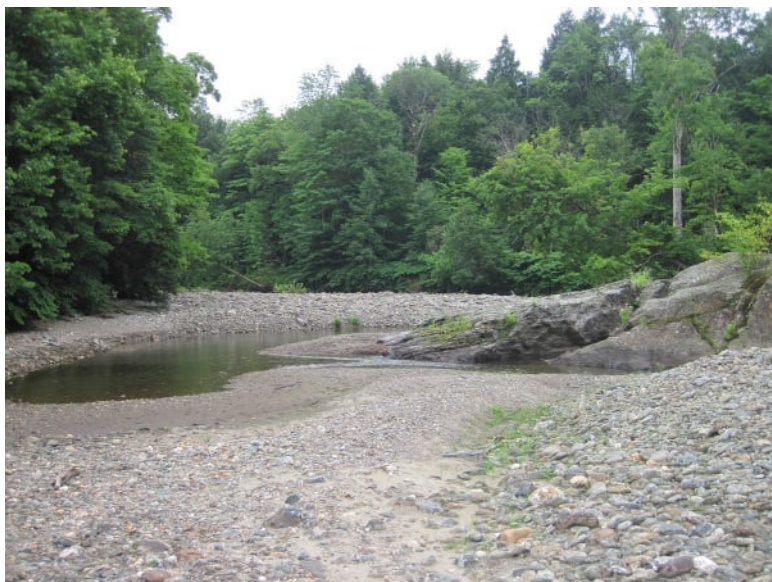
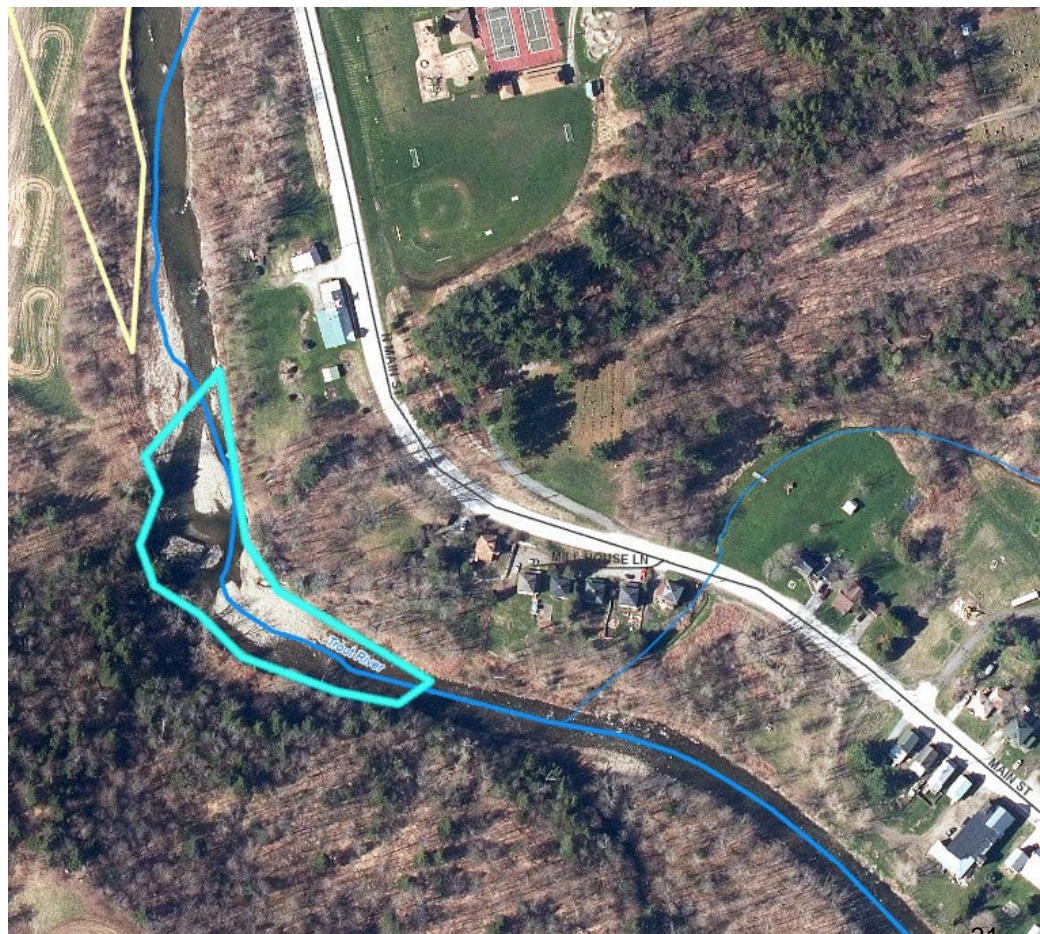
# Alternative 11

- Natural constriction below Village
- Remove deposition filling channel around bedrock

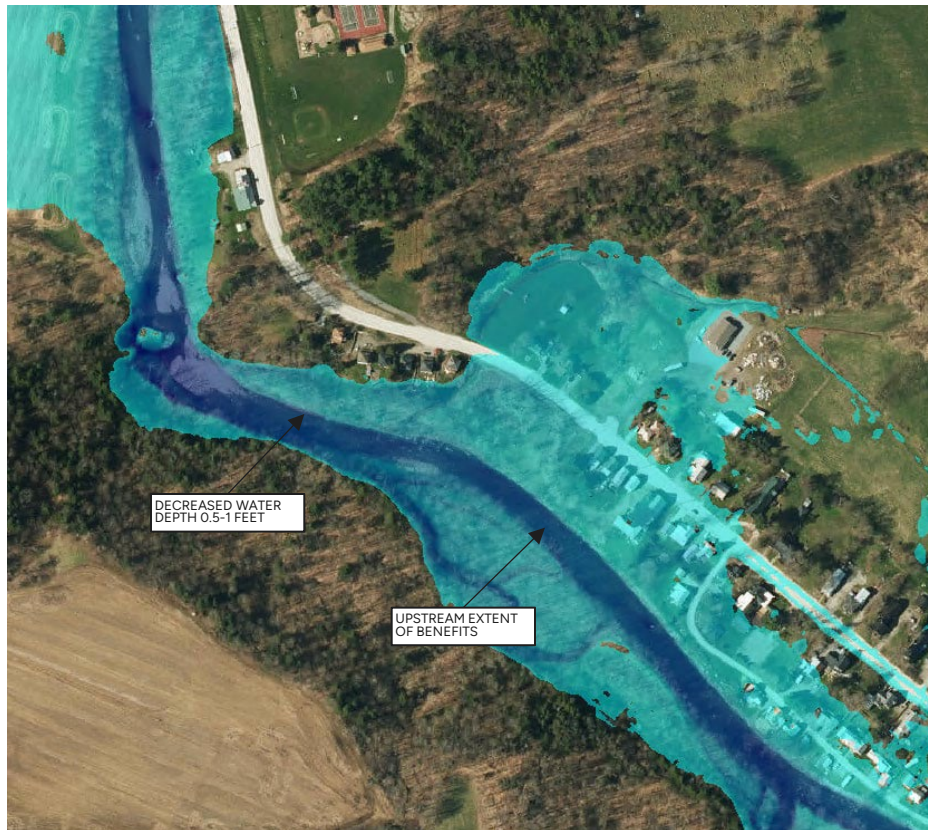
# Alternative 11

- No reduction in extent of flooding
- Effects carry 1,300 feet upstream but do not reach Center homes and businesses

- No reduction in extent of flooding
- Effects carry 1,300 feet upstream but do not reach Center homes and businesses
- May not need to be done, as the upstream alternatives are very effective without it.

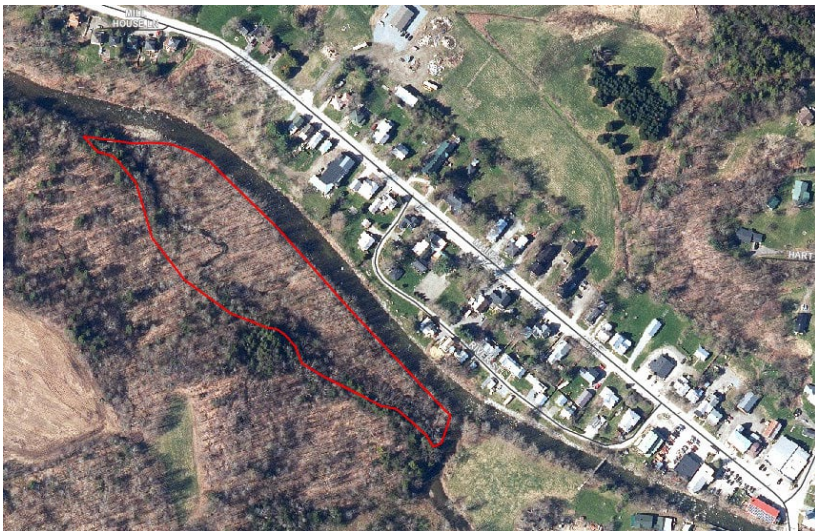
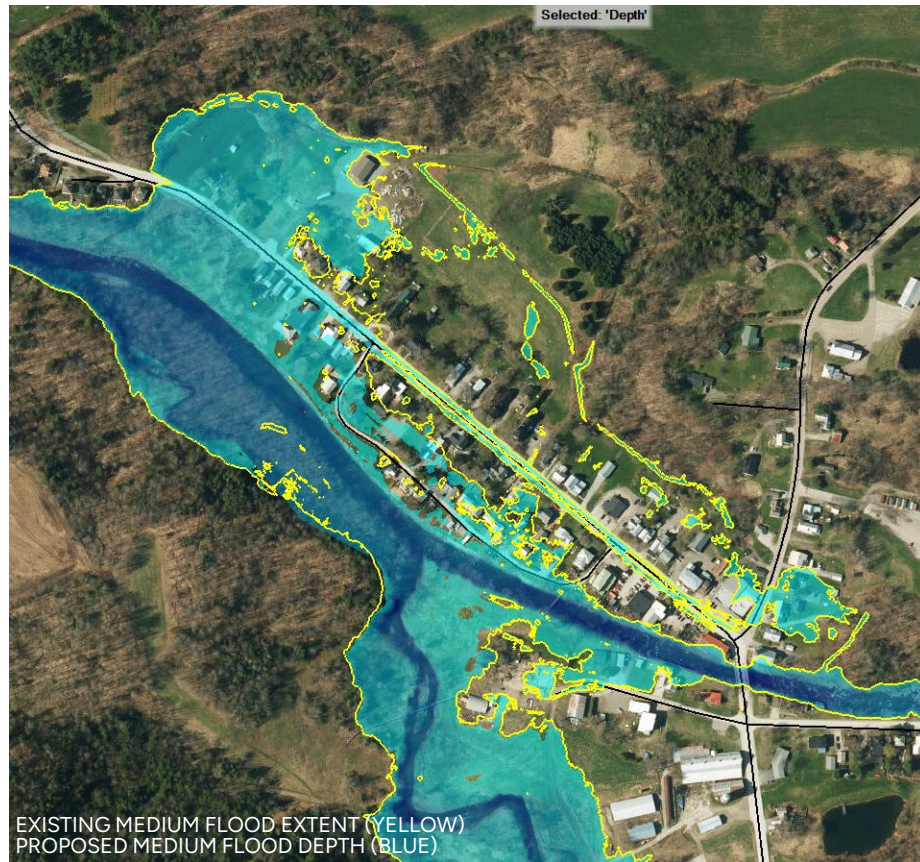
# Alternative 12

- Slight reduction in extent of flooding with 0.5-2 feet reduction in flood depths around some homes

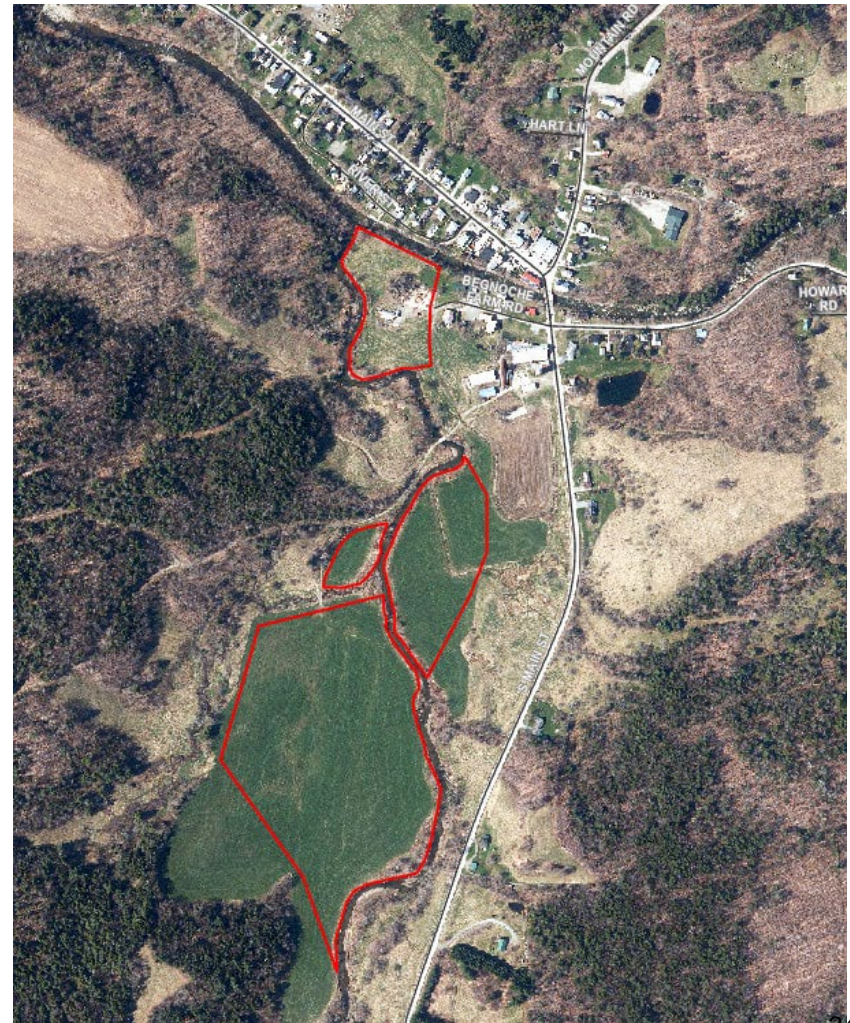
# Alternative 13 – South Branch Floodplain Restoration

- Upper cluster of floodplains modeled separately from lowest
- No reduction in flood depths or extent of floodwaters observed in Center from upper floodplains

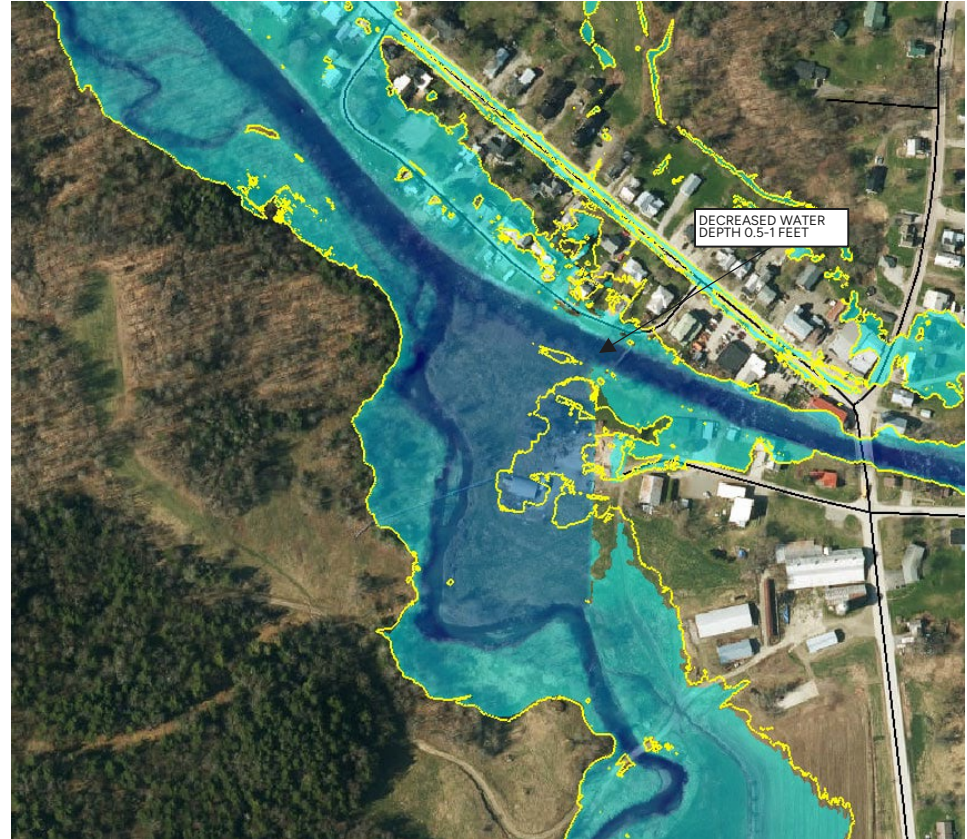
# Alternative 13 – South Branch Floodplain Restoration

- Localized reduction in flood depth and extent with lowest floodplain

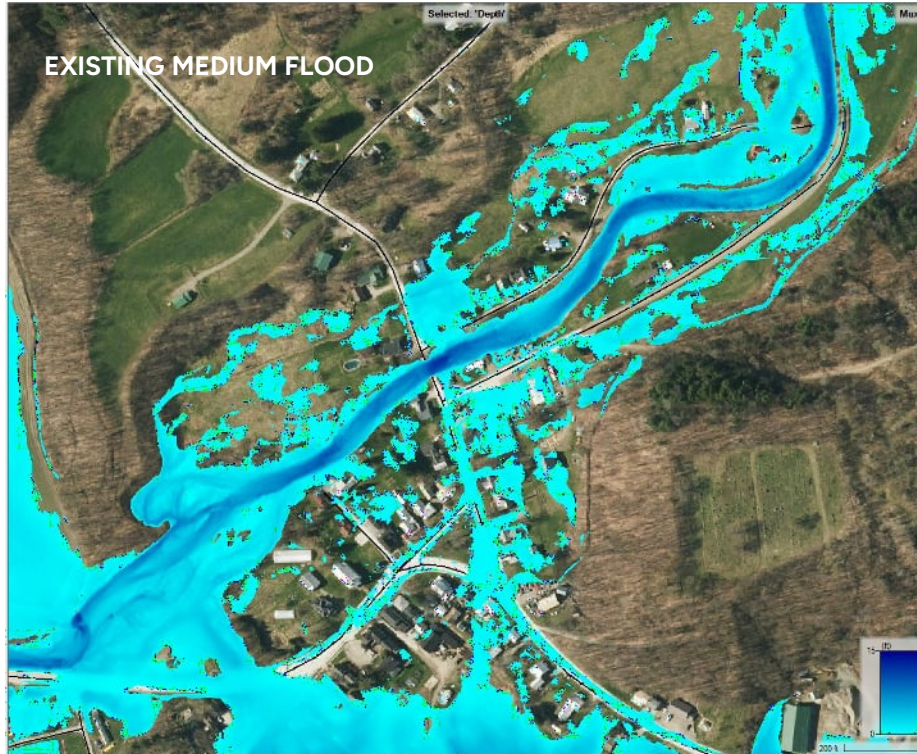
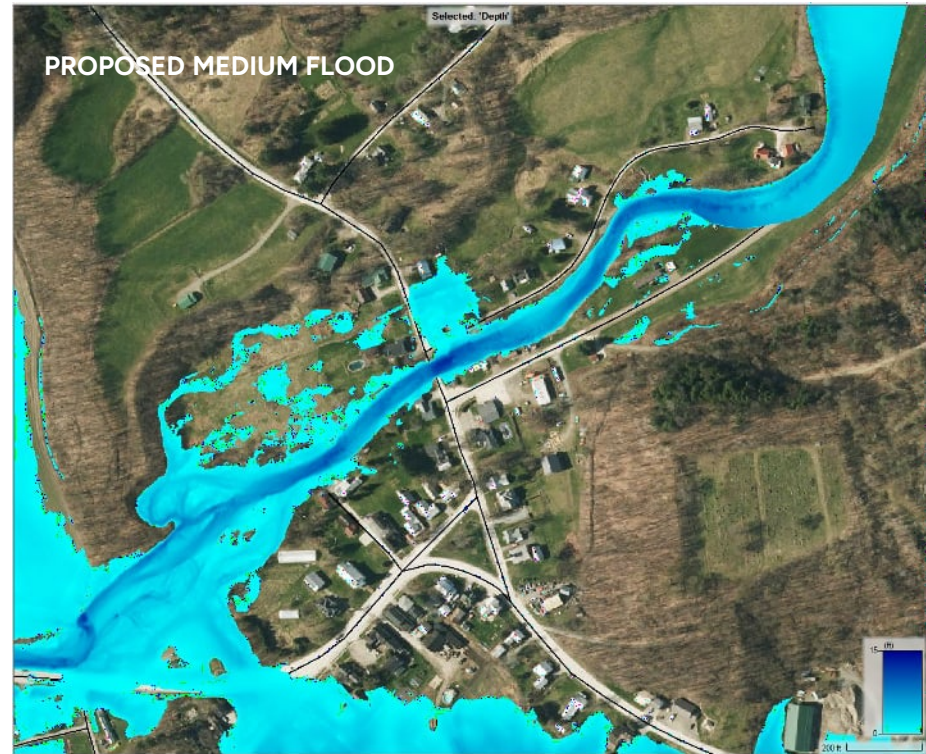
- Upper floodplain creation

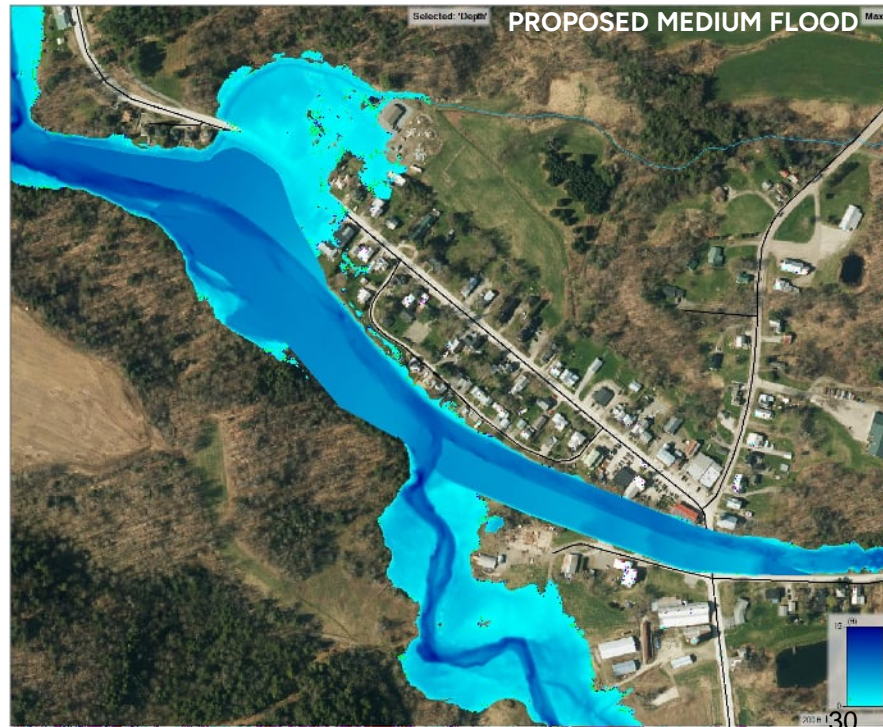
# Alternative 12 & 15

- Reduction in flood depths 1-2' downstream South Branch and 4-5 feet for 1,000' to upstream of South Main Street

- Increase capacity through Center with floodplain reconnection, bridge replacement, and sediment management at natural constriction
- Reduction in flood depths through entire Center
- 4-5 feet for 1000' from upstream of South Main Street to just above South Branch
