MEETING MEMO

TO: LAMOILLE BASIN WATER QUALITY COUNCIL (BWQC)
FR: LAMOILLE BASIN CLEAN WATER SERVICE PROVIDER (CWSP) STAFF
RE: MEETING ON DECEMBER 4, 2025
DA: NOVEMBER 26, 2025

Lamoille Basin Water Quality Council (BWQC) regular meeting
Thursday, December 4, 2025
9:00-11:00 AM

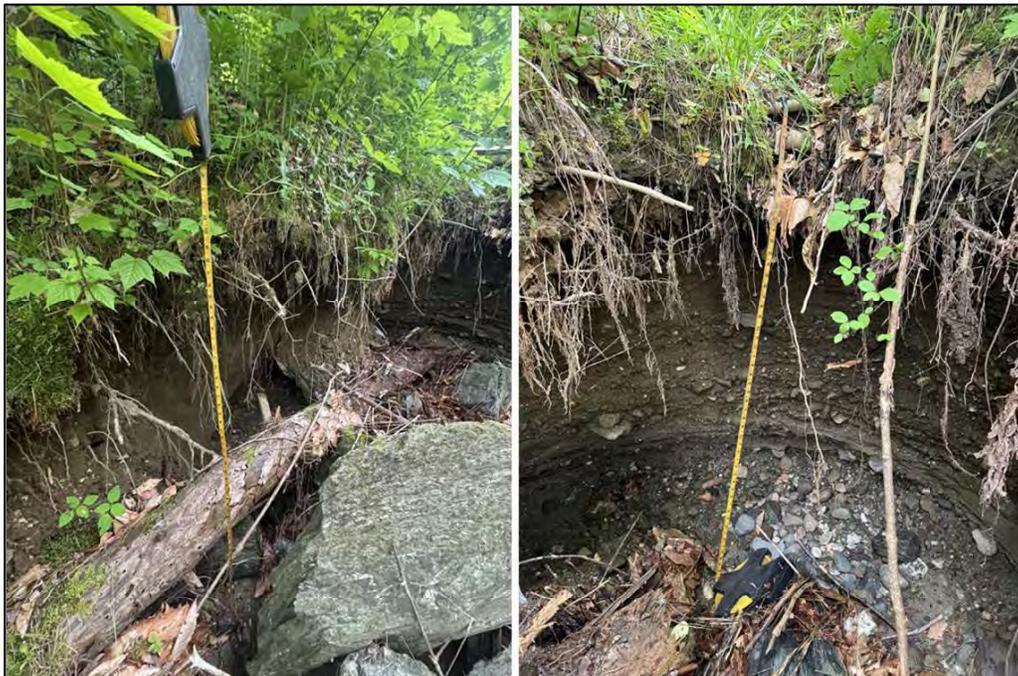
A significant gully has formed as a result of stormwater runoff on the private residential property at 15 Range Rd in Underhill, Vermont. An overview map of the relevant drainage patterns and gully location can be found in Attachment A. The gully is approximately 34 ft in length, 4 ft in depth, and 6 ft in width (Figure 1).

Figure 1. Gully erosion is present along 15 Range Road. Photos provided by landowner Dan Lee.

The soils in this area are mapped as Hydrologic Soil Group (HSG) A, indicating that soils are generally sandy and well infiltrating. Potential solutions for this area include surface or subsurface infiltration practices along Range Road to reduce stormwater volumes and limit stormwater flows to the gully area. Additionally, the gully itself would be stabilized and revegetated. Solutions could include rock gabions, stone stabilization, a plunge pool, and grading and slope stabilization.

This site was deemed to be applicable for crediting through the “Outlet and Gully Erosion” calculator. Gully dimensions and gully age were provided by Dan Lee, the homeowner at 15 Range Road. The specifics for the phosphorus reduction calculations are provided in Table 1 below. In total mitigation of the gully will result in a phosphorus reduction of 2.65 kg/yr. Note that while stormwater management is recommended to address the contributing drainage to the gully in addition to in-gully stabilization, the phosphorus reduction crediting for the site (regardless of the specifics of the stormwater treatment practice(s)) is limited to the gully stabilization credit shown below (Table 1). The stated design life for this project type is eight years¹, though it is expected that this design life could be increased with proper operations and maintenance.

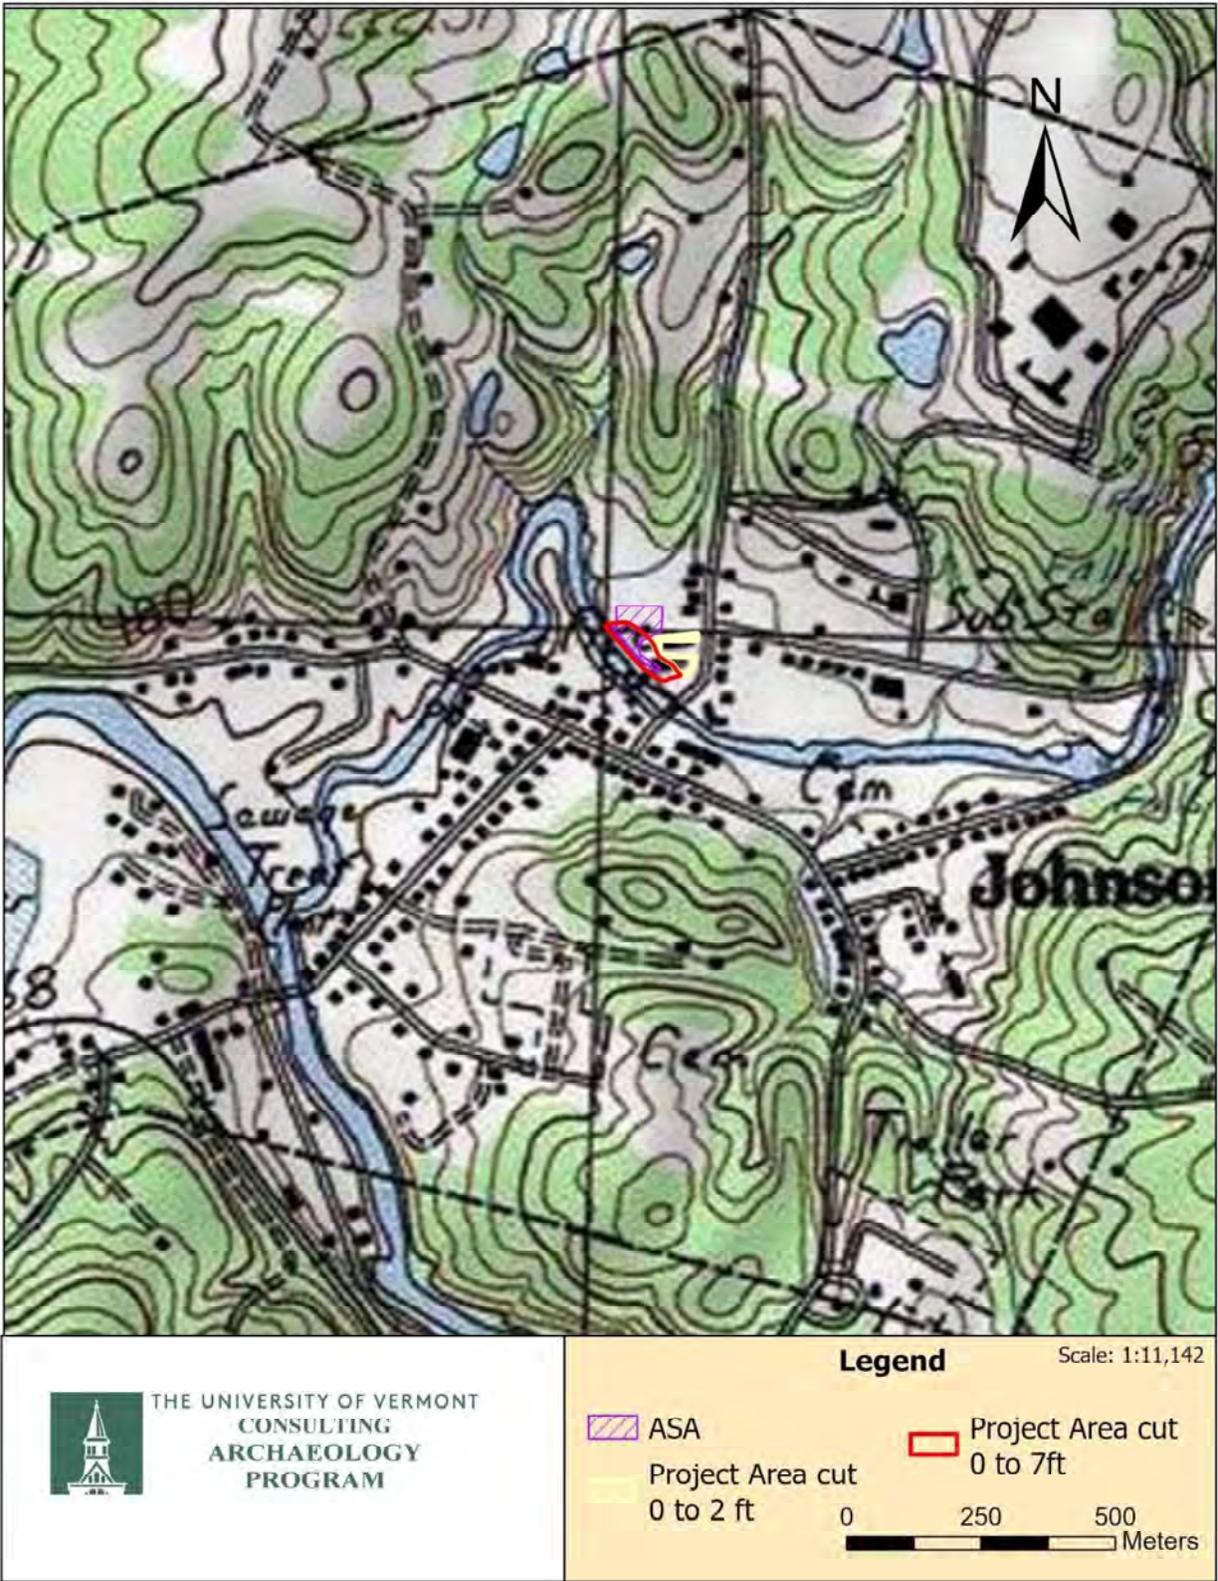
Figure 1. USGS Topographic map of Johnson showing the location of the Vermont Studio Center Floodplain Restoration Project, Johnson, Lamoille County, Vermont.

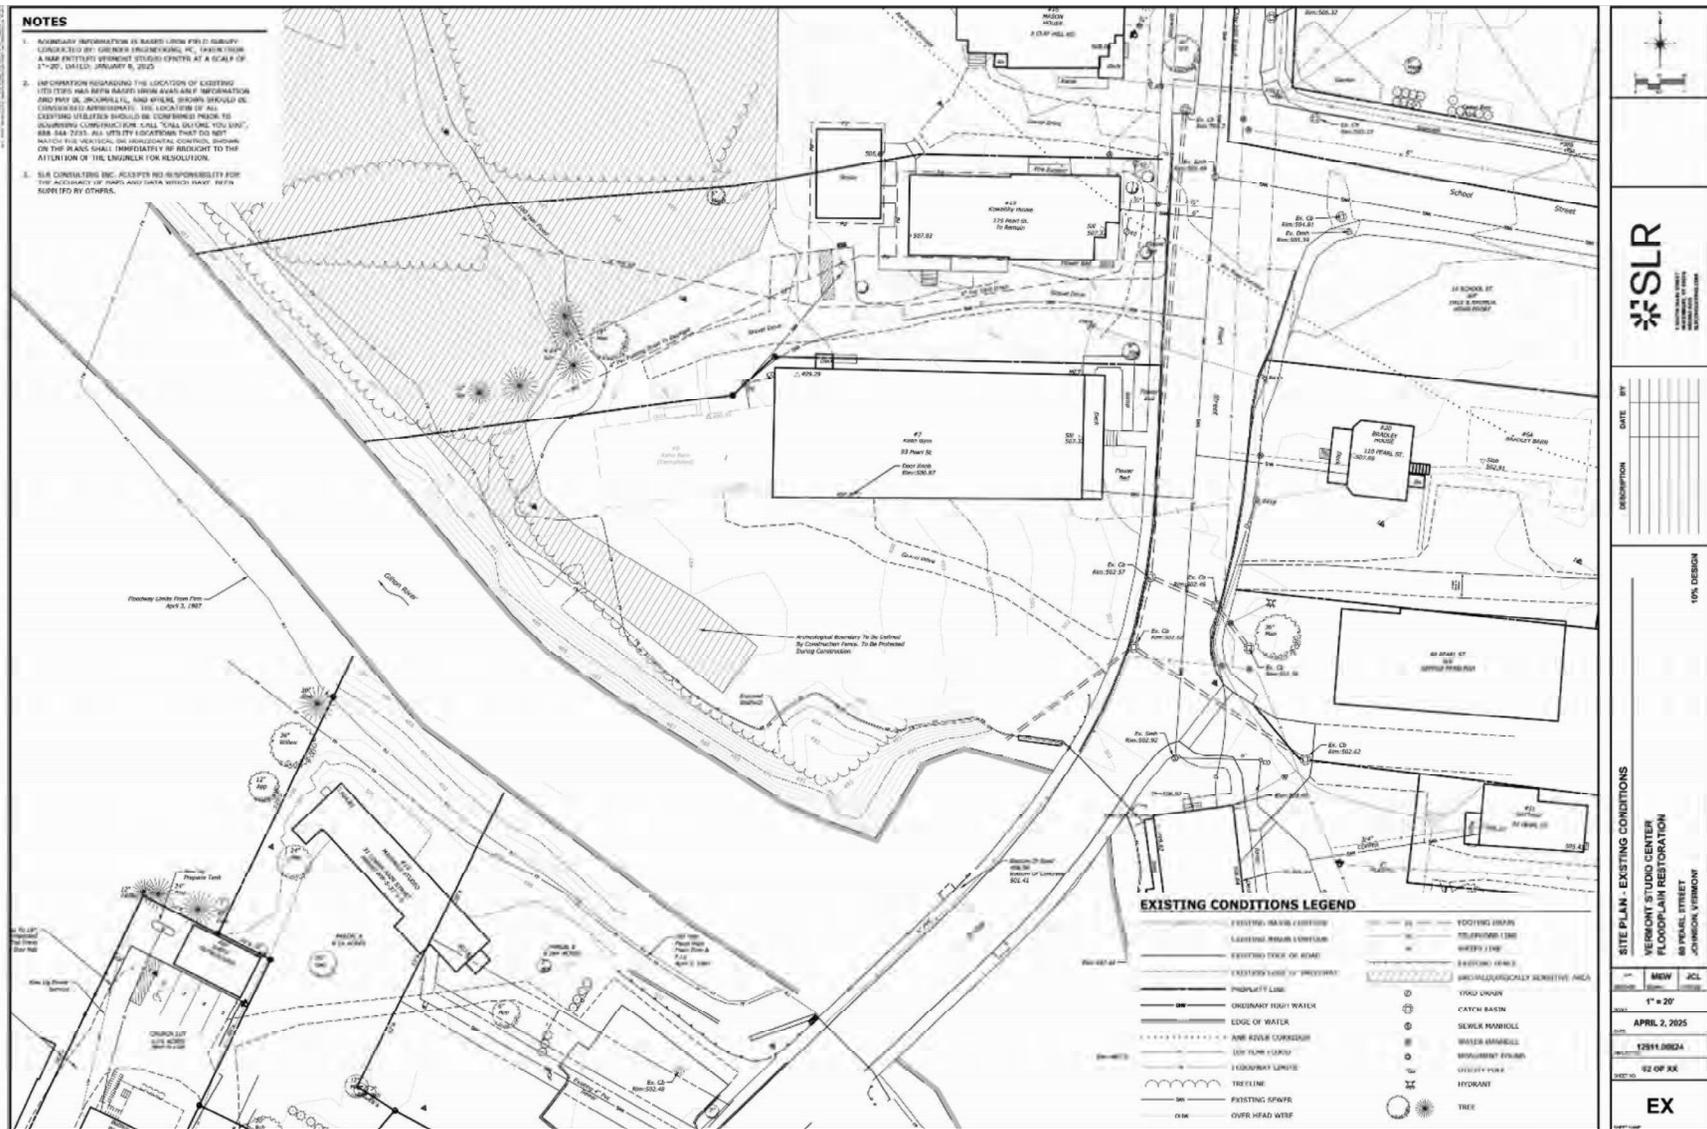
Figure 2. Plan showing existing conditions and the archaeologically sensitive area for the Vermont Studio Center Floodplain Restoration Project, Johnson, Lamoille County, Vermont.

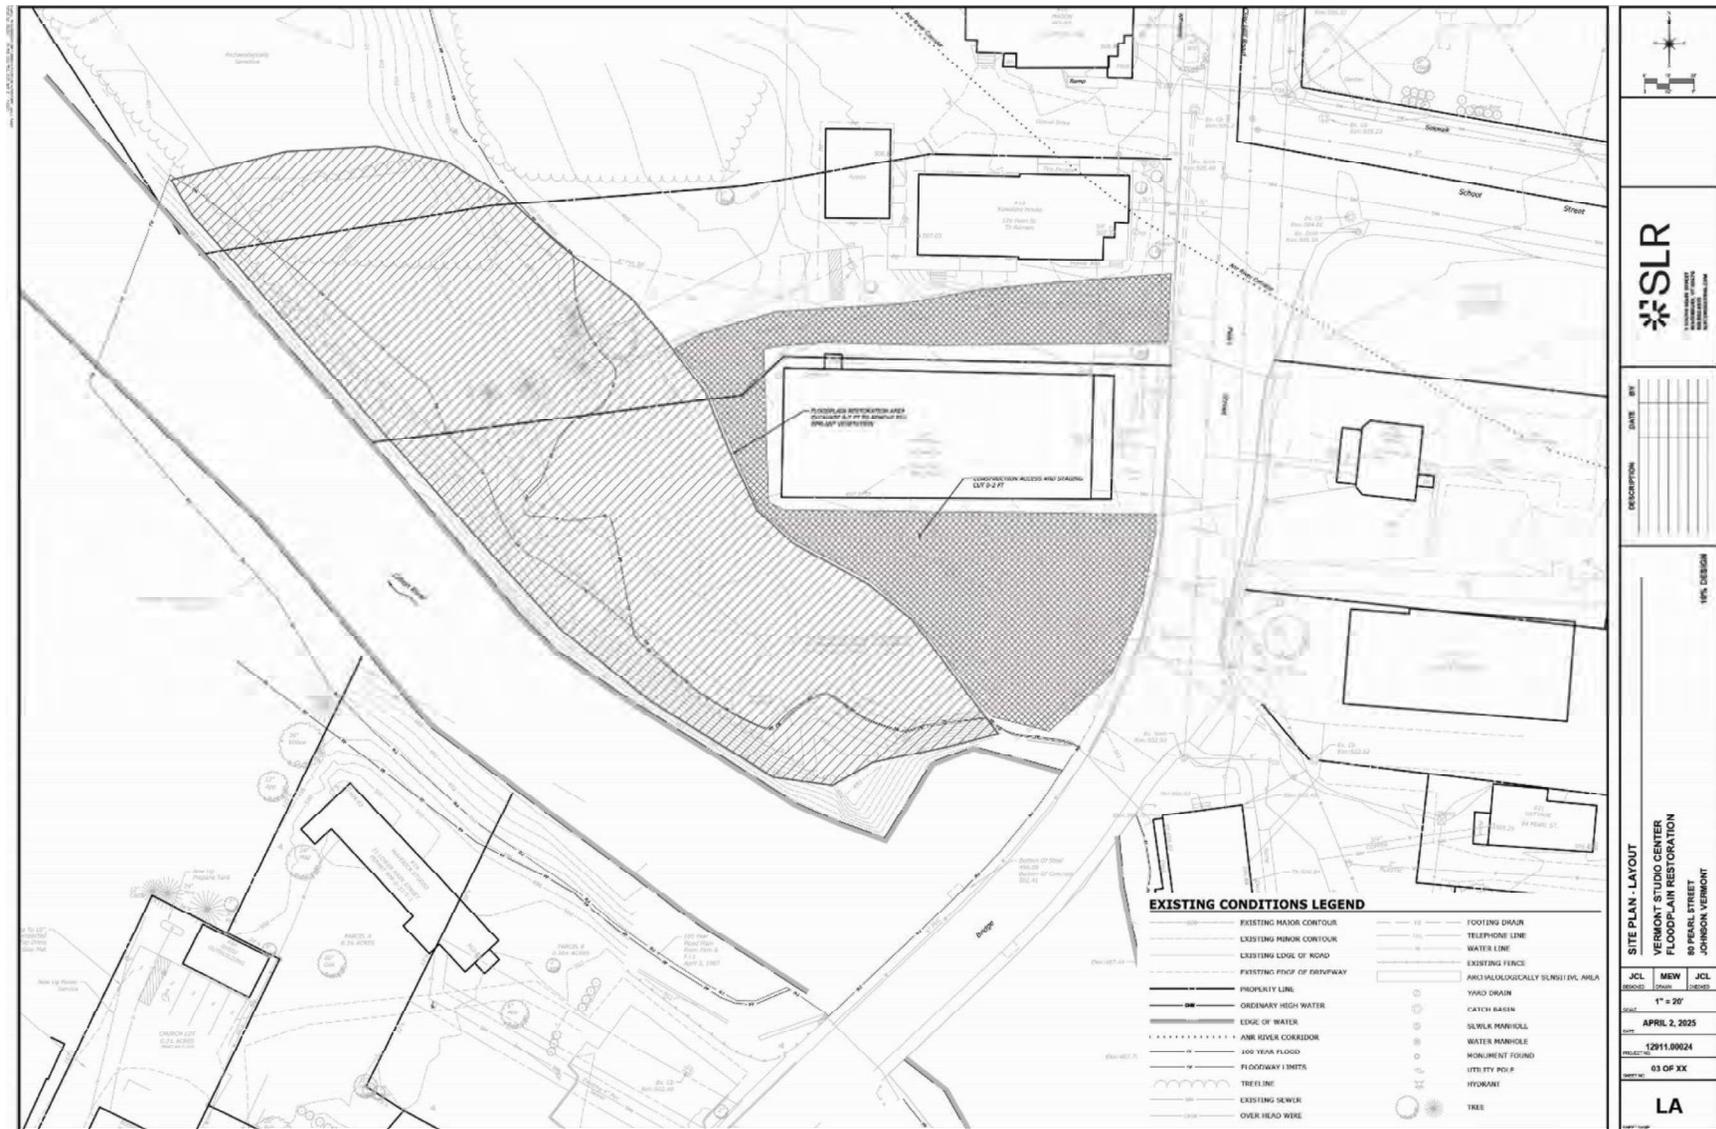
Figure 3. Concept plans of the Vermont Studio Center Floodplain Restoration Project, Johnson, Lamoille County, Vermont.

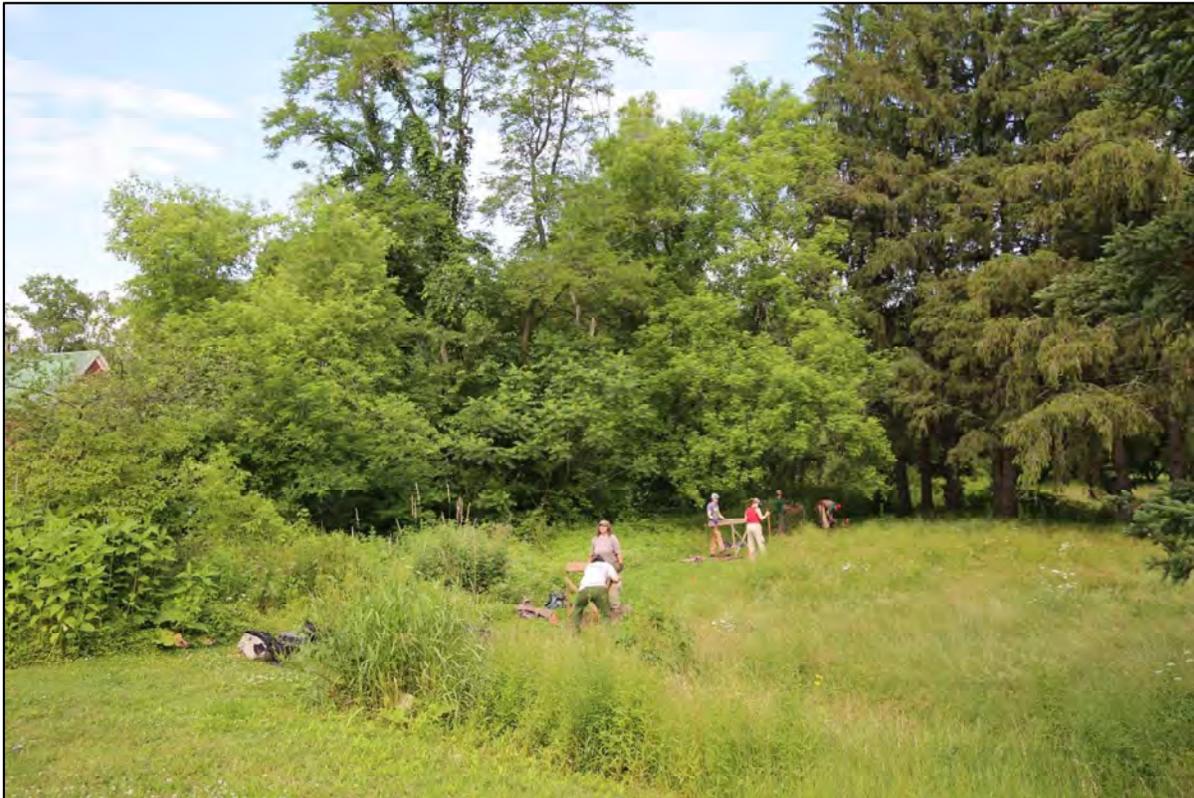
Figure 8. View west of UVM CAP archaeologists excavating test pits along Transect 1 during the Phase I Survey of the Vermont Studio Center Floodplain Restoration project APE, Johnson, Lamoille County, Vermont.

The UVM CAP completed the Phase I Survey on June 25th, 2025. The field work consisted of the excavation of a total of seven 50 x 50 cm (20 x 20 in) subsurface test pits arrayed along four linear transects to sample the archaeologically sensitive area defined within the project's APE (Figures 8 and 9). The archaeologically sensitive area is comprised of a gentle westerly sloping landform, along the northern bank of the Gihon River. At its western extent is a line of spruce trees bisected by a broad, meandering intermittent drainage channel which continues west beyond the project area. To the south of the drainage is the low floodplain and to the north is a slightly elevated knoll. Transects 1 and 3 were emplaced in the low floodplain area, while Transect 4 was excavated to the north on the higher elevation knoll. Transect 2 was excavated at the head of the drainage channel (see Figure 9).

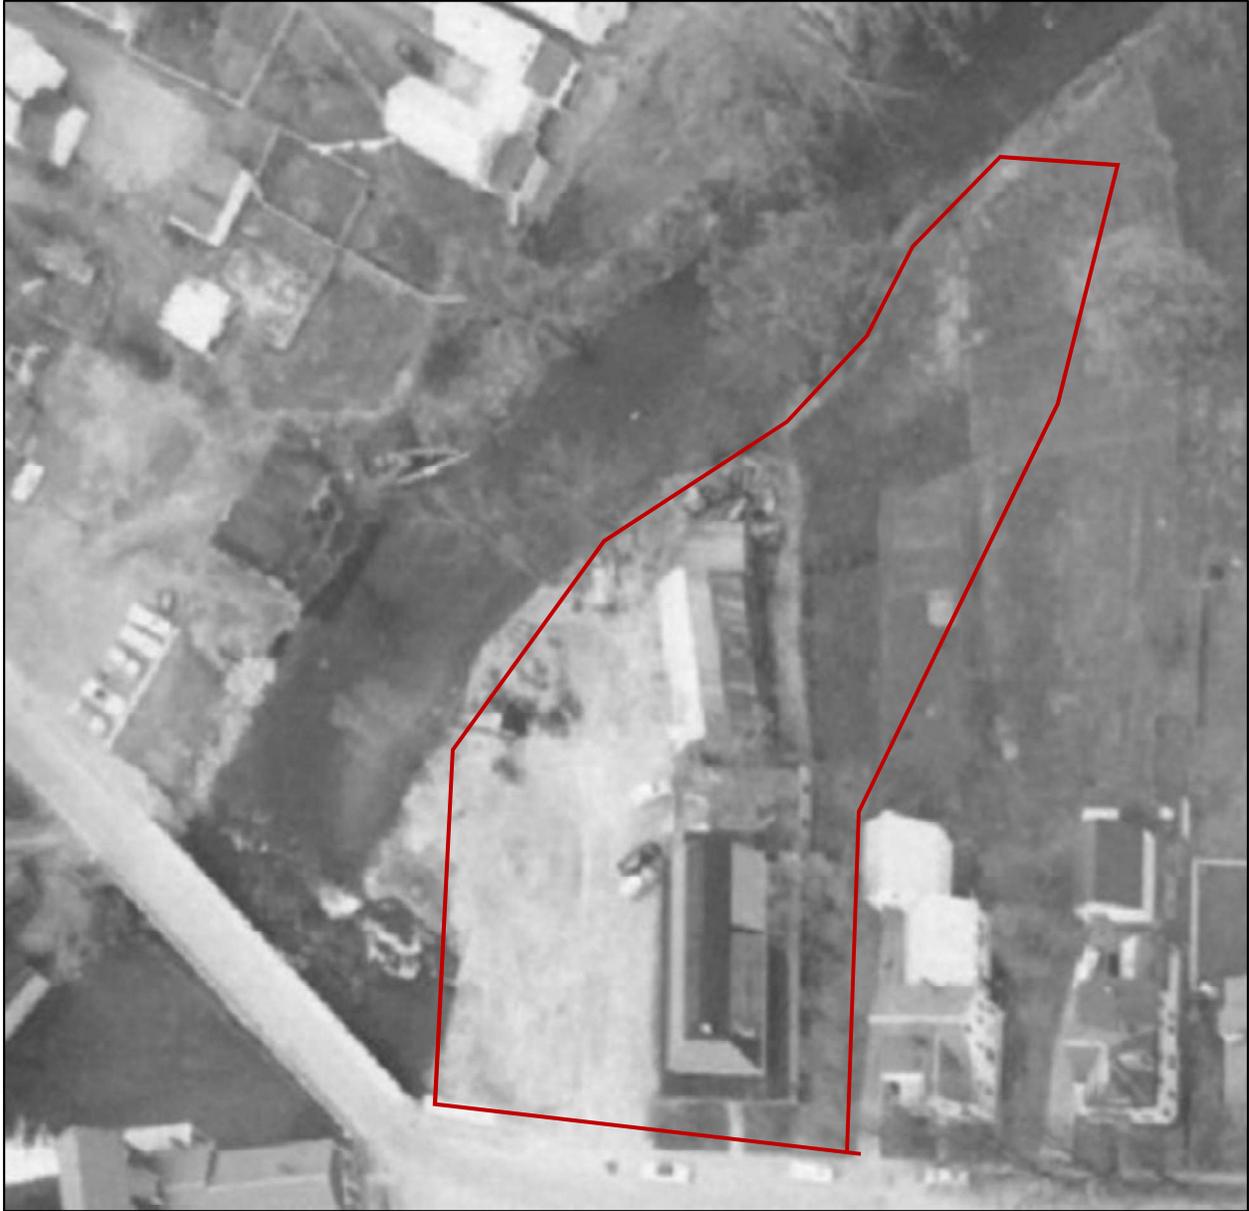
Figure 10. Detail of 1962 aerial imagery with approximate project area outlined in red. Note: former garage building (Kahn Barn) behind gymnasium and gravel lot between buildings and Gihon River (Geotechnics & Resources Inc. 1962).

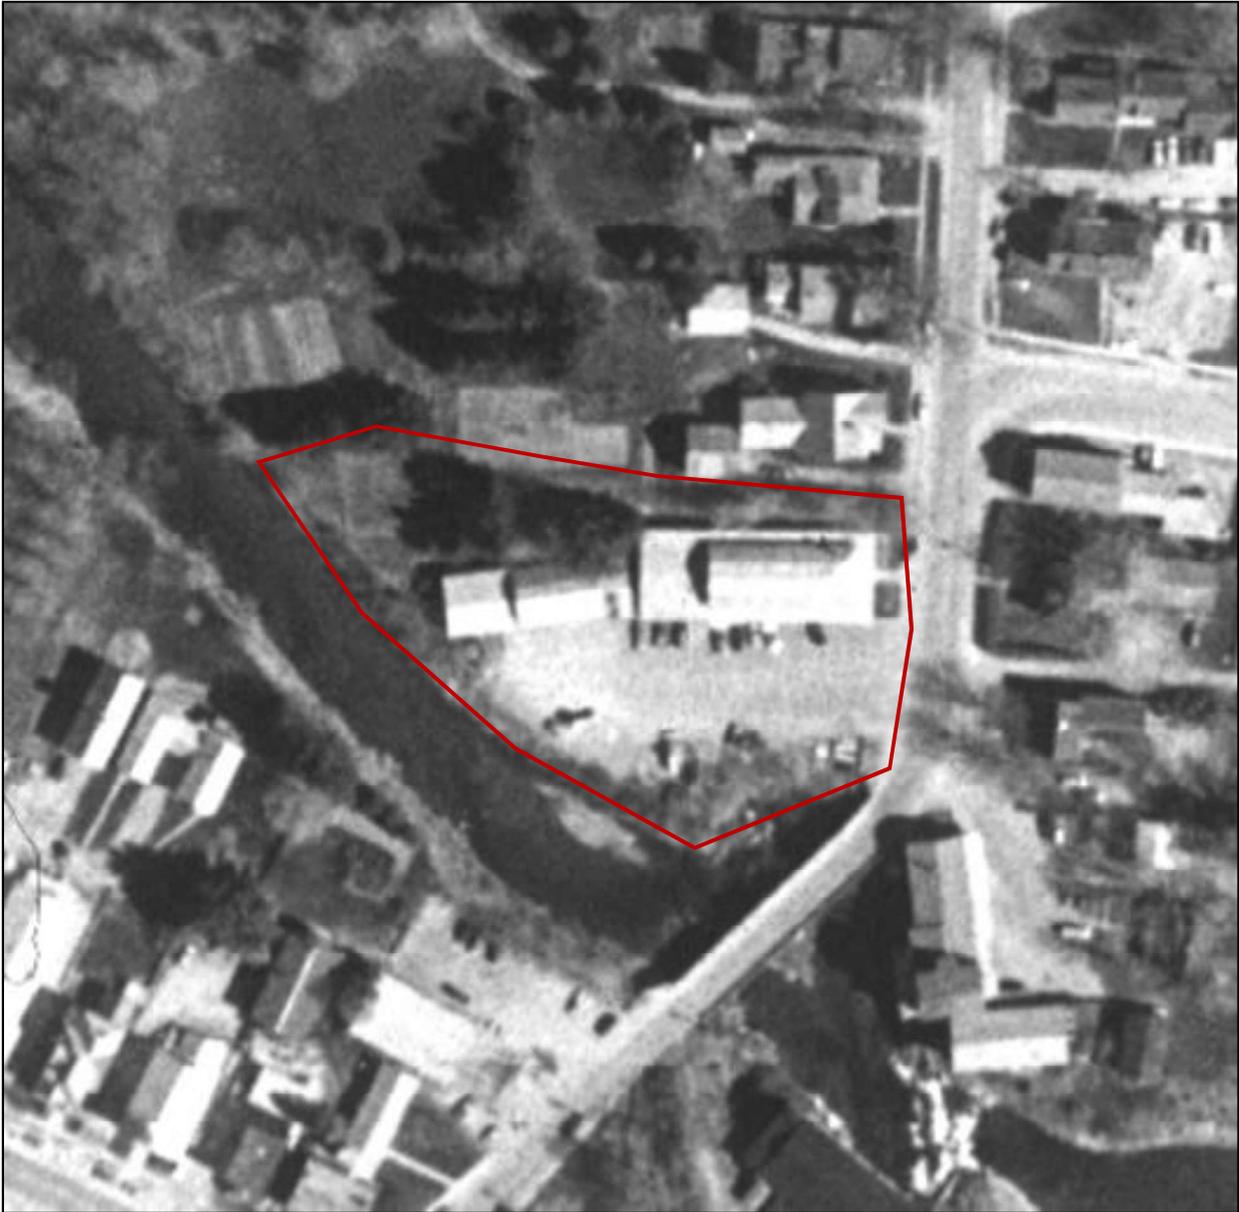
Figure 11. Detail of 1995 aerial imagery with approximate project area outlined in red. Note: parking area to south of Kahn Gymnasium (Vermont Mapping Program 1995).

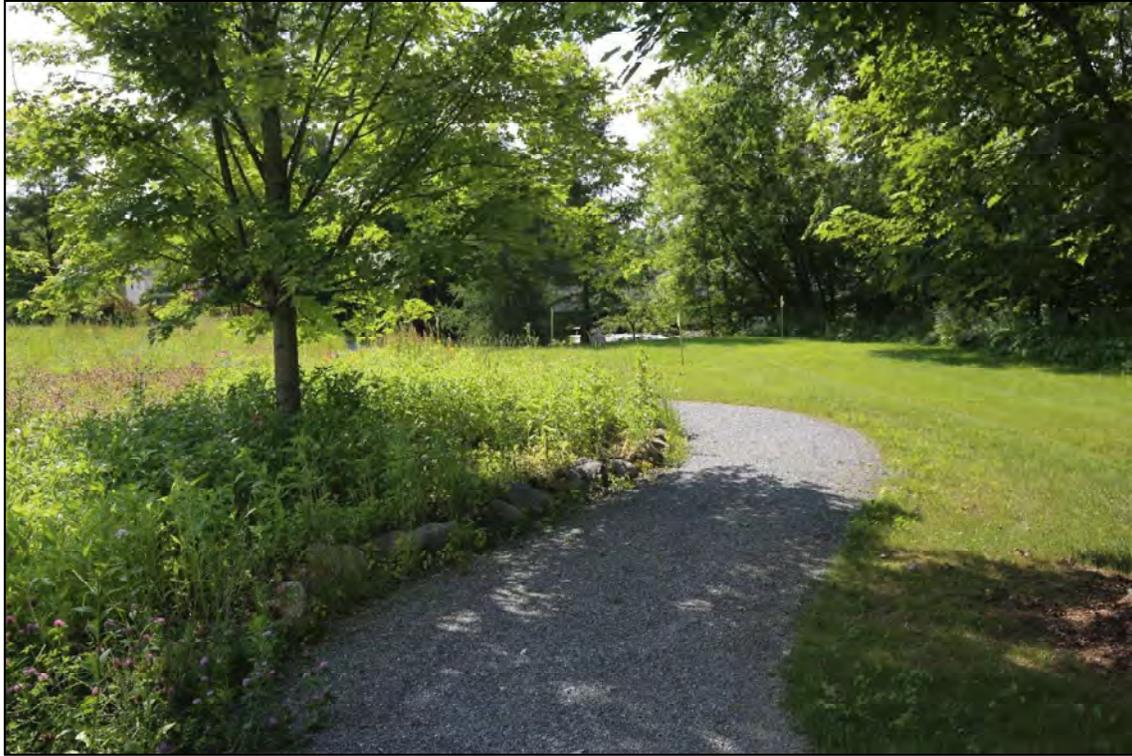
Figure 14. View southeast of ‘Mason Green’ area to the south of the Kahn Gymnasium with soil contamination area stakes and landscaped path in image center.

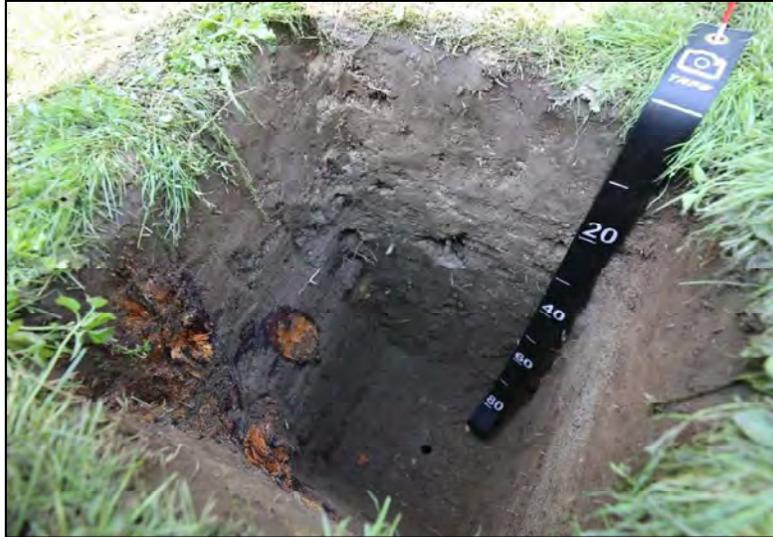
Figure 15. Image of Transect 1 Test Pit 1 during the Phase I Survey of the Vermont Studio Center Floodplain Restoration Project APE, Johnson, Lamoille County, Vermont.

The excavation of the remaining two test pits along Transect 1, TR1 TP2 and TR1 TP3, revealed three to four fill episodes, extending to depths between 41-64 cmbs (16-25 in), underlain by a series of buried plowzones and alluvial episodes which were excavated to 95 cmbs (37 in) and hand soil cored to 118-138 cmbs (46-54 in) (Figure 16). The fills were comprised of varying degrees and sizes of gravel, while the buried plowzones were described as brown to olive brown sandy loam. The alluvial stratum which separated the buried plowzones were characterized as thin sandy deposits, typically around 5-10 cm (2-4 in) in thickness. In TR1 TP3, a quartzite lithic debitage specimen was identified from 20-30 cmbs (8-12 in) within the second fill stratum. Along with this probable precontact Native American artifact, various historic artifacts were collected from the same depth and fill episode including beer bottle glass, corroded pennies, and metal and plastic buttons. As the lithic debitage was recovered from a fill context with a preponderance of associated historic deposits, its original provenience has been disturbed and therefore it is not considered significant.

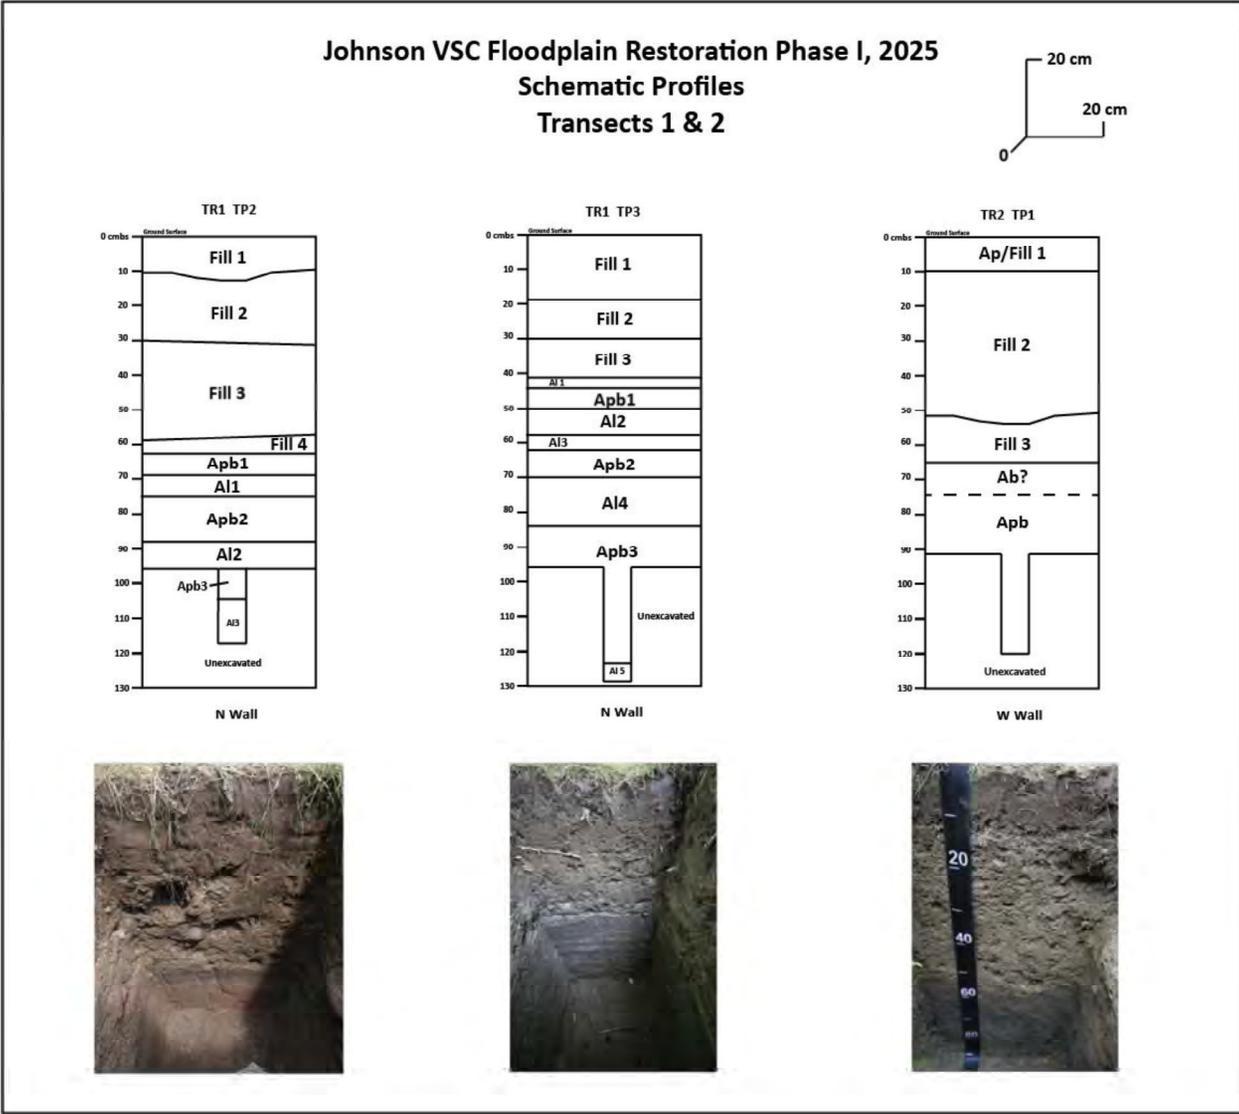
Figure 16. Schematic profiles of test pits along Transect 1 and 2, along with corresponding images, during the Phase I study of the Vermont Studio Center Floodplain Restoration Project APE, Johnson, Lamoille County, Vermont.

The stratigraphy identified within much of the lower floodplain area indicates that the parcel has undergone several flood events in the past in which thin sandy sediments were deposited. Following these historic flood events, it appears that new topsoil may have been added and subsequently plowed, thus slowly raising the level of the landform in this area. The artifact range suggests this plow/flood sequence may have occurred between the mid-19th–mid-20th century. Additionally, several rocky fills were likely added to the landform in the more recent past. These fill strata contained a mix of modern and historic materials, such as beer bottle glass, plastic buttons and caps, and ceramic fragments, along with a precontact Native American artifact, devoid of its original provenience.

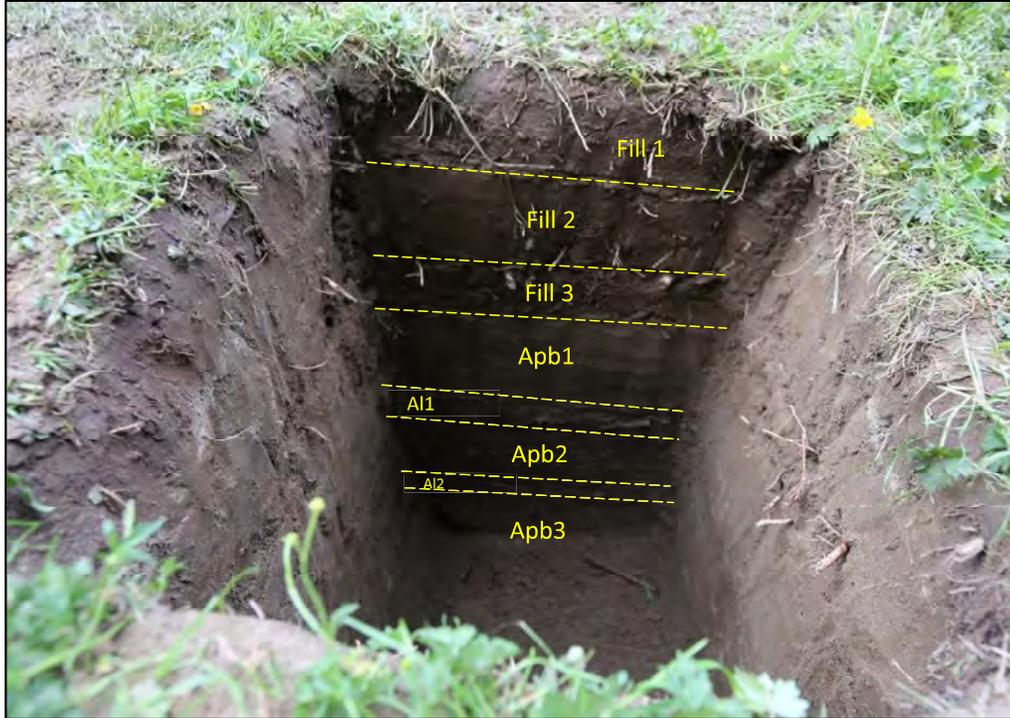
Figure 17. Image of the west wall soil profile, with stratigraphic breaks, of Transect 3 Test Pit 1 for the Phase I Survey of the Vermont Studio Center Floodplain Restoration Project APE, Johnson, Lamoille County, Vermont.

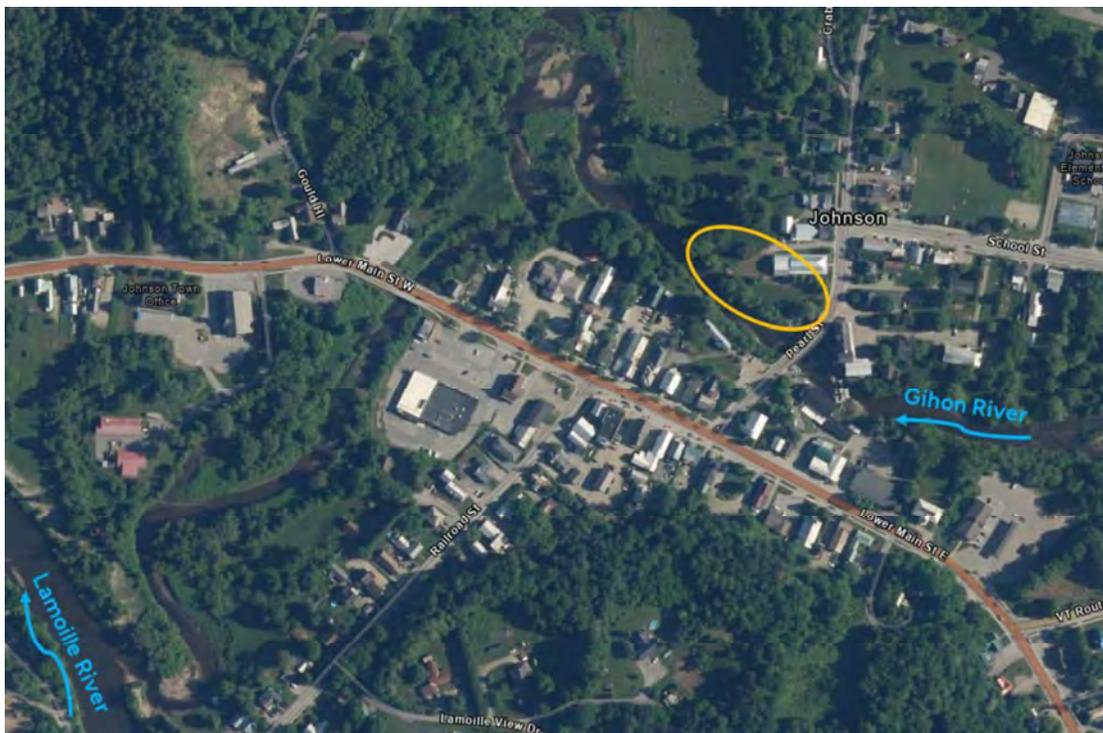
Figure 1: Vermont Studio Center Floodplain Restoration Project Site, Johnson, Vermont

A floodplain restoration opportunity was identified at the Vermont Studio Center in the location of the former Johnson Town Garage (Figure 1). In 1990, two underground storage tanks (USTs) were removed from the site, but elevated concentrations of petroleum contamination remain (Appendix A). Ross Environmental Associates, Inc. (REA) conducted an Evaluation of Corrective Action Alternatives (ECAA) and recommended the removal of approximately 360 cubic yards of petroleum contaminated soil. Building upon the limited soil excavation proposed by REA, we were tasked with exploring a more comprehensive floodplain restoration project along the Gihon River in partnership with the Vermont Studio Center and Lamoille County Planning Commission (LCPC). A concept design was completed for a floodplain restoration project for the selected Alternative B that preserves the existing pollinator garden and walking path. The alternatives analysis and details on the concept design follow.

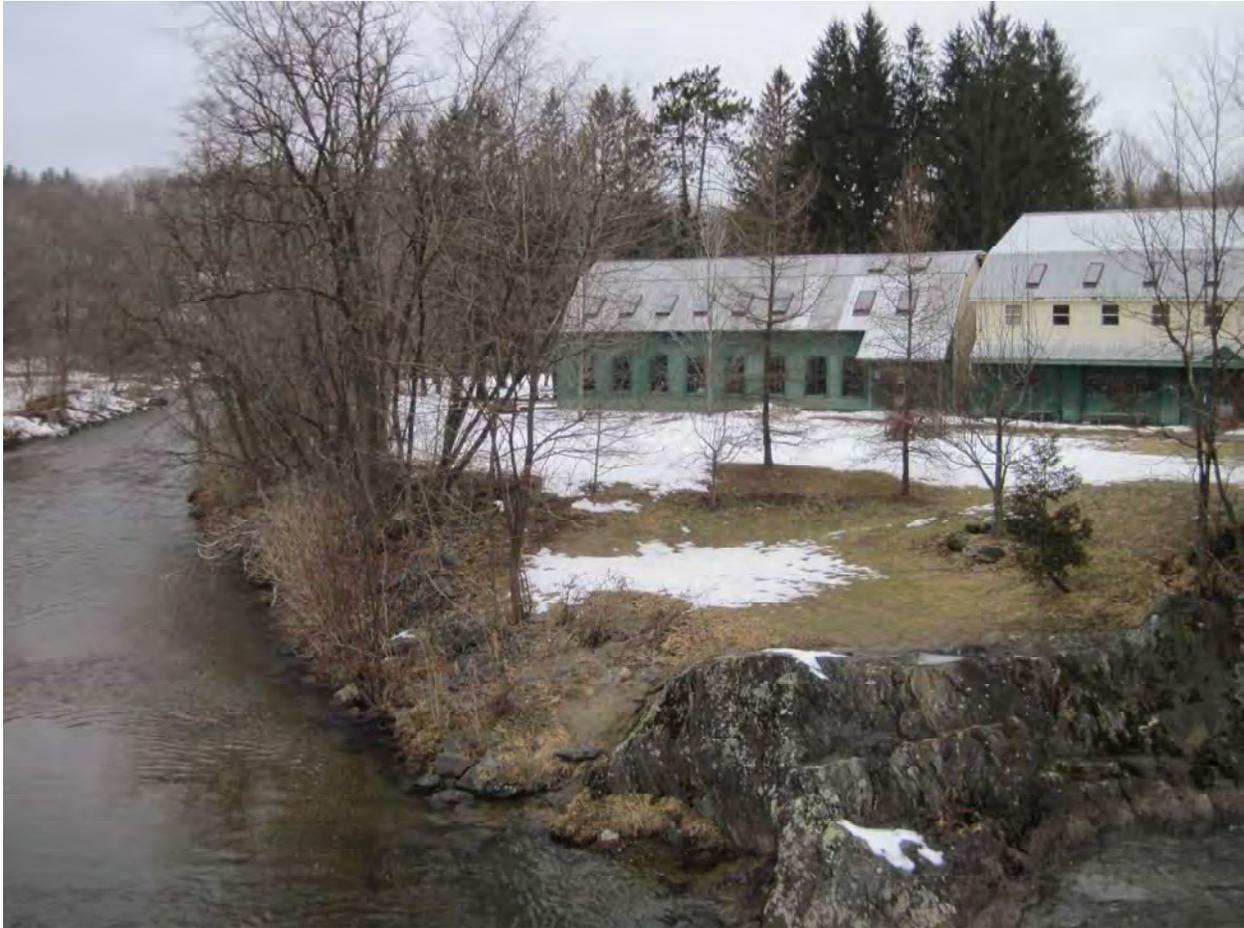
Figure 3: Bedrock outcrop looking downstream from the Pearl Street Bridge

The proposed floodplain is along the Gihon River, downstream of the Pearl Street bridge and adjacent to the Wolf Kahn Studio Building. In 2024, VSC created the Junebug Pollinator Garden and Trail which established a vibrant pollinator garden and gravel path that meanders between the studio building and the river and provides an alternate path to the Johnson Arboretum (Figure 2). A grass lawn spans the space between the gravel path and a strip of trees and shrubs that grow along the Gihon's sloping riverbank. The is a small river access where the lawn slopes down to a bedrock outcrop (Figure 3).

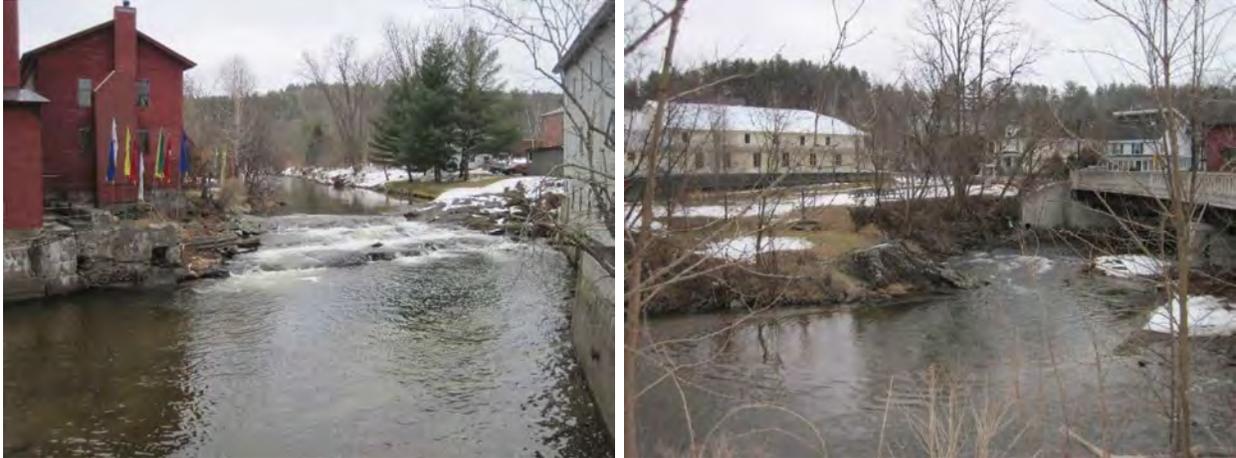
Figure 4: Bedrock falls (Left) and Pearl Street bridge (Right) upstream of project area

The Gihon River flows over a small bedrock falls and through the Pearl Street Bridge, just upstream of the project area (Figure 4). Through the project area, the Gihon is incised and confined by steep banks. Downstream of the project area, the Gihon has a less steep slope resulting in slower moving water and larger meanders (Jesus Beach area) before flowing under Route 15 and entering the Lamoille River (Figure 5). The project site is located in this slope transition zone and is also under the influence of backwater from the Lamoille at higher flows.

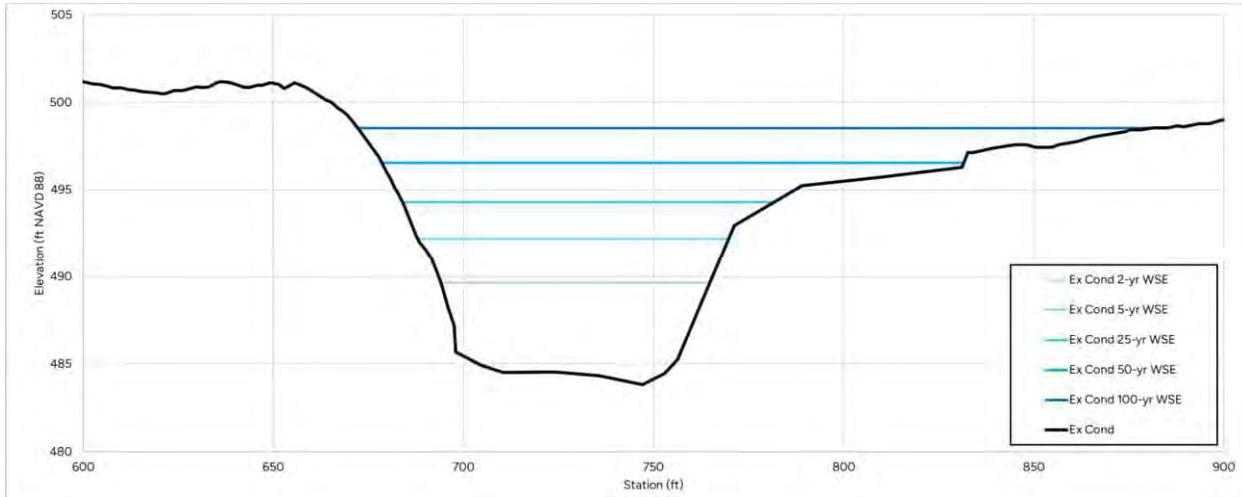
Figure 7: Hydraulic model cross section 34 looking downstream with existing conditions terrain and water surface elevations

The model results confirm the incised conditions of the Gihon River through the project area, as flood waters will not spill out onto the banks until the 50-year flood (Figure 7). For comparison, the floodplain just downstream of the project site activates (allows flood water to spill out onto the floodplain) at the 5-year flood and has been used as a reference for potential floodplain conditions at the Vermont Studio Center site (see cross section 32 in Figure 6).

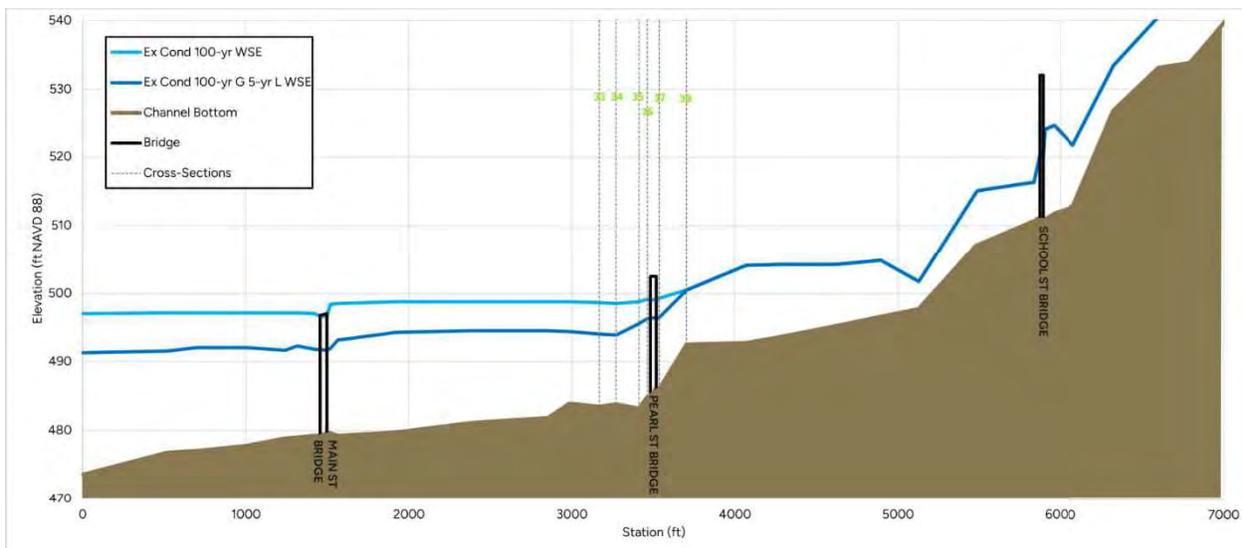
Figure 8: Longitudinal profile of the Gihon River with the existing conditions

Additionally, the model highlighted the impact of the backwatering from the Lamoille (Figure 8). We compared the water surface elevation profile of the 100-yr flood on both the Lamoille and Gihon with the profile of a 5-yr flood on the Lamoille and a 100-yr flood on the Gihon. This illustrates the strong influence of the Lamoille in Johnson's Village center as the backwatering of the Lamoille extends to just upstream of the Pearl Street Bridge.

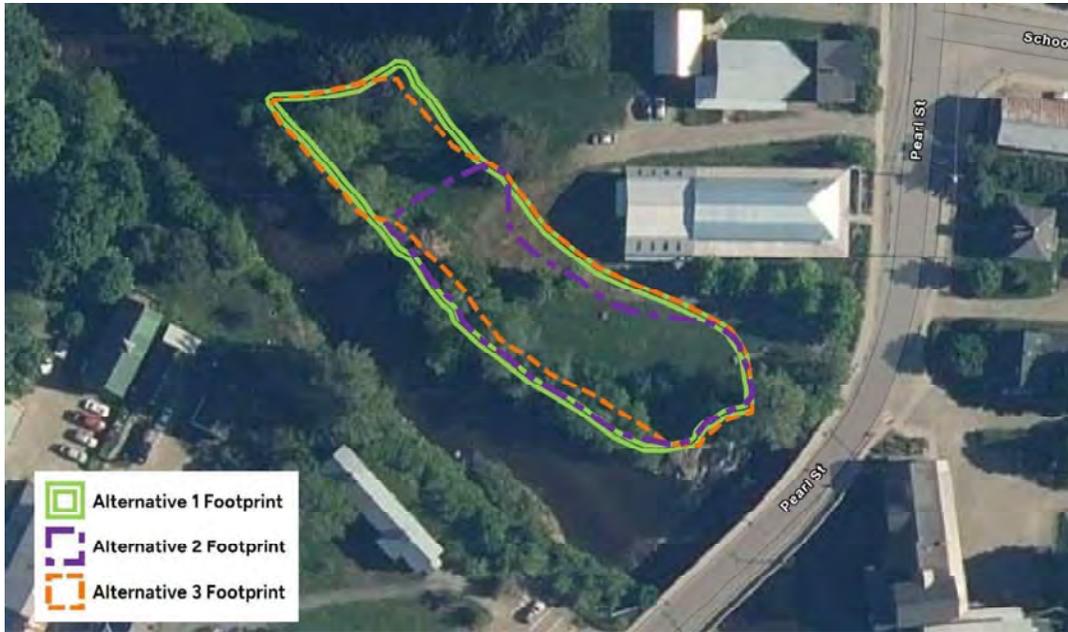
- Alternative 1: Larger floodplain lowered to 2-yr flood
- Alternative 2: Smaller floodplain lowered to 5-yr flood
- Alternative 3: Flood chute floodplain lowered to 5-yr flood preserving trees and vegetation along the river

Figure 9: Proposed floodplain footprints for alternatives 1, 2, and 3

This project evaluated five floodplain restoration alternatives with different footprints and elevations. In the first iteration of the alternative analysis, three alternatives were considered (Figure 9 and Figure 10).

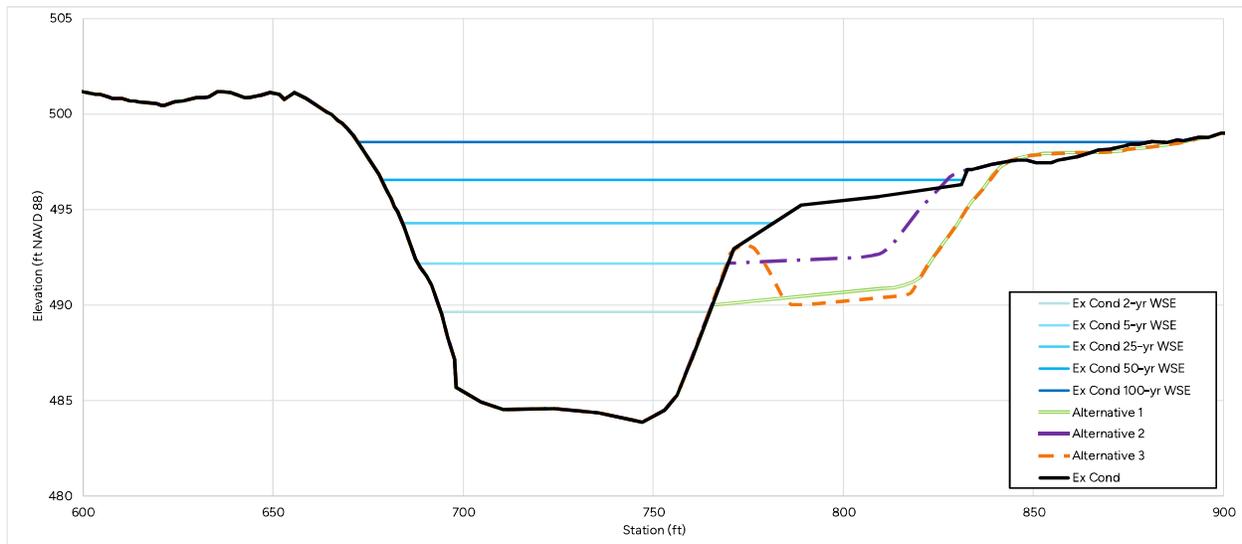
Figure 10: Hydraulic model cross section 34 looking downstream with existing and proposed alternatives terrain and existing conditions water surface elevations

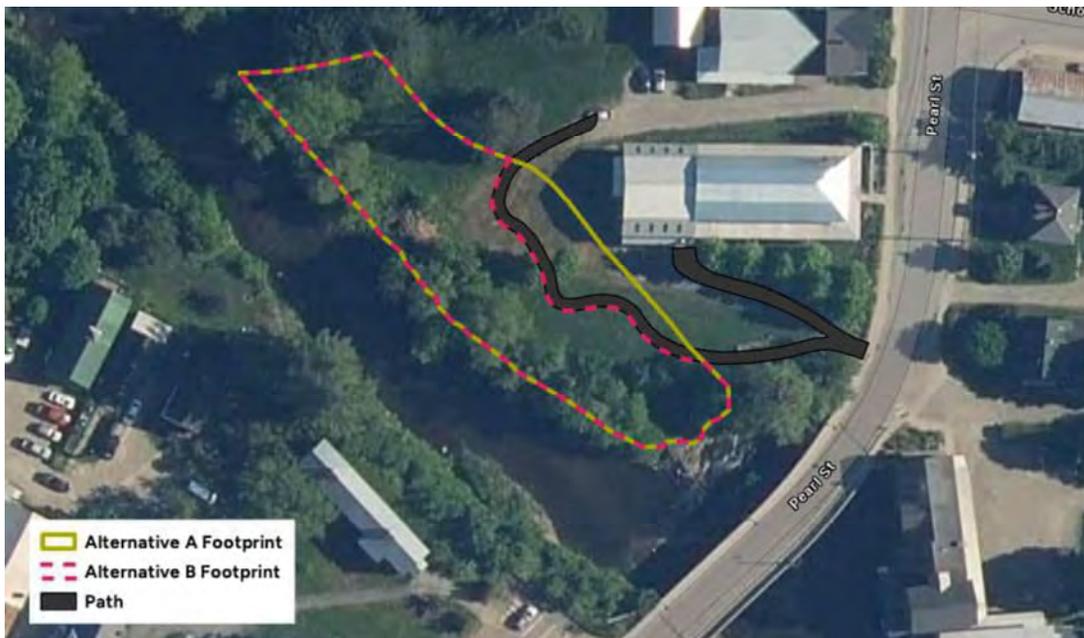
- Alternative A: Floodplain lowered to 5-yr flood
- Alternative B: Floodplain lowered to 5-yr flood and preserves pollinator garden and path

Figure 11: Proposed floodplain footprints for alternatives A and B

Alternative B has been selected for concept design.
