MEETING MEMO

TO: LAMOILLE BASIN WATER QUALITY COUNCIL (BWQC)
FR: LAMOILLE BASIN CLEAN WATER SERVICE PROVIDER (CWSP) STAFF
RE: MEETING ON DECEMBER 4, 2025
DA: NOVEMBER 26, 2025

Lamoille Basin Water Quality Council (BWQC) regular meeting
Thursday, December 4, 2025
9:00-11:00 AM

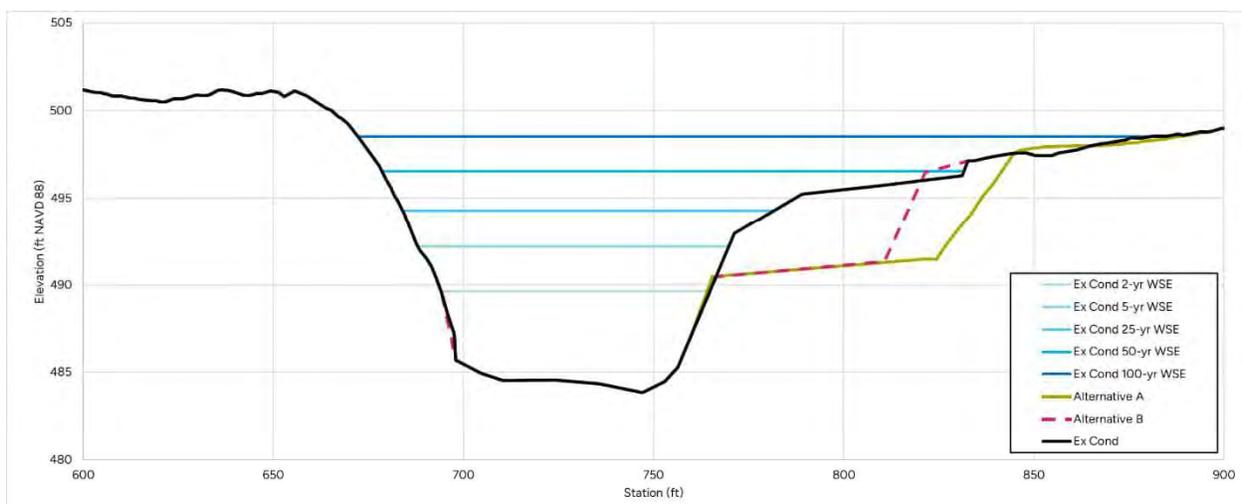
Figure 12: Hydraulic model cross section 34 looking downstream with existing and proposed alternatives terrain and existing conditions water surface elevations

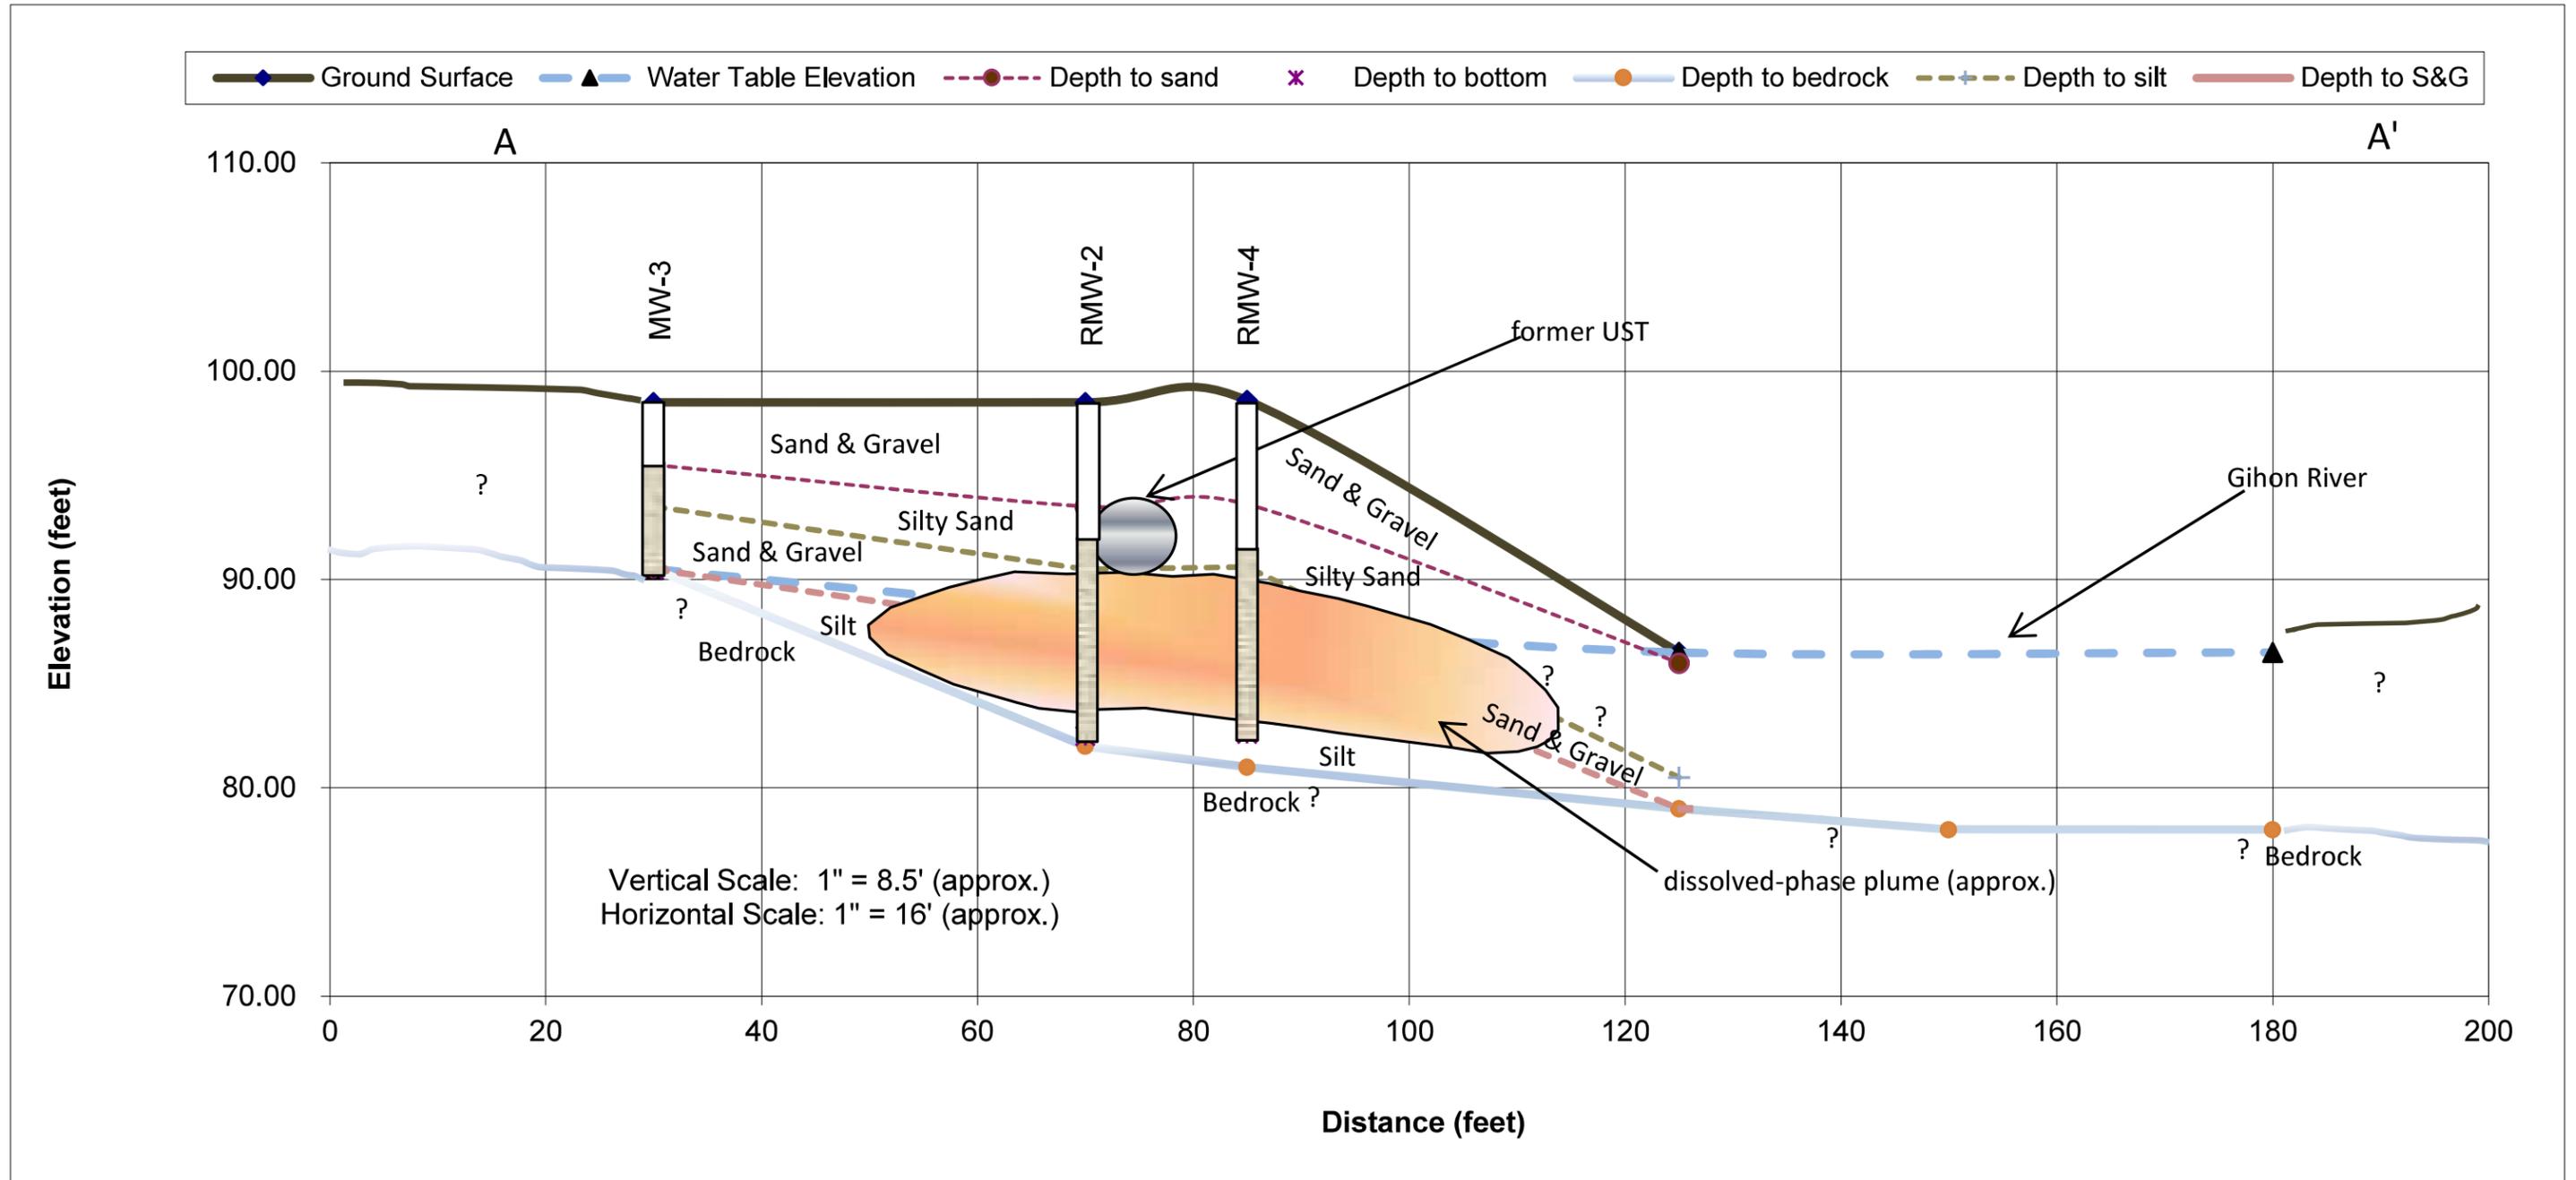
**Geologic Cross Section
A - A'**

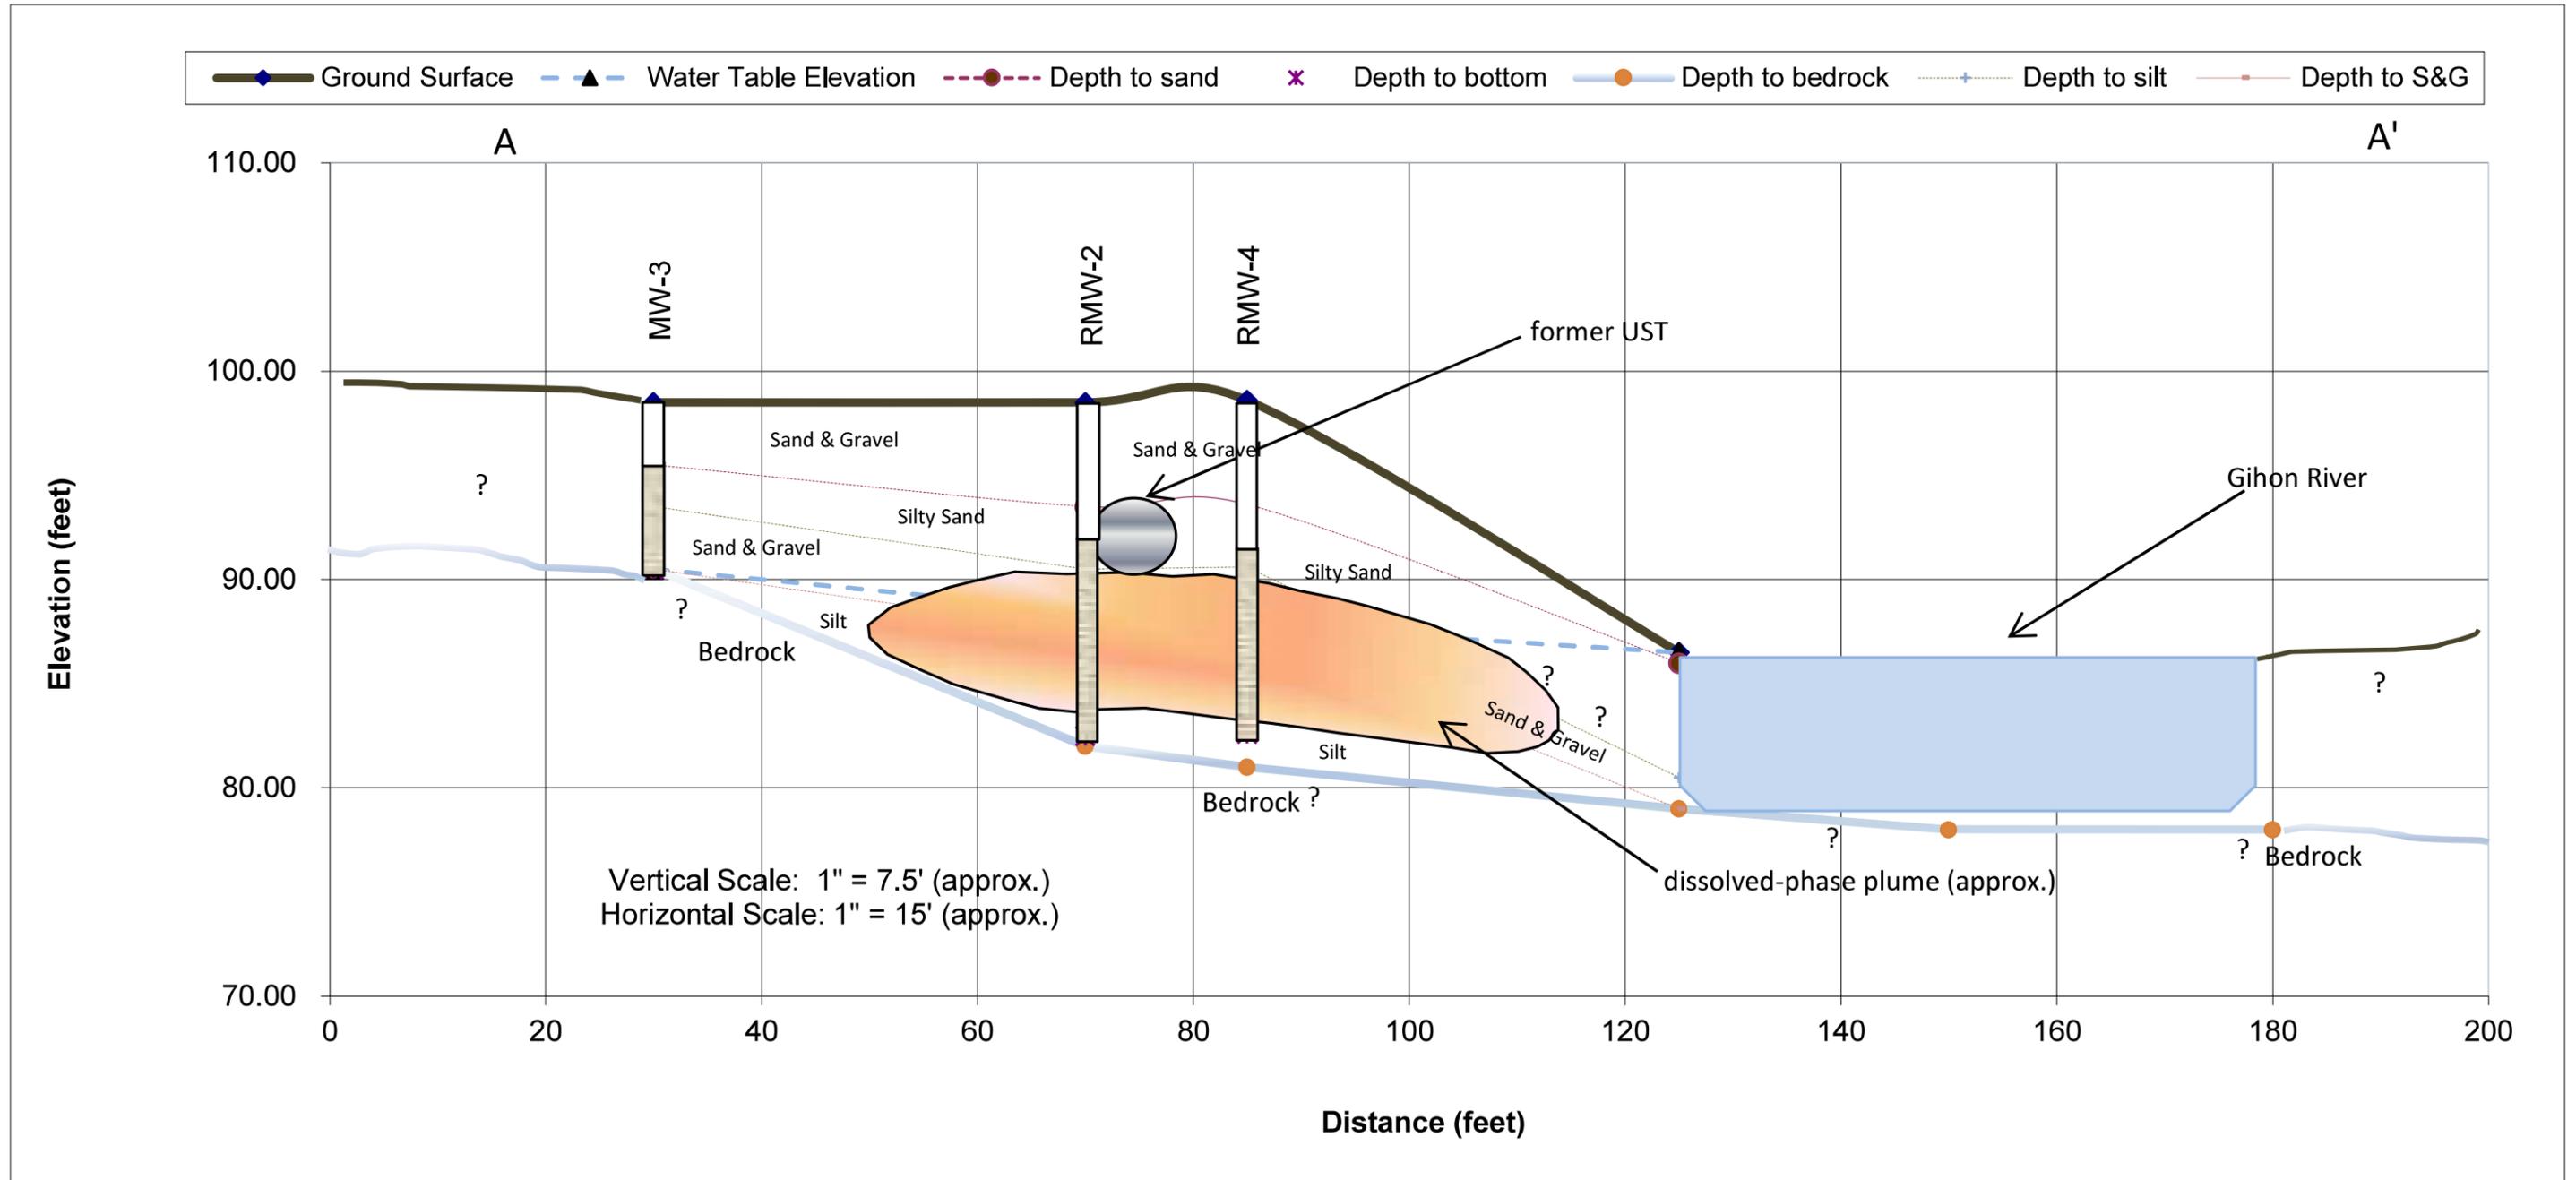
**Geologic Cross Section
B-B'**

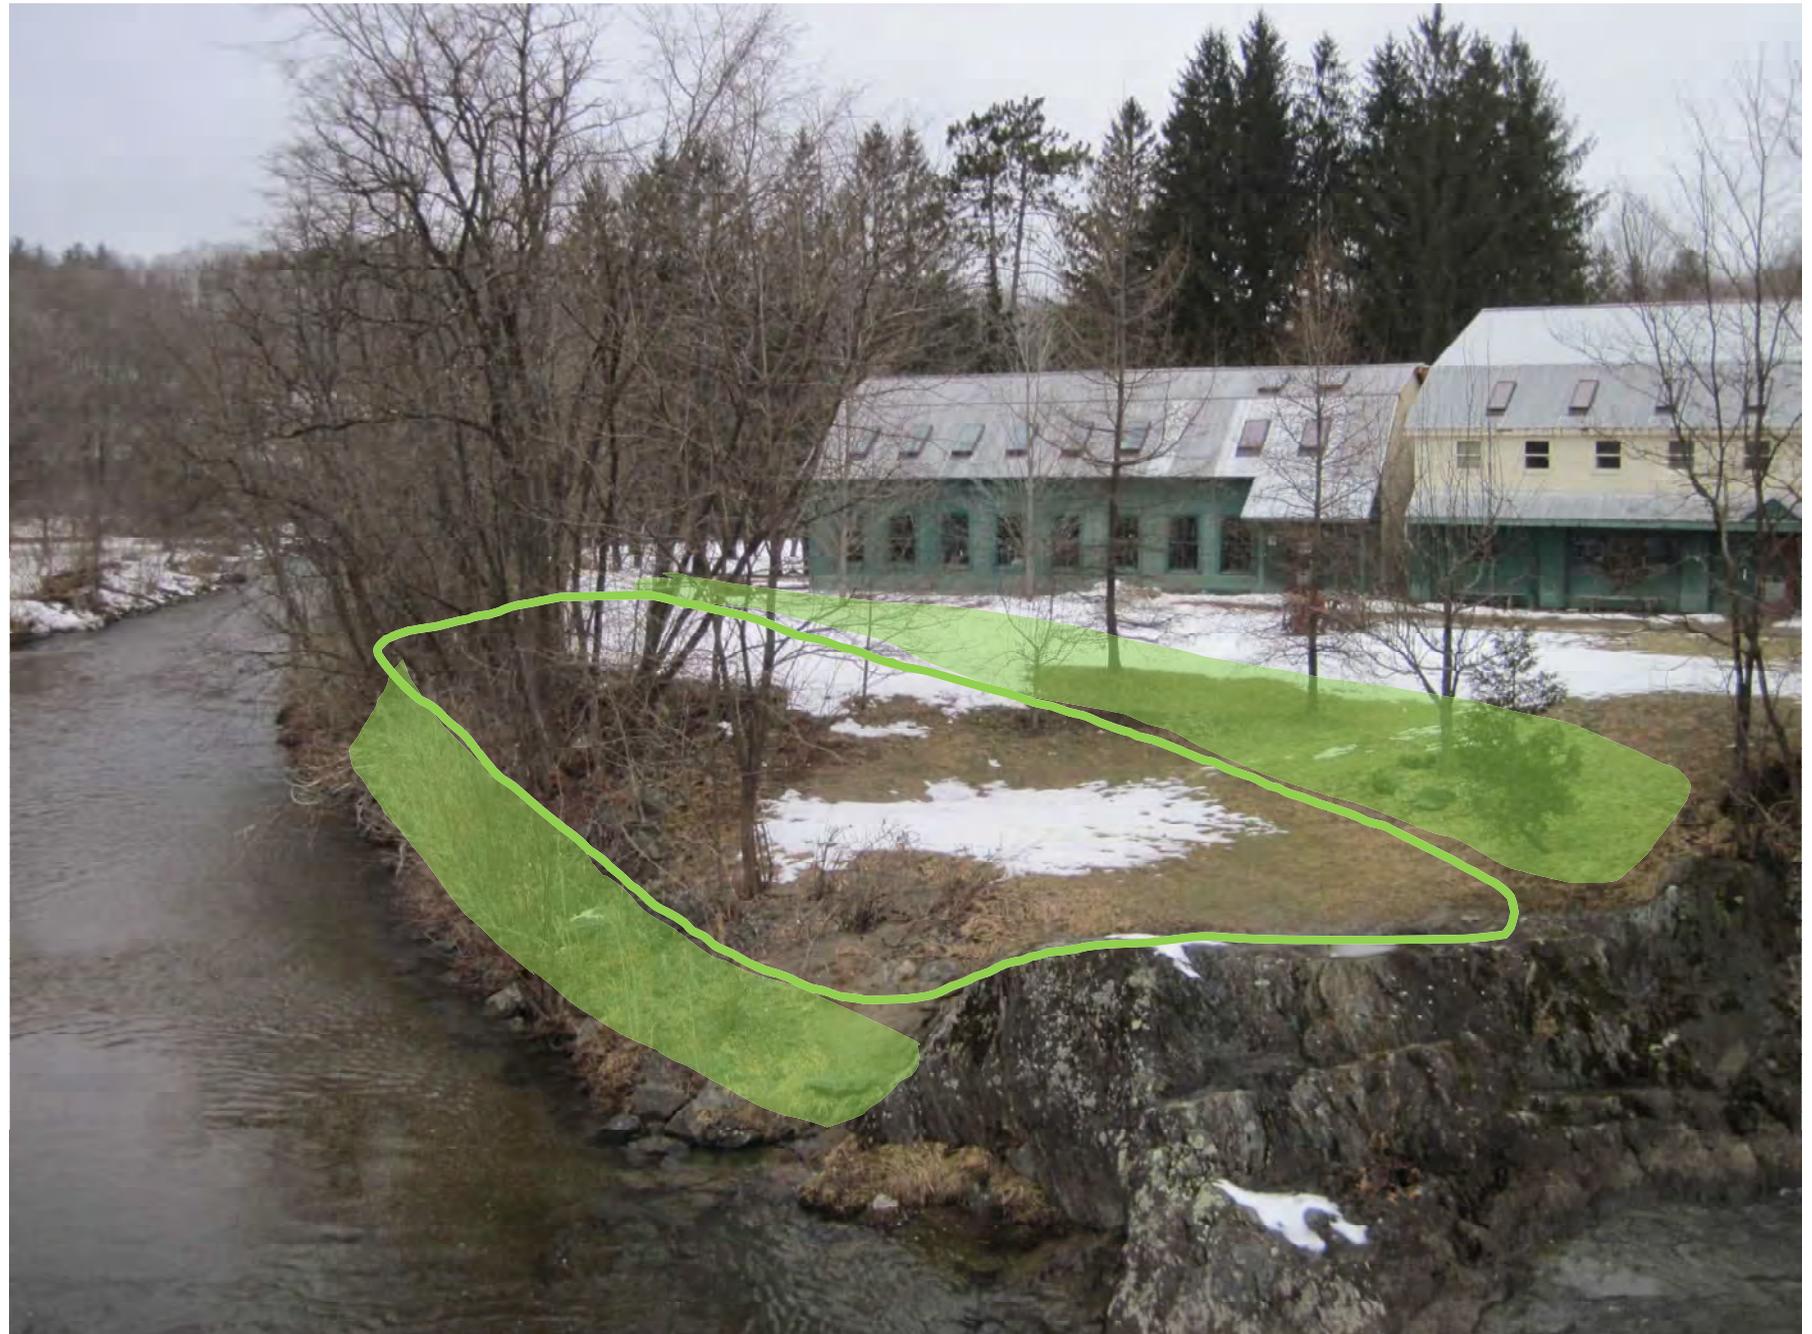
Alternative 1:

Floodplain lowered to 2-yr flood

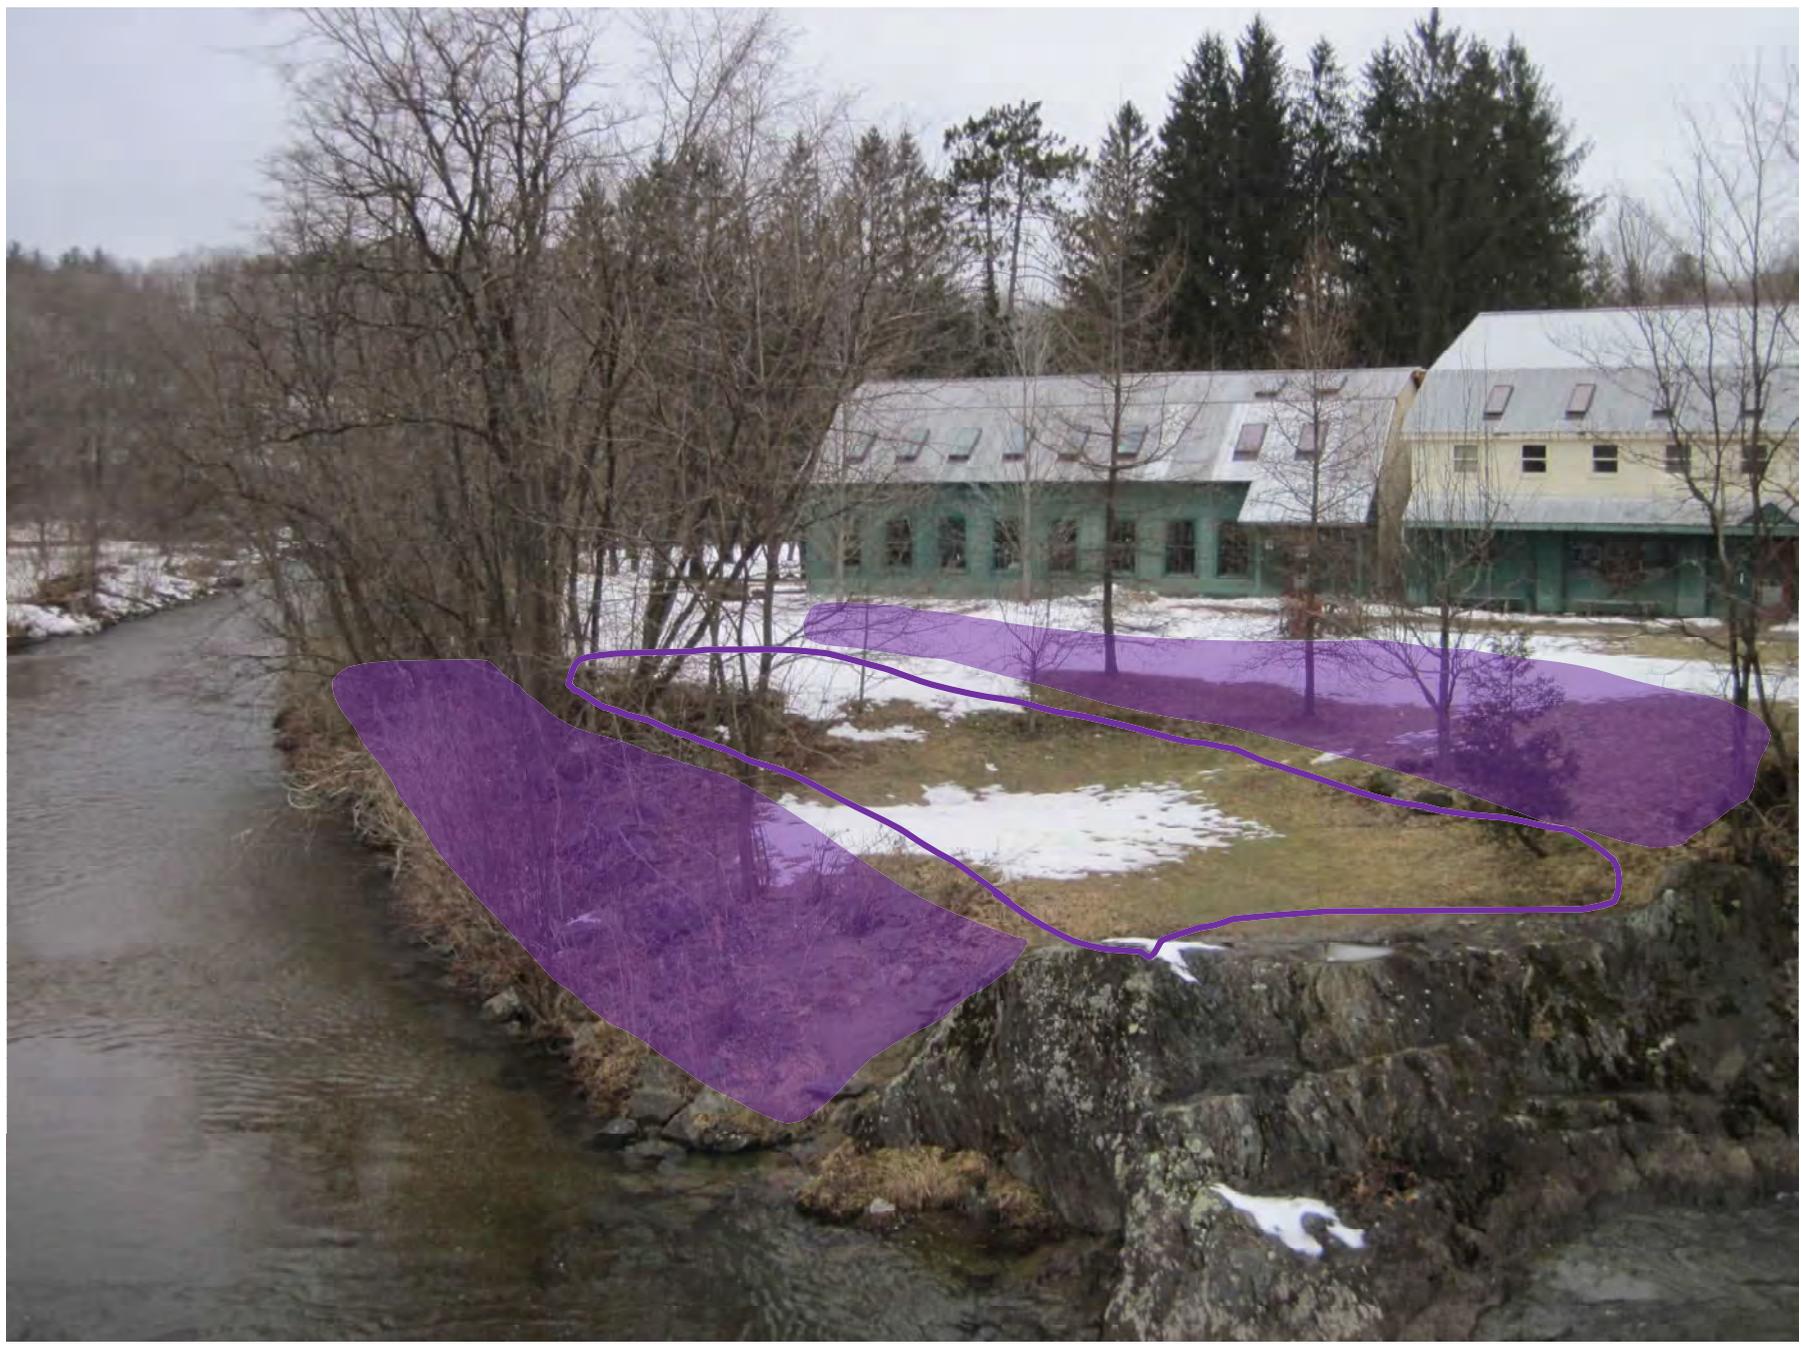
Alternative 2:

Smaller floodplain lowered to
5-yr flood

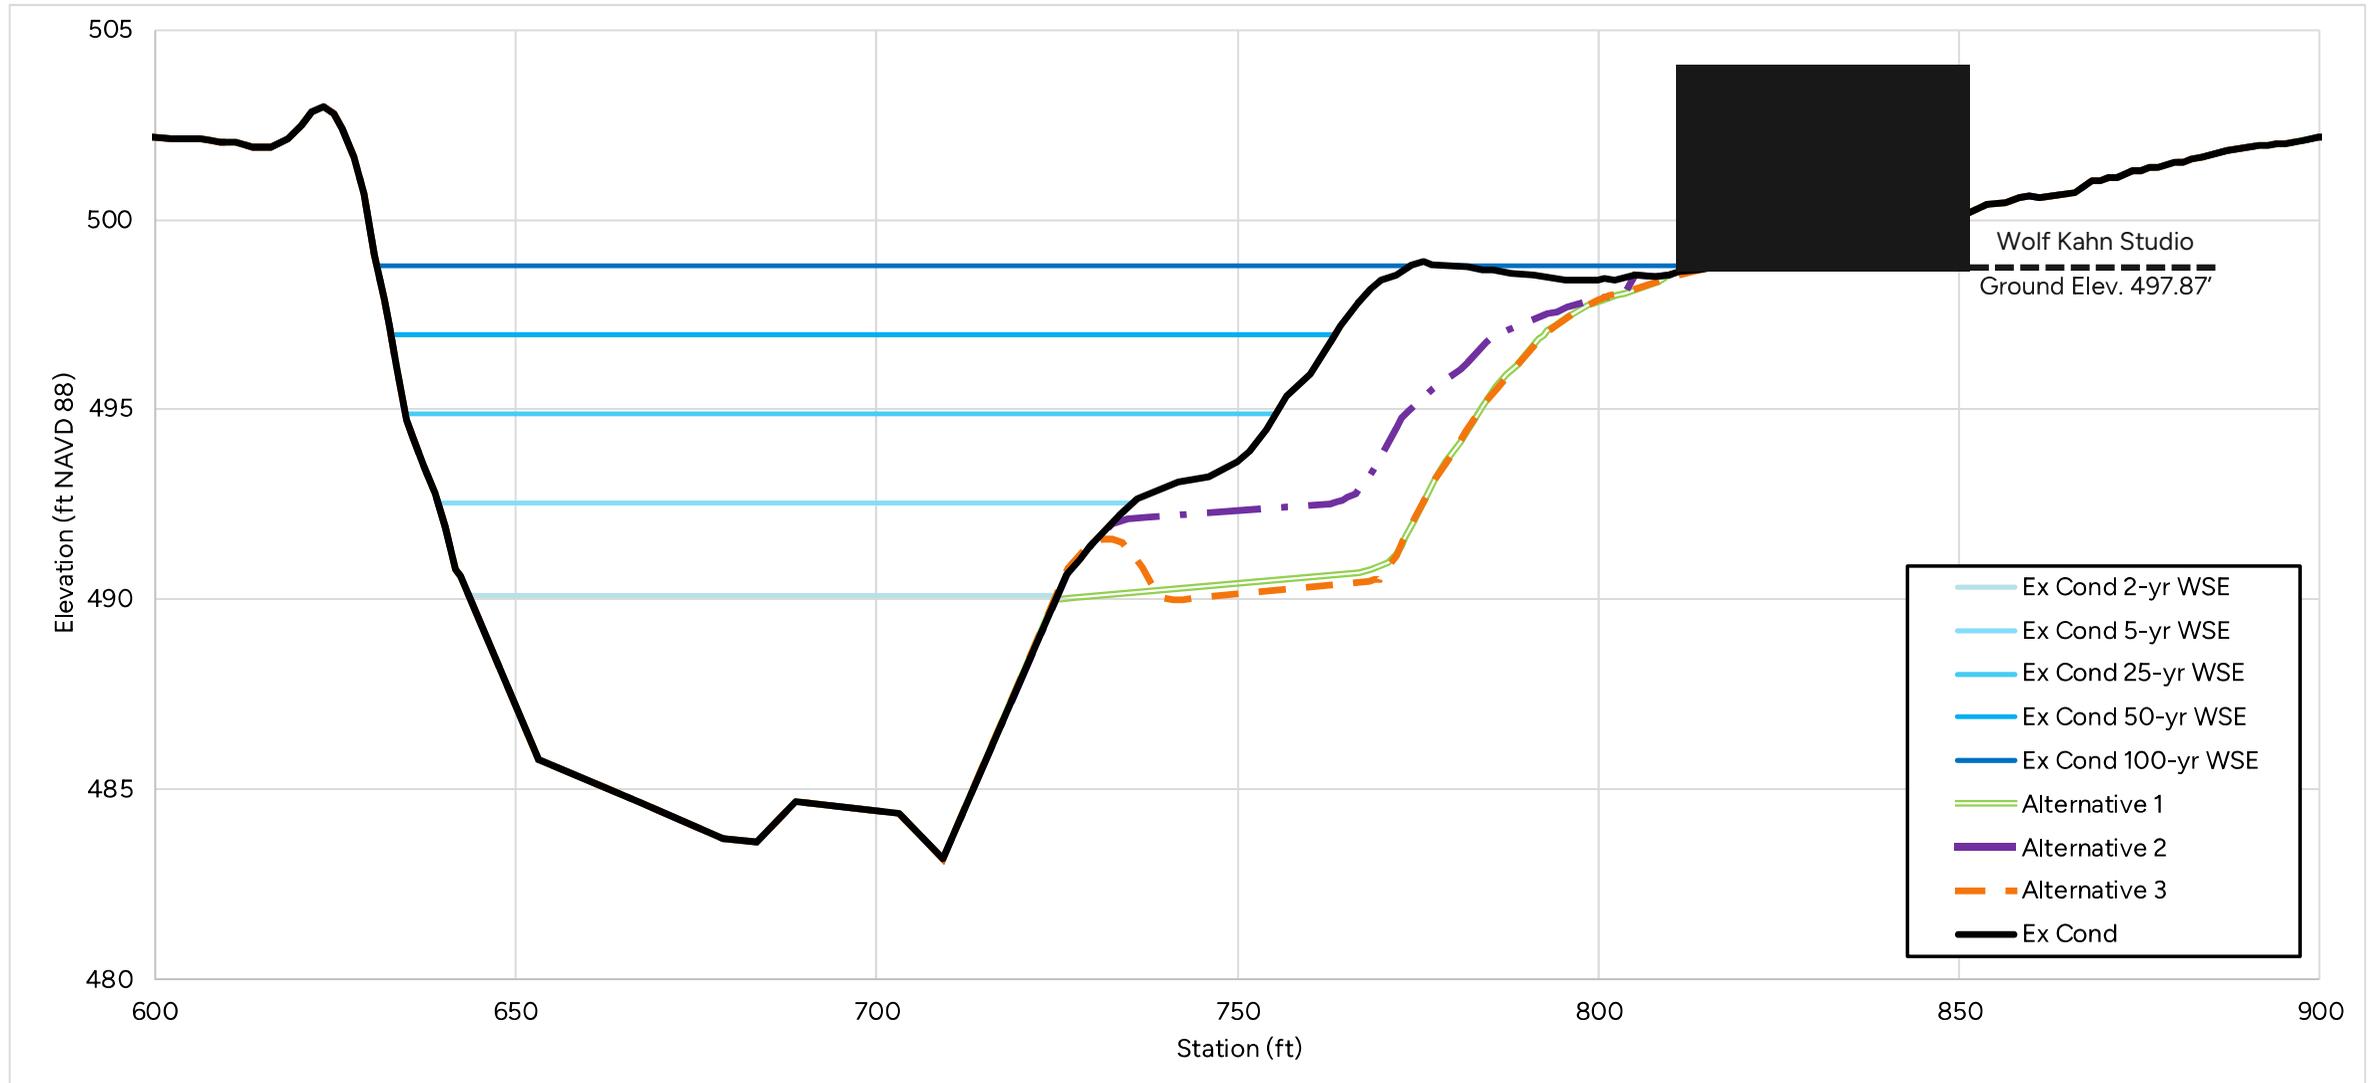
Cross Section 34

Water surface elevations (WSE) for existing conditions with elevation profile of each alternative.

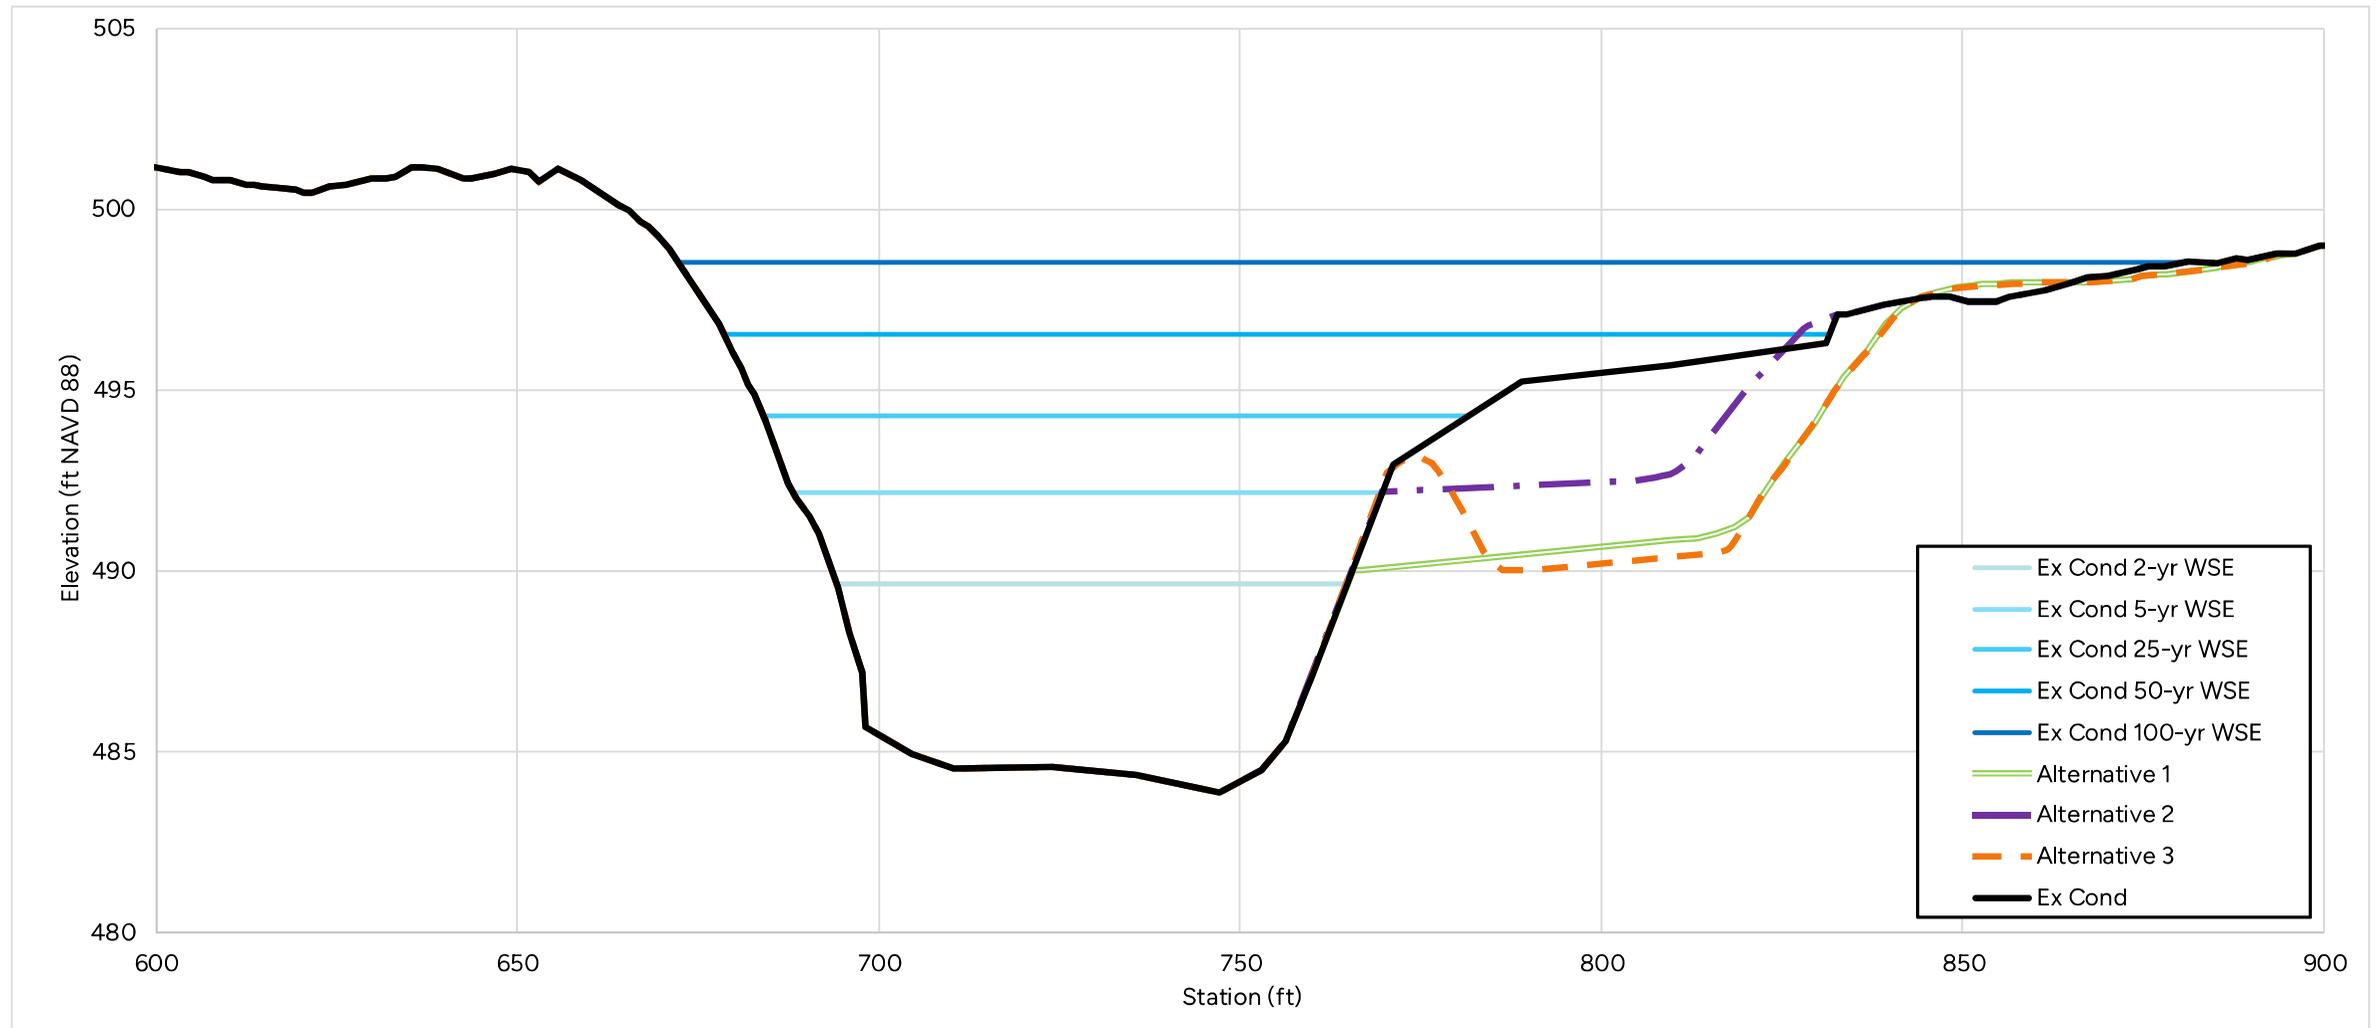
Cross Section 33

Water surface elevations (WSE) for existing conditions with elevation profile of each alternative.

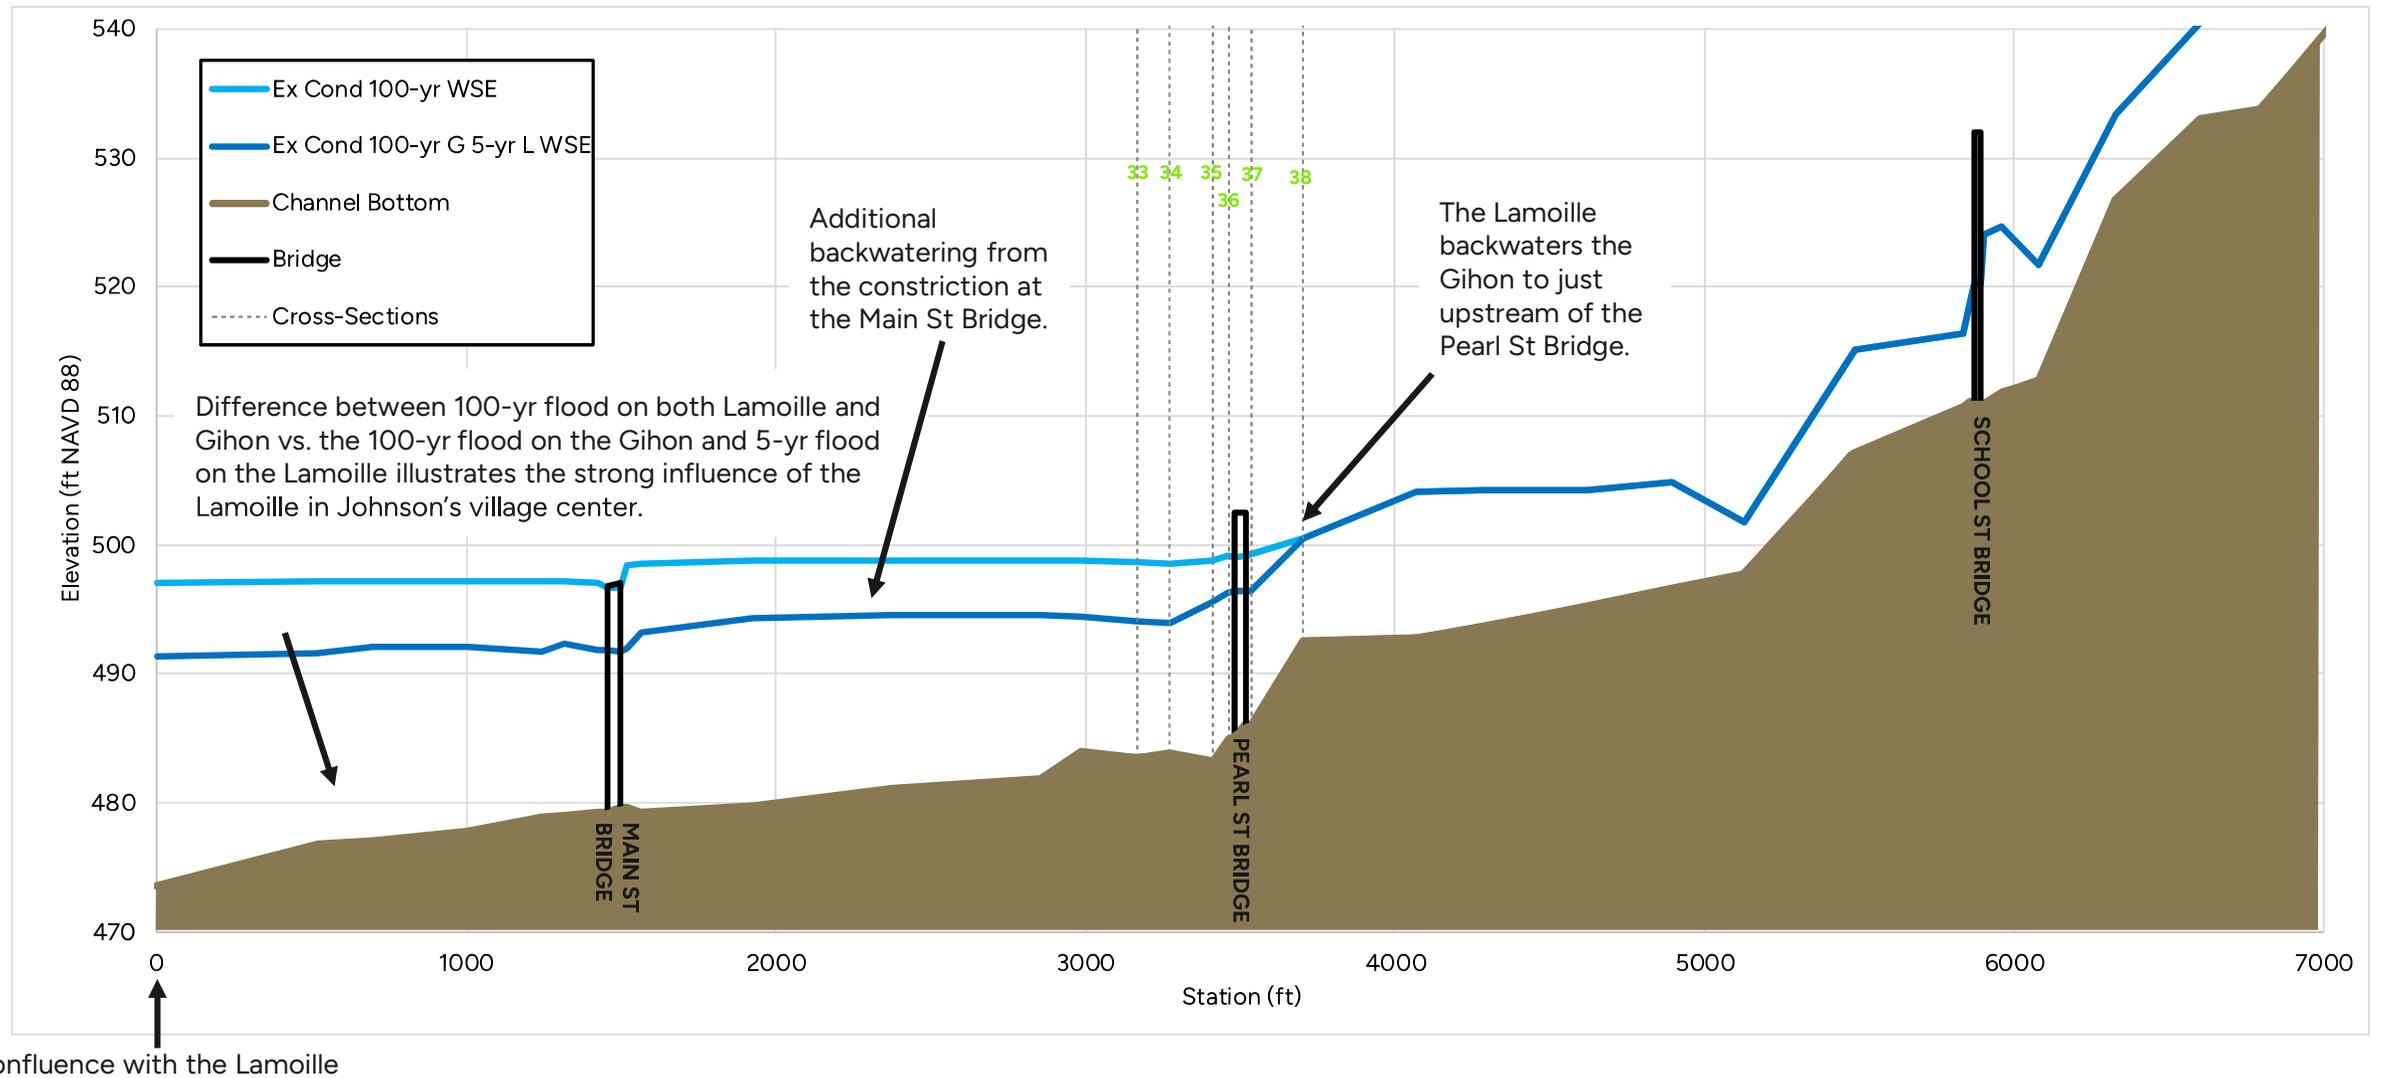
Longitudinal profile of Gihon river WSE comparing a **100-yr flood** on both rivers and when the **Gihon is at the 100-yr flood and the Lamoille is at the 5-yr flood** for existing conditions.

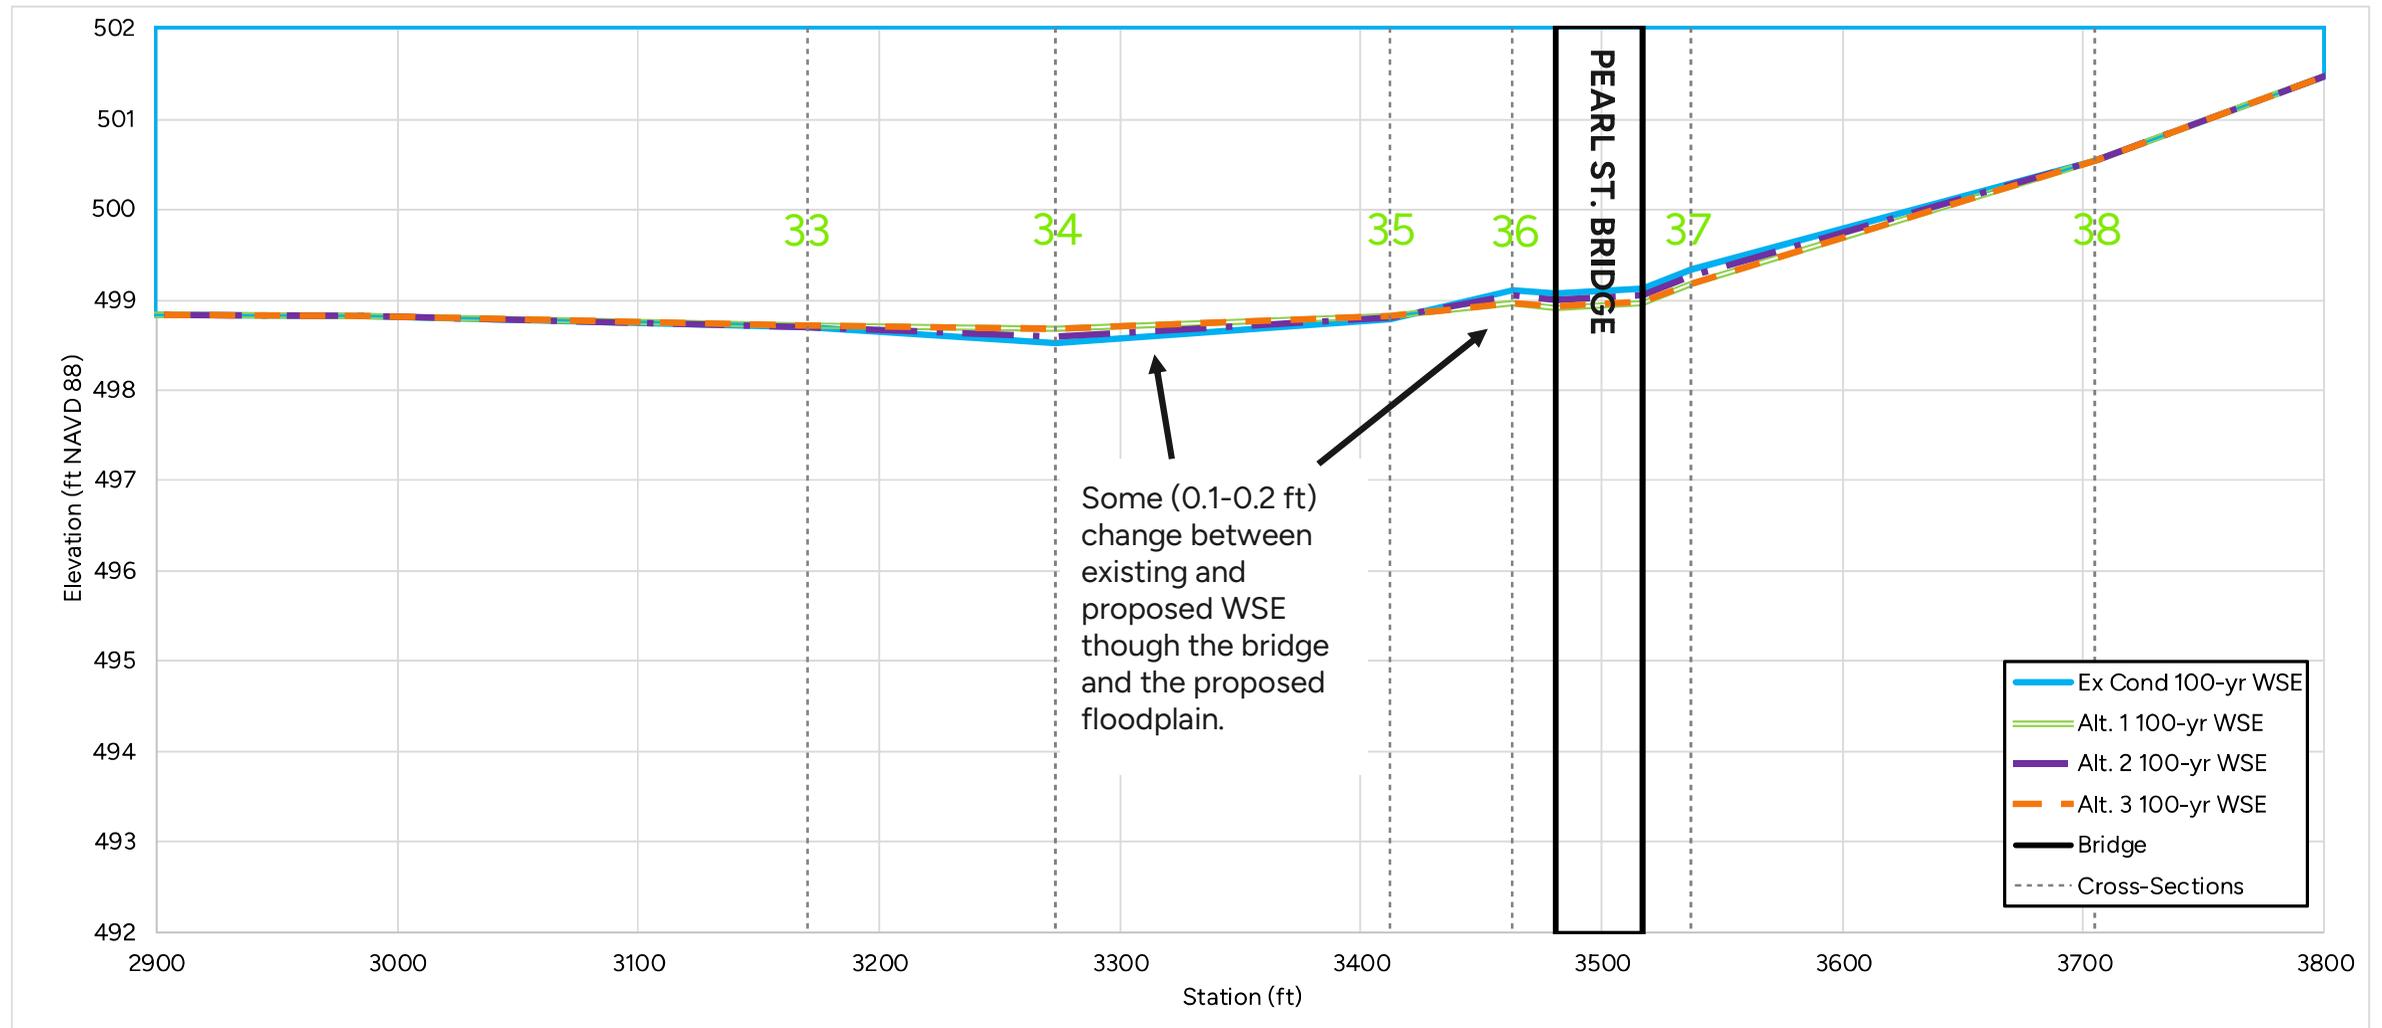
Longitudinal profile of Gihon river WSE at the **100-yr flood** for existing conditions and alternatives.
