MEETING MEMO

TO: LAMOILLE BASIN WATER QUALITY COUNCIL (BWQC)
FR: LAMOILLE BASIN CLEAN WATER SERVICE PROVIDER (CWSP) STAFF
RE: MEETING ON DECEMBER 4, 2025
DA: NOVEMBER 26, 2025

Lamoille Basin Water Quality Council (BWQC) regular meeting
Thursday, December 4, 2025
9:00-11:00 AM

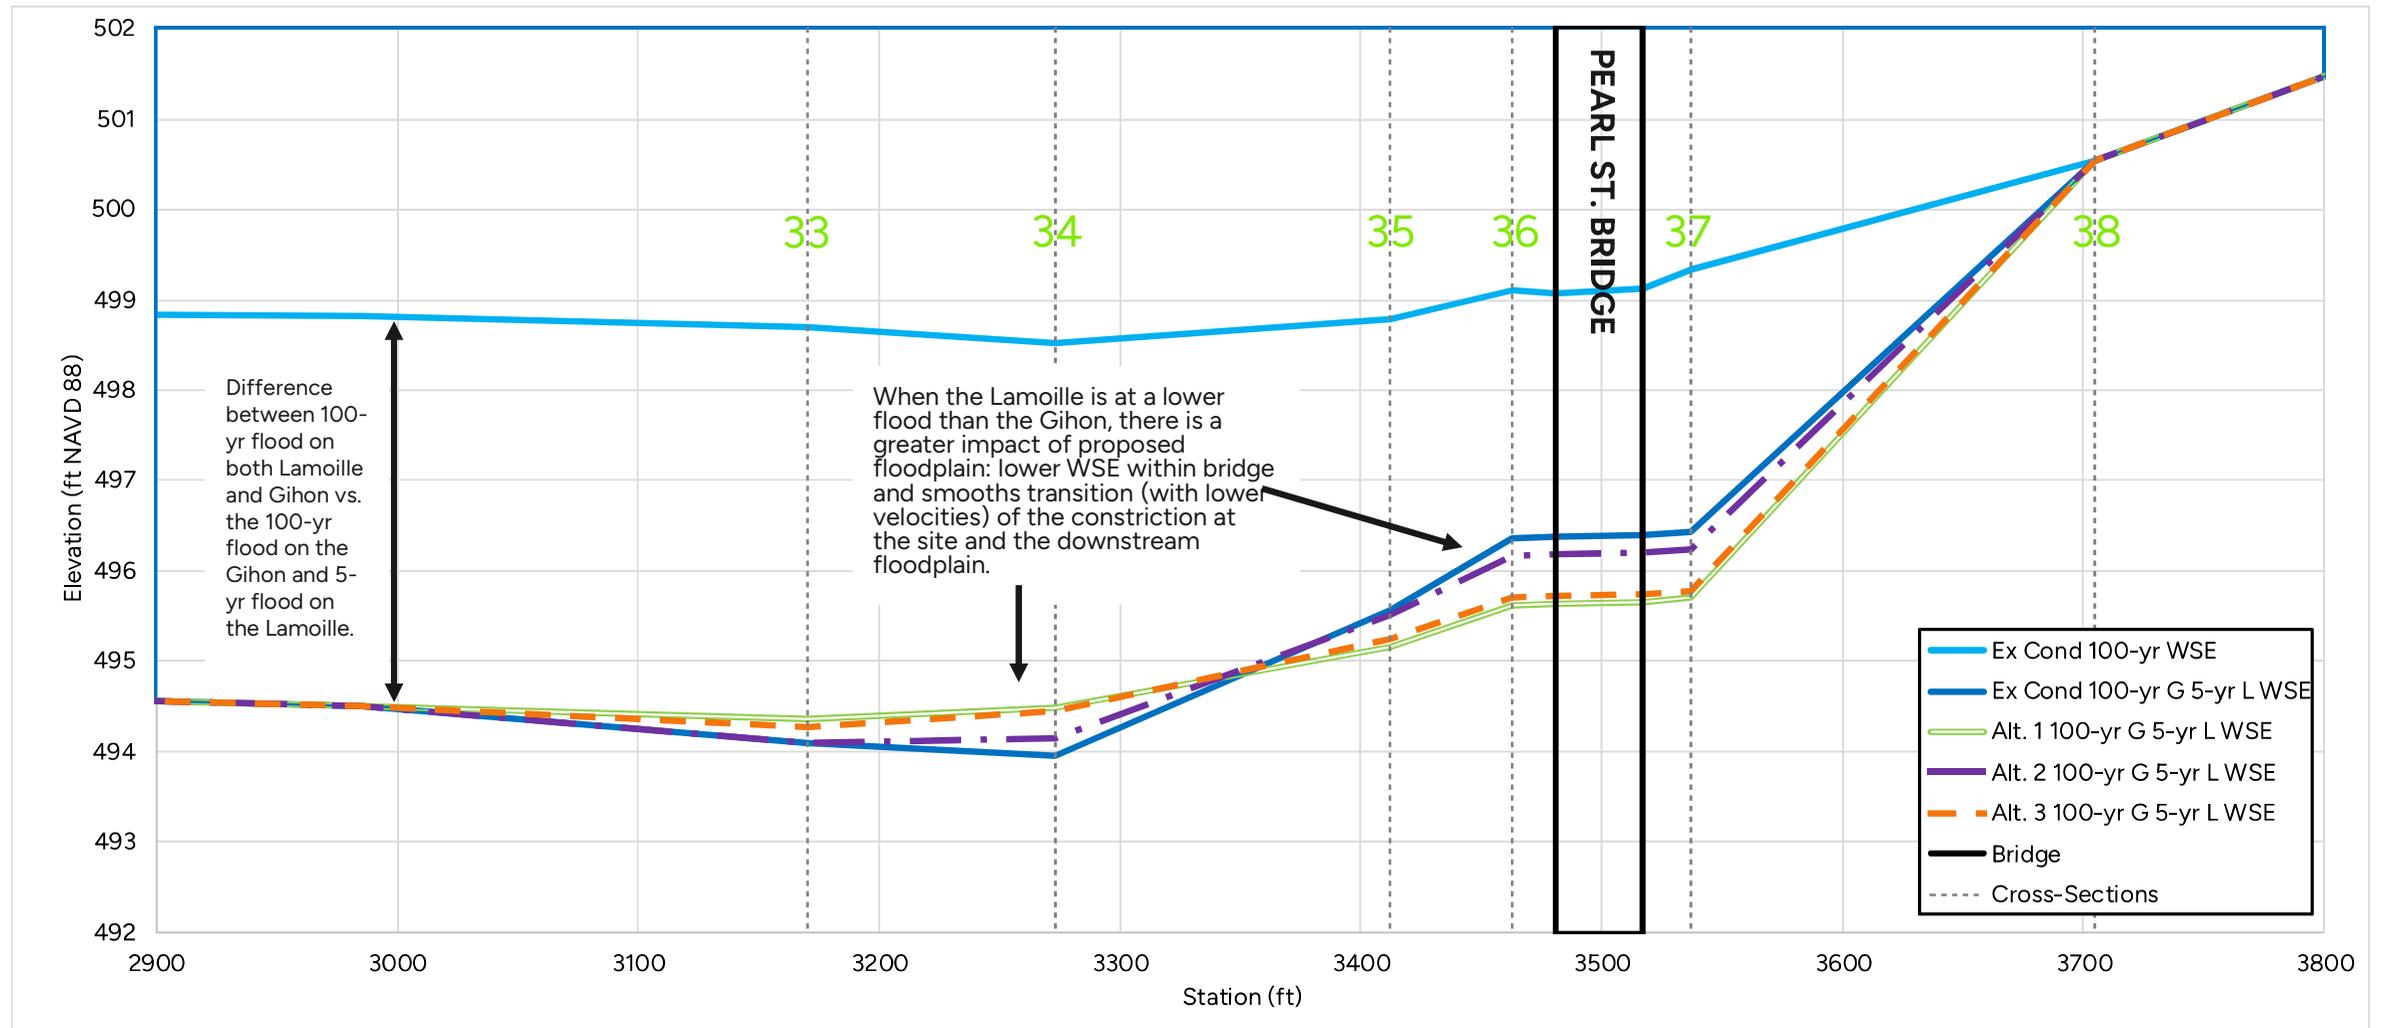
Longitudinal profile of Gihon river WSE when the **Gihon is at the 100-yr flood and the Lamoille is at the 5-yr flood** for existing conditions and alternatives.

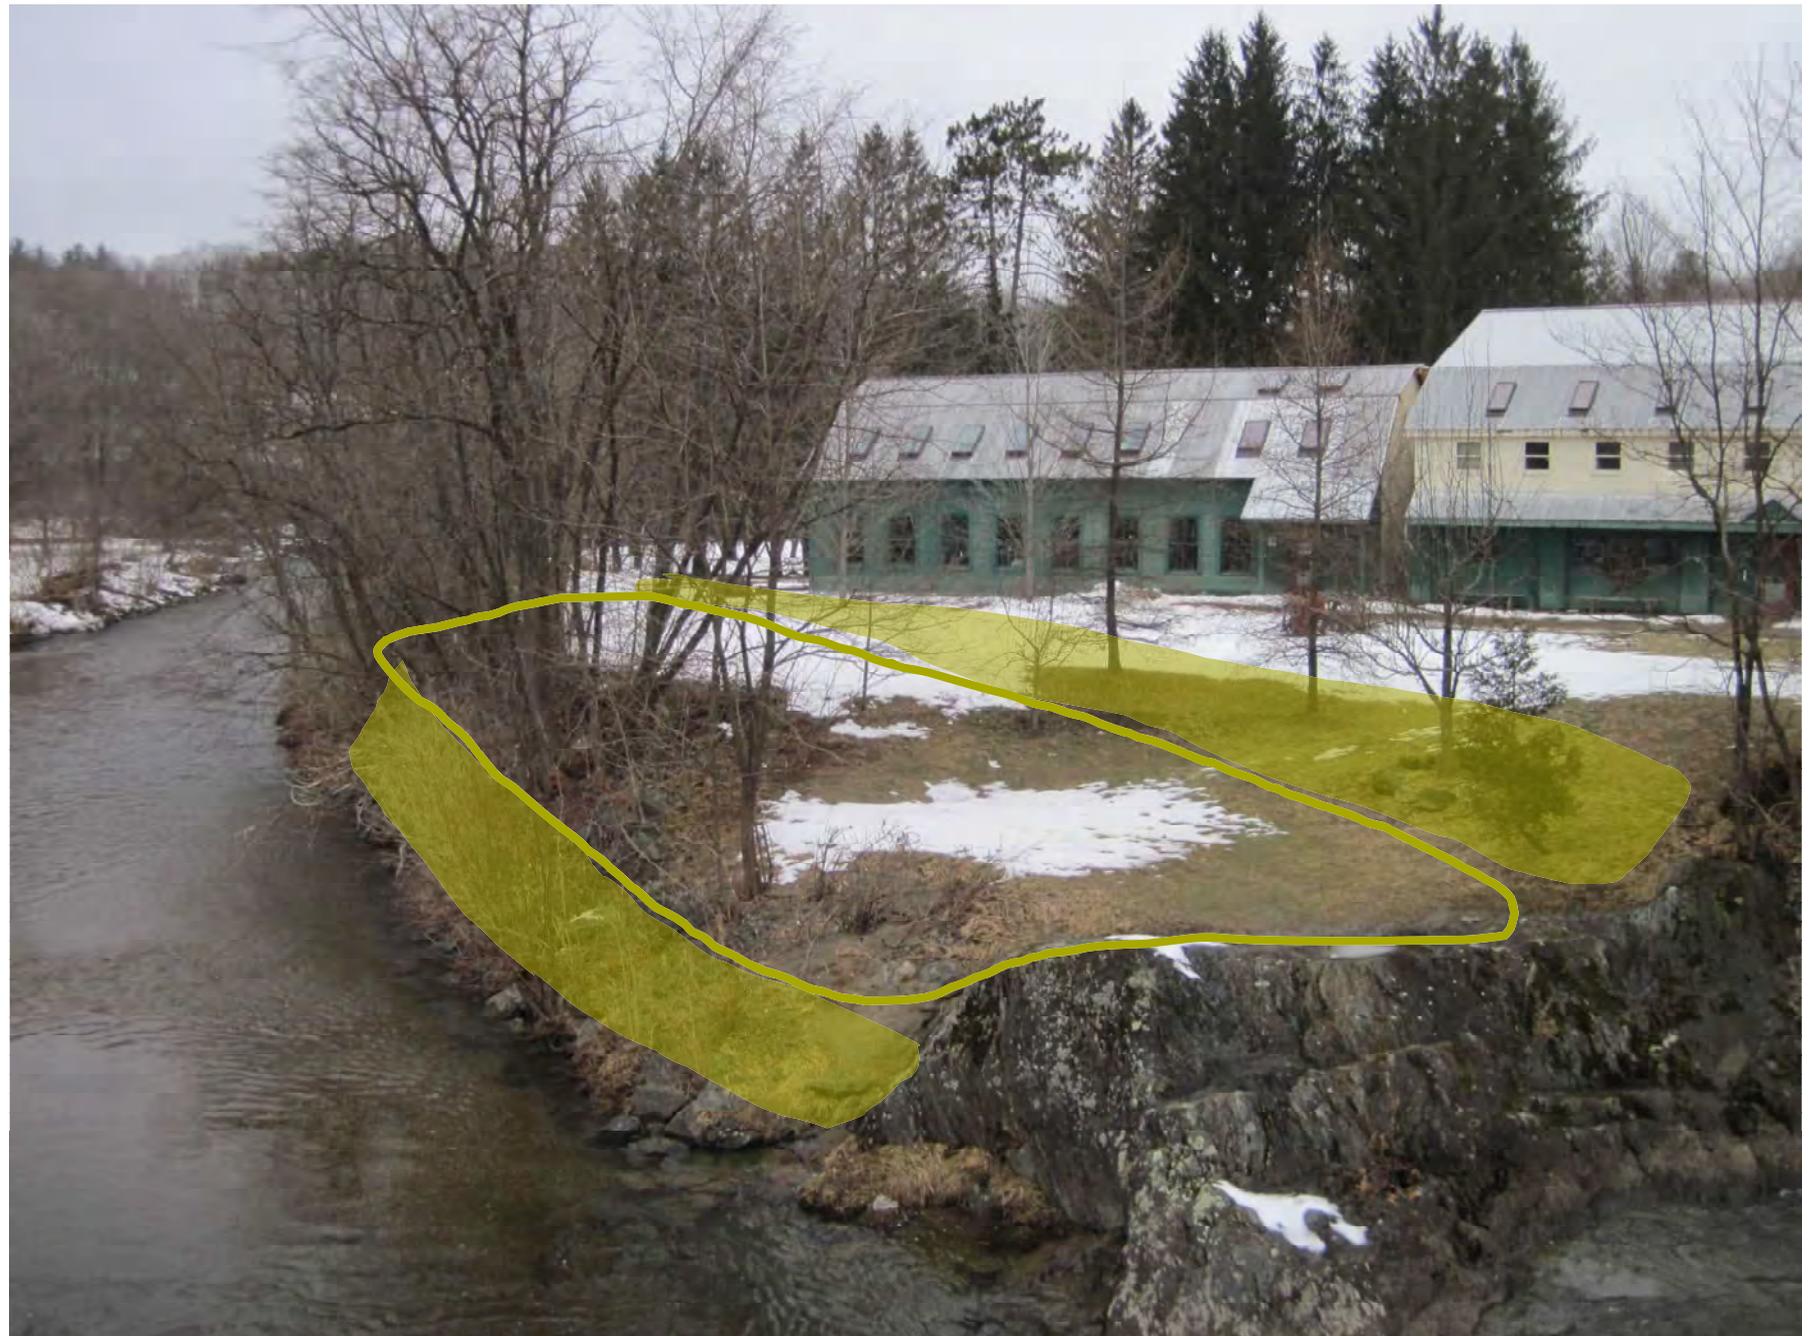
Alternative A:

Floodplain lowered to 2-yr flood

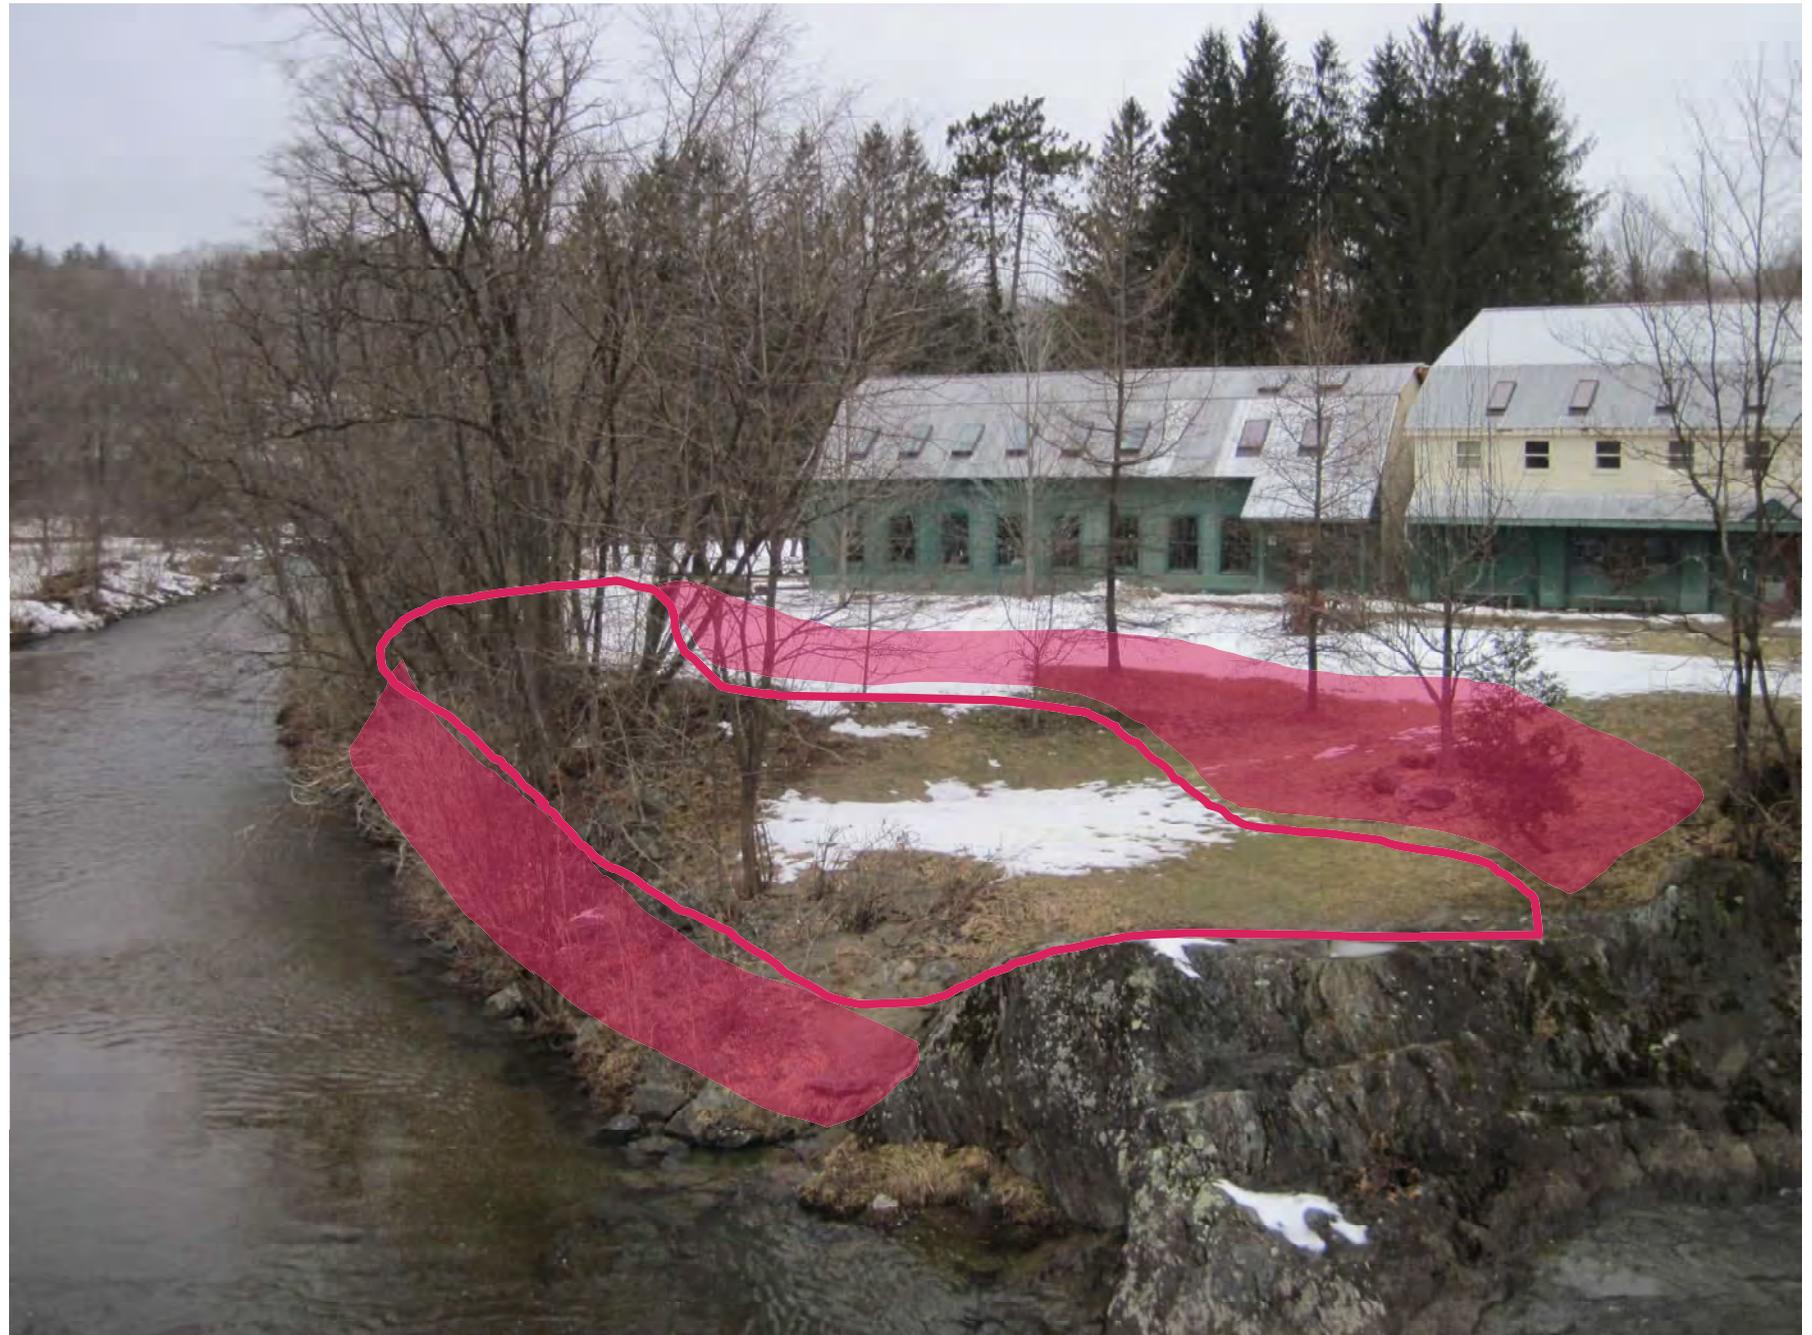
Alternative B:

Floodplain lowered to 2-yr flood
and preserves pollinator garden
and path

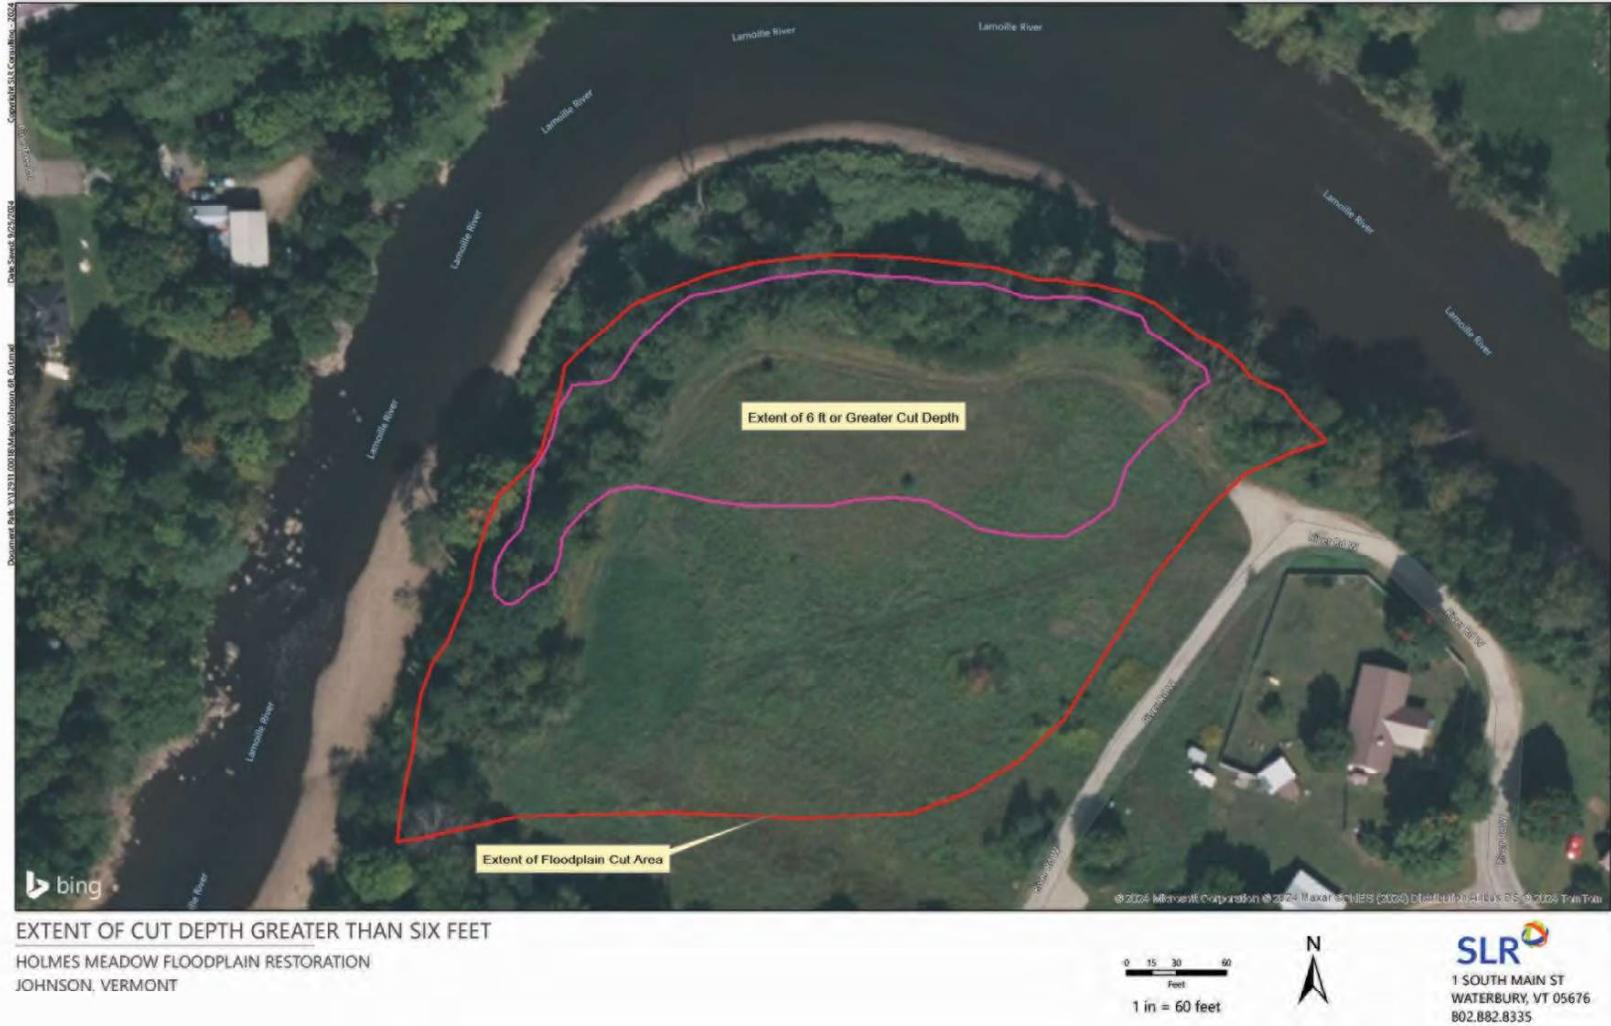
Figure 4. Aerial imagery of the proposed Holmes Meadow Floodplain area, Johnson, Vermont with an overlay of the extent of the depth within the floodplain cut areas.

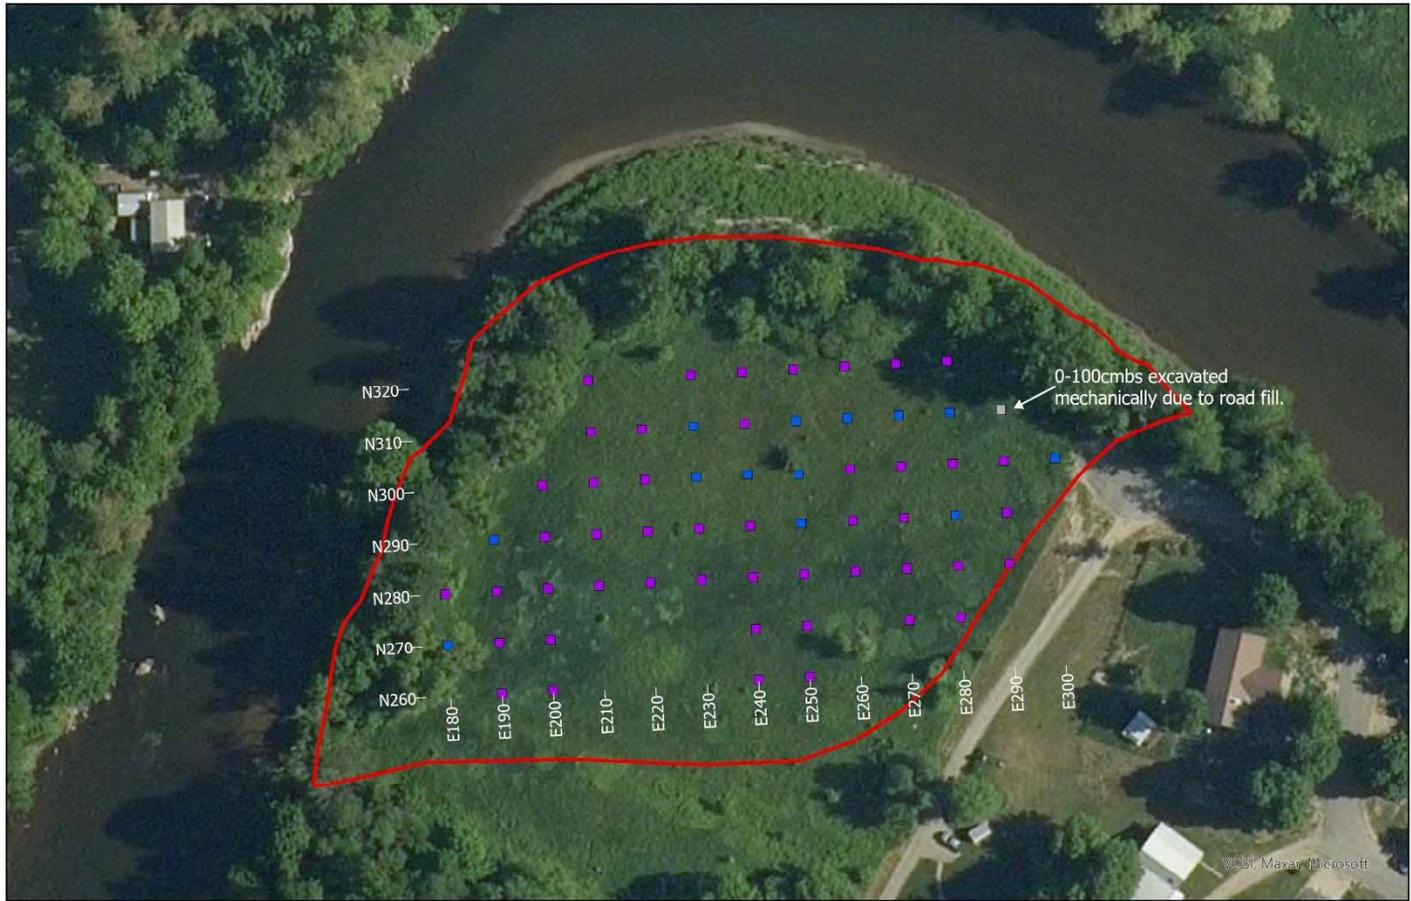
Figure 5. Aerial photo showing the location of Archaeological Phase I Survey test pits excavated from 0-100 cm below the ground surface within the Johnson Holmes Meadow Floodplain Restoration project area, Johnson, Vermont.

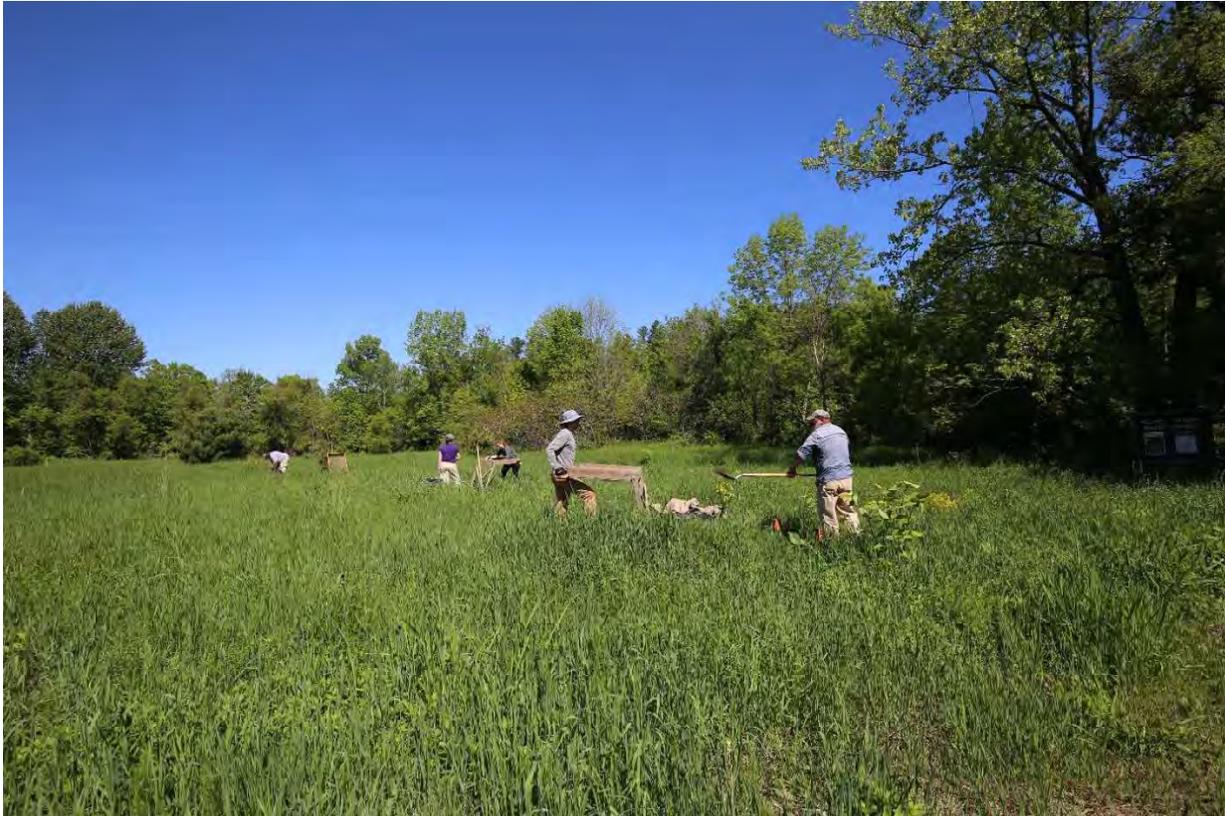
Figure 6. UVM CAP crew, facing west, excavating test pits from 0-100 cm below the ground surface within the Johnson Holmes Meadow Floodplain Restoration project area, Johnson, Vermont.

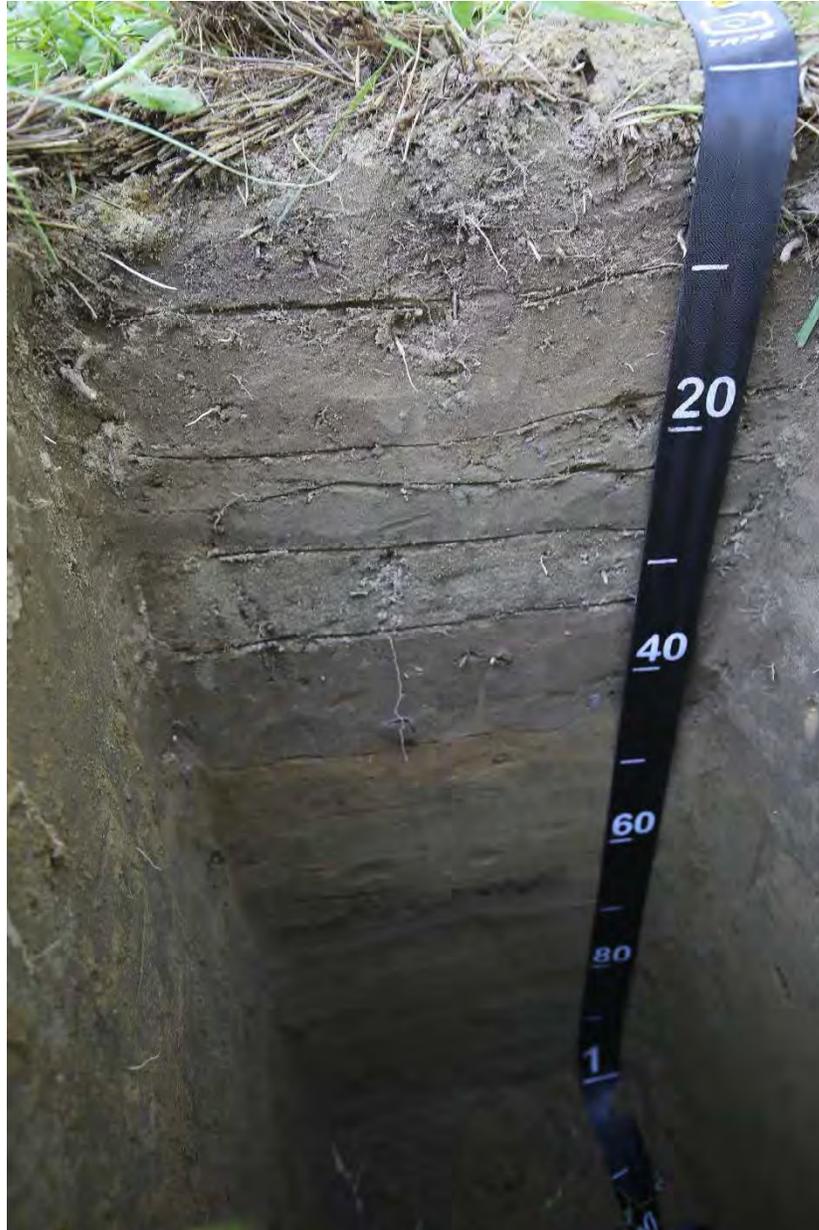
The first episode of test pits indicate a relatively recent series of depositional events formed the upper 100 cm of the project APE, with evidence of buried plow zone (Ap) horizons (Figure 7).

Figure 7. View of profile of 0-100 cm in test pit N300 E 200 within the Johnson Holmes Meadow Floodplain Restoration project area, Johnson, Vermont.

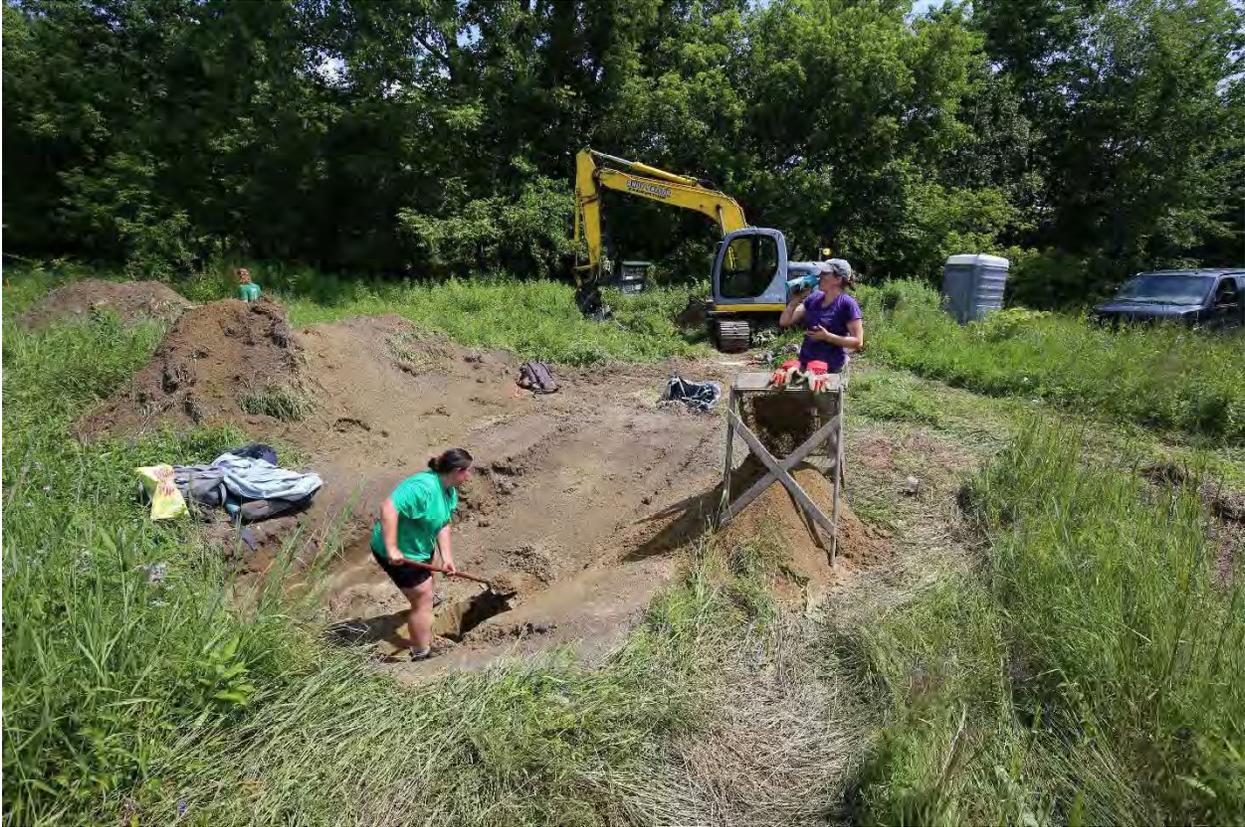
Given that no significant cultural deposits were recovered in the upper 100 cm of the project APE, the UVM CAP, in consultation with VDHP, worked in collaboration with a mechanical excavator to remove the upper 3ft from each test pit location, along with an additional safe work area. Following the mechanical removal of upper horizons at each location, each test pit was “resumed” and excavated to 200 cm below the ground surface (Figures 8 and 9). A total of 59 test pits were excavated to 200 cm below the ground surface (Figure 10). No precontact Native American artifacts were recovered, though a light density of historic period artifacts were recovered indicating a relatively young age for deeper depositional sequences across the project APE (see Figure10).

Figure 8. UVM CAP crew excavating test pit from 100-200 cm below the ground surface following removal of upper 3 ft of sediment with an excavator, facing north within the Johnson Holmes Meadow Floodplain Restoration project area, Johnson, Vermont.

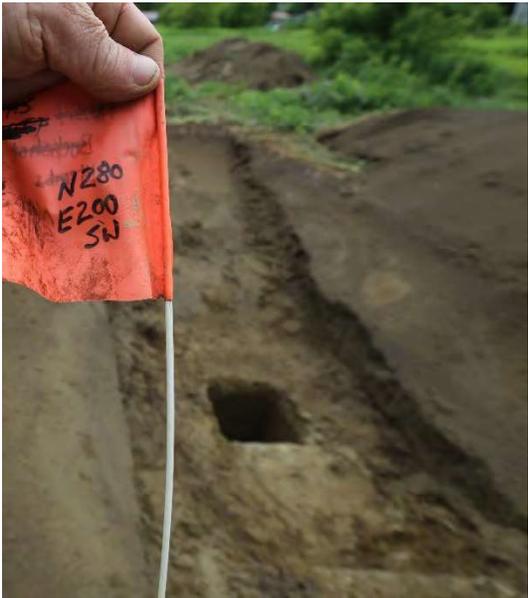
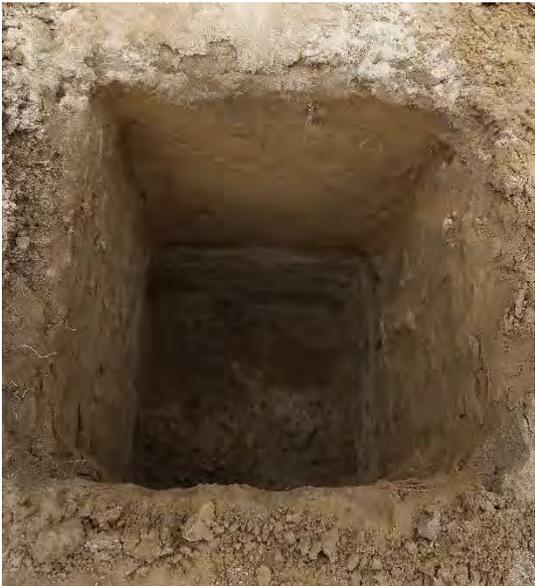
Figure 9. View of mechanically excavated trench / work area and 100-200 cm of test pits N280E200 within the Johnson Holmes Meadow Floodplain Restoration project area, Johnson, Vermont..

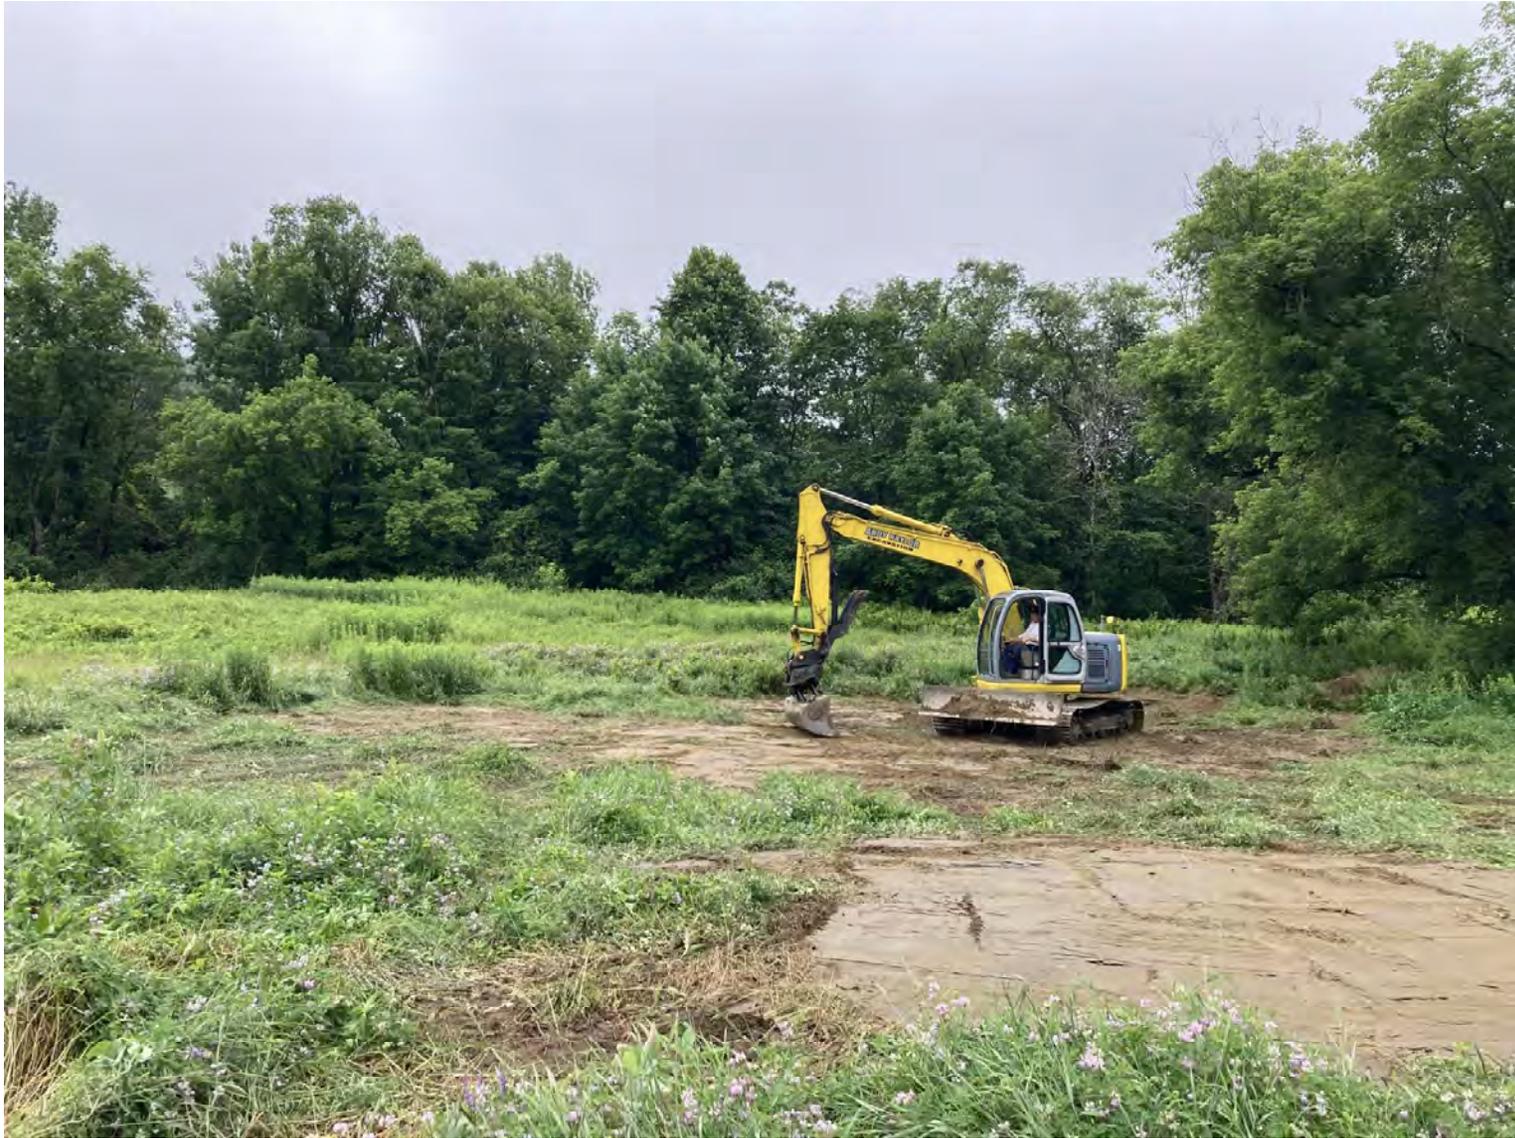
Photo 2. Exploratory Trenches and Test pits excavated during environmental review.

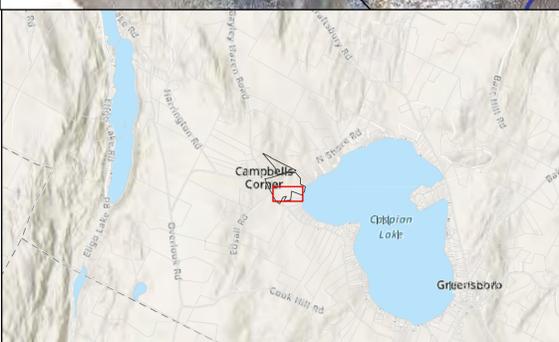
Barr Family LLC Stream & Wetland Restoration - Transect Analysis

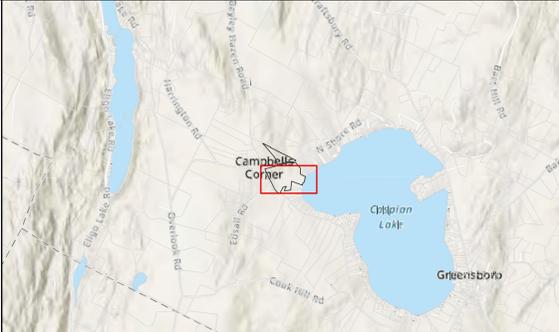
Barr Family LLC Stream & Wetland Restoration - 100% Concept - Overall Plan

100% DESIGN NOTES:
1. 100% DESIGN AS OF 9/27/2025 7:48 AM.

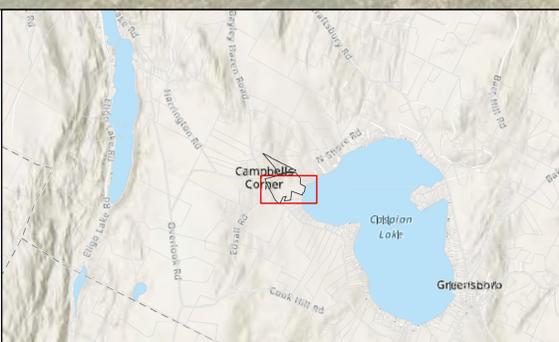
Barr Family LLC Stream & Wetland Restoration - 100% Design - Planting Plan

- 100% DESIGN NOTES:**
- 100% DESIGN AS OF 9/27/2025 7:49 AM.
 - THE PREDOMINANT NATURAL COMMUNITY IN THIS LOCATION HAS BEEN DETERMINED AS ALDER SWAMP WITH SOME ASPECTS OF NORTHERN WHITE CEDAR SWAMP.

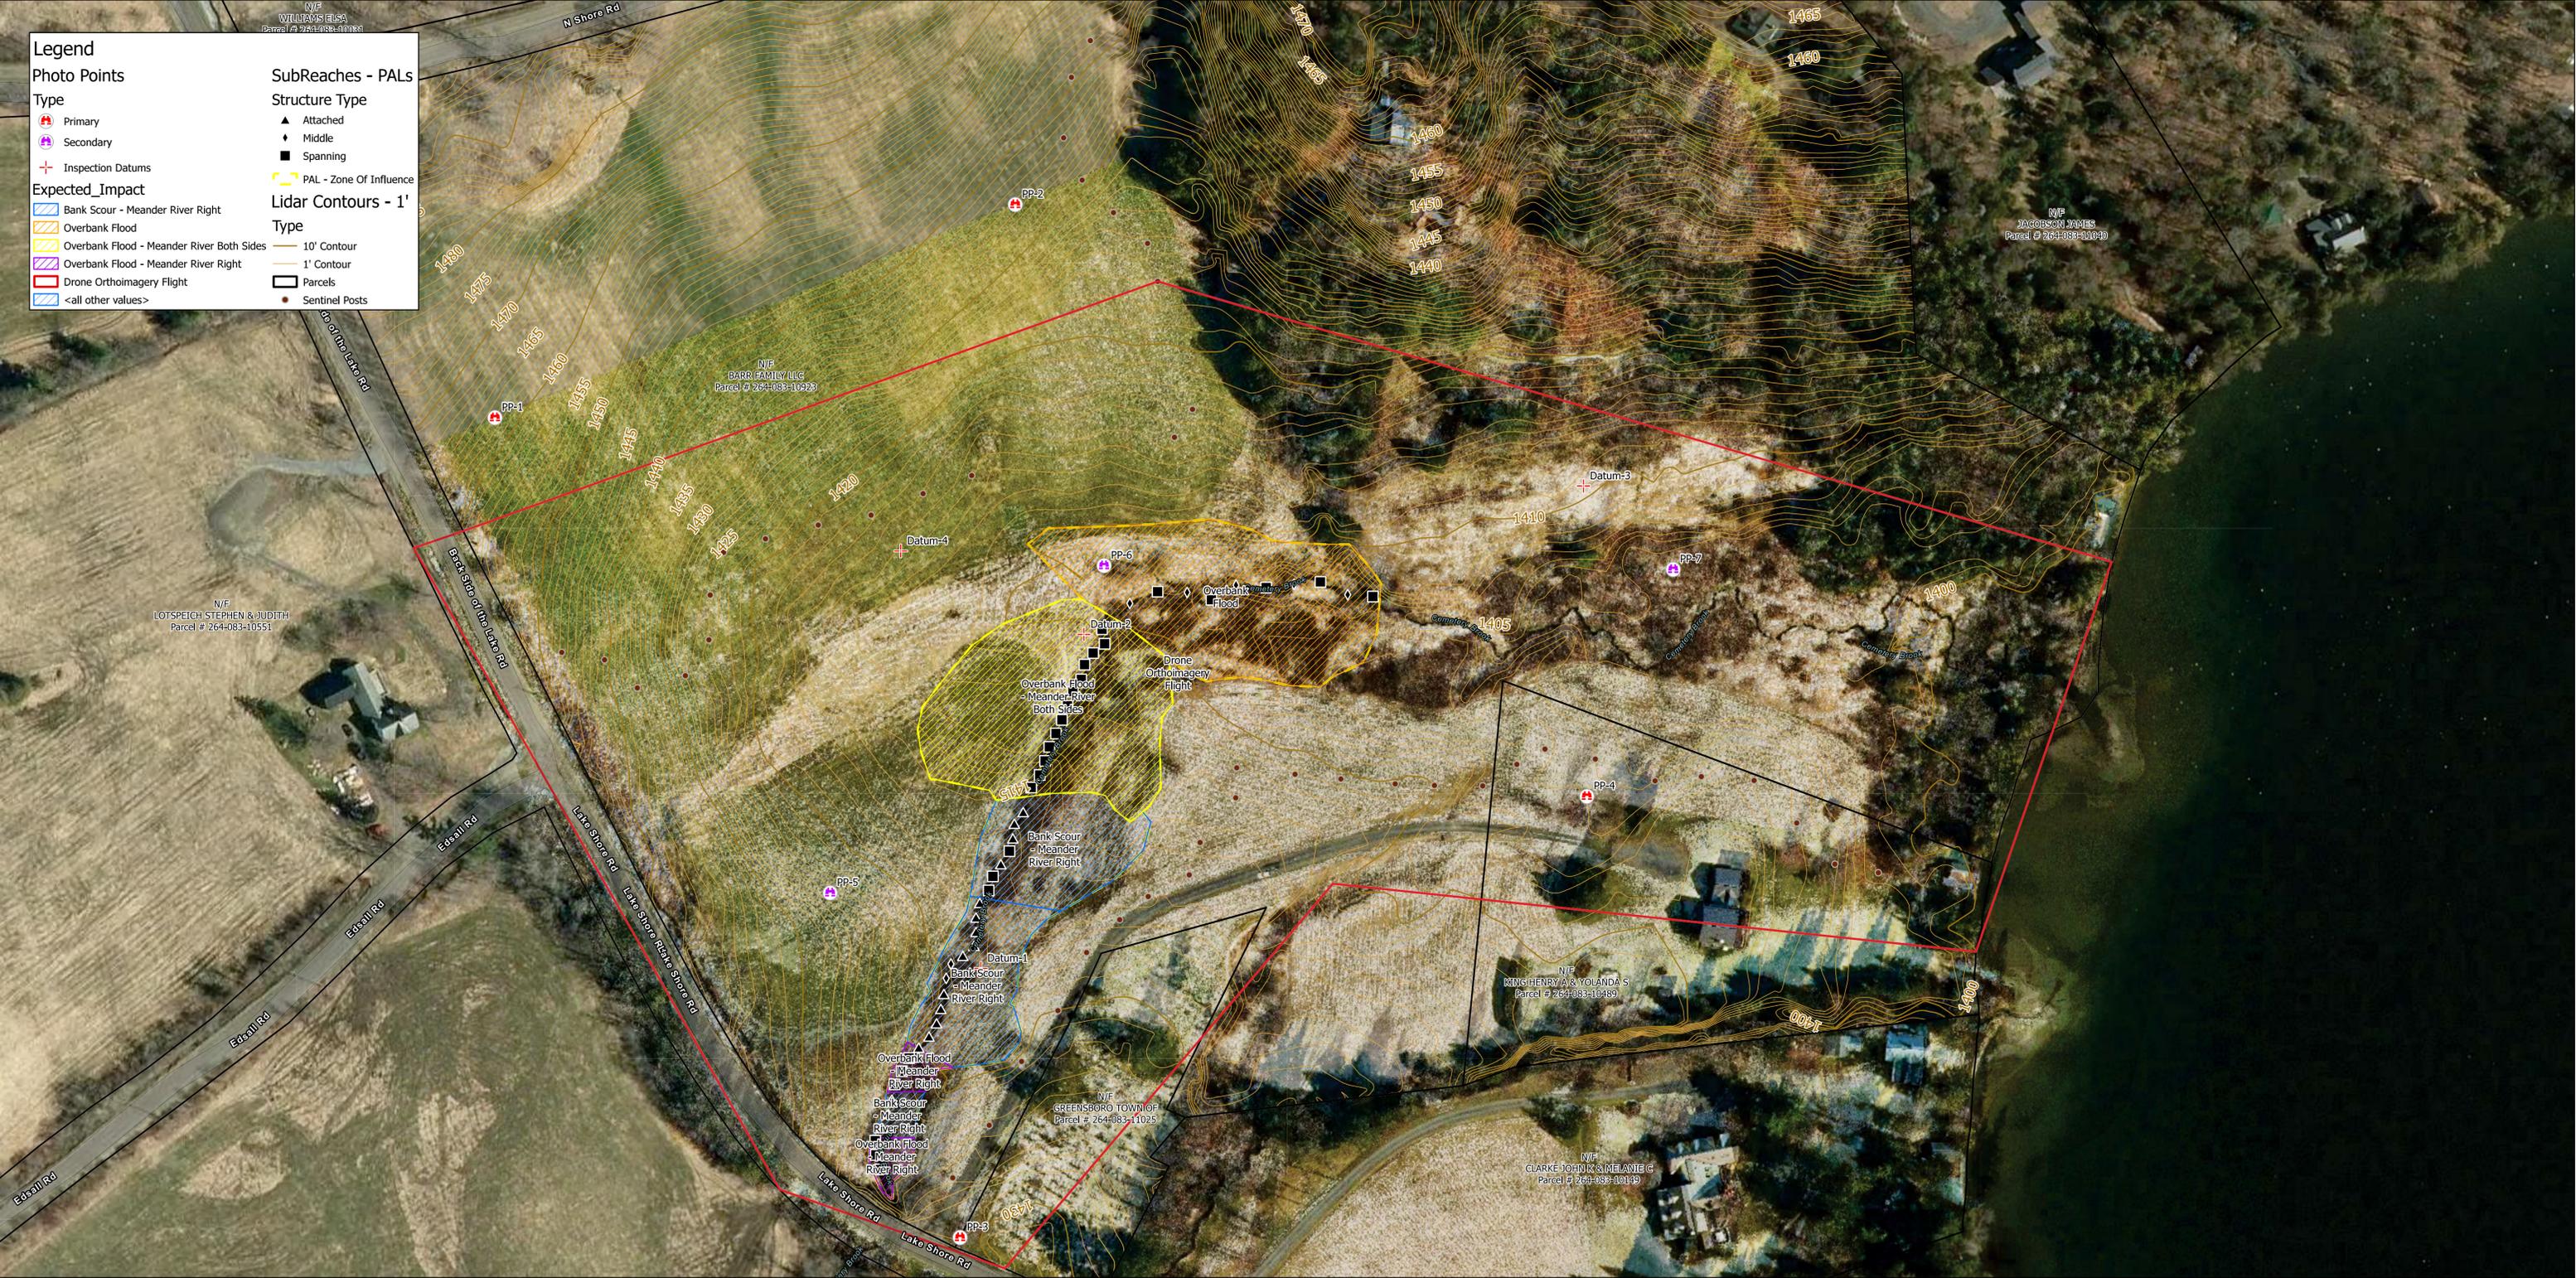
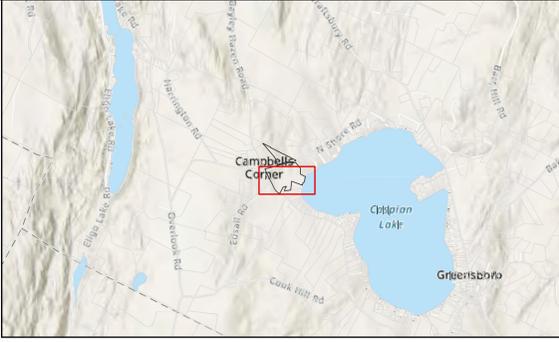
Stream & Wetland Restoration - 100% Design - Operation & Maintenance Inspection Points and Areas

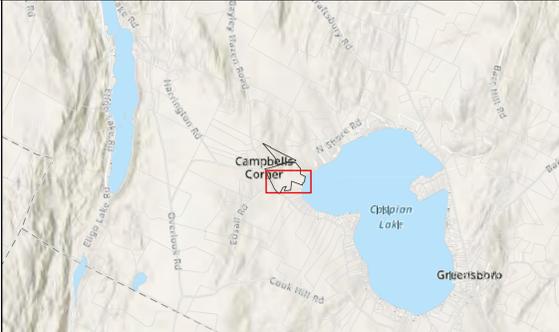
Stream & Wetland Restoration - 100% Design - Phosphorus Reduction Areas

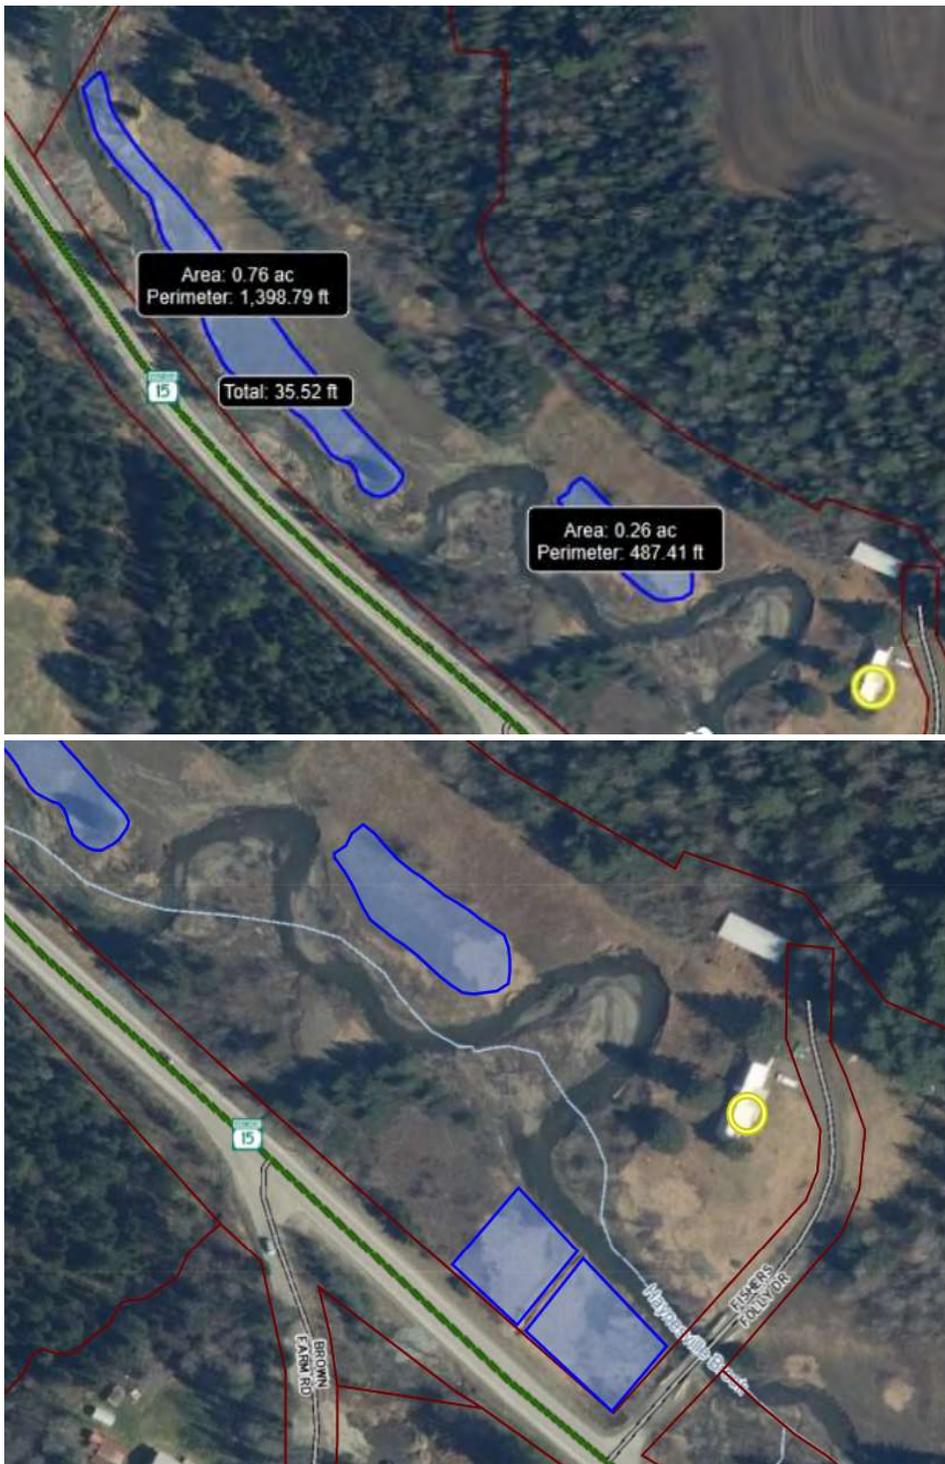
I wanted to circle back to this property for TFS. We had gotten your initial approval and input and just wanted to get another confirmation that we are good to go here. Below is the proposed planting-- we are starting 10-15 ft back from the streambank in the more dynamic areas and choosing species that are better fitted to occasional flooding. In addition, we are planting a section southeast of the originally discussed area, shown on the second screenshot below:
