US Route 7 / VT 104A Intersection and VT104A Bridge No. B1 over Arrow head Mountain Lake

In the Town of Georgia, Vermont

Table of Contents

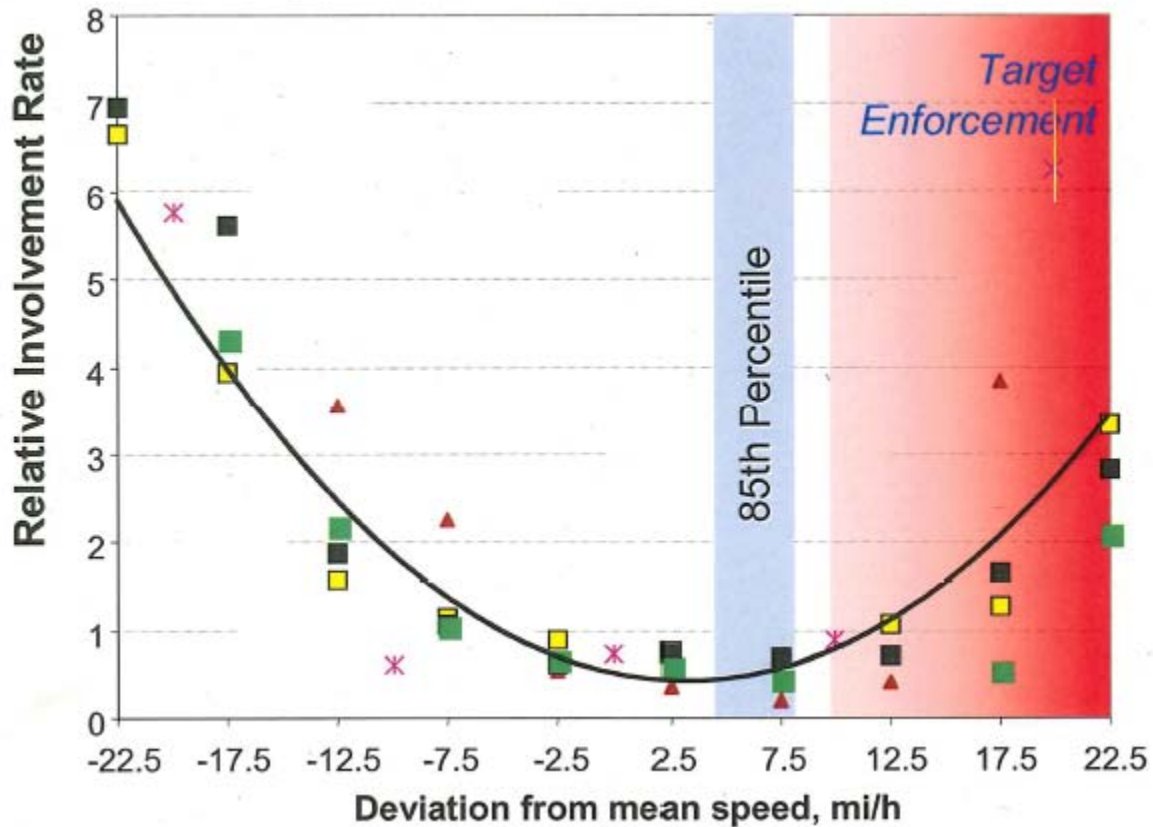
Figure 4, Targeted Enforcement Concept

Concept: From the enforcement side, if enforcement is to contribute to the safety of this road, it should be done according to the following concept suggested by FHWA. As depicted in Figure 4, Research has shown that the crash involvement rate increases as traveling speeds deviate from the 85th percentile speed. This means that targeting motorists that are traveling above the 85th percentile speed will apprehend motorists that are more likely to cause a crash. Crash involvement starts to increase more drastically 5 mph above the 85th. Applying this concept to this section of VT 104a means that the focus should be put on vehicles that are traveling at or above 56 mph.

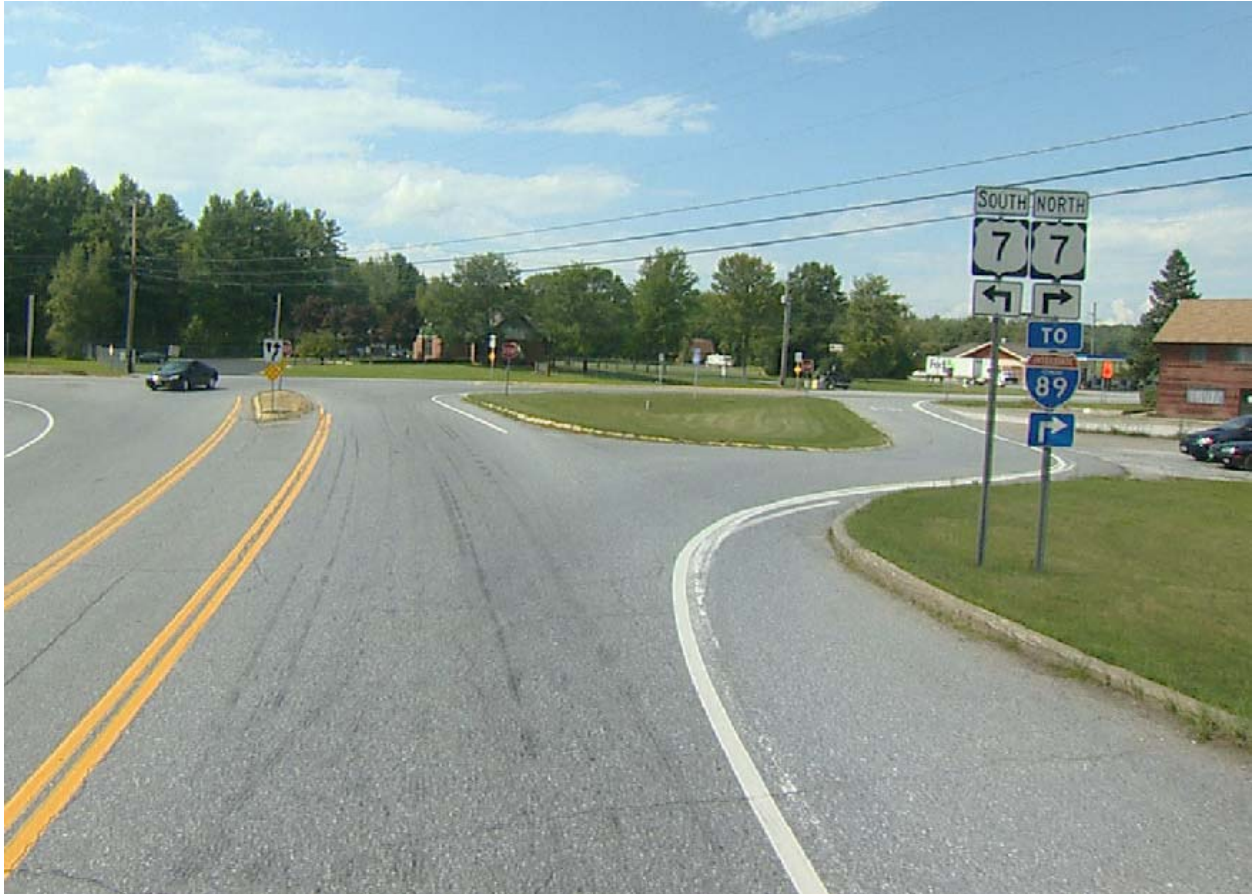
Figure 5a, VT 104a Approach to the US 7 Intersection (Visidata 2012)

Conflicting movements between a right turning truck and a second right turning vehicle caused by the de facto right turning lane on the VT 104a approach of the US 7 intersection. Conflicting movements between right turning vehicles on the VT 104a approach and right turning motorists that use the road that acts as some kind of a slip lane. See Figures 5a & 5b.

Observation	NWRPC	Town of Georgia	Sheriff	AOT Traf Ops	AOT District	AOT Traffic Design	AOT Traffic Pavement	Strategy	Decision Agree Reject	Planned Completion Date	Comments
<u>Problem #4</u> Conflicting movements between a right turning truck and a second right turning vehicle caused by the de facto right turning lane on the VT 104a approach of the US 7 intersection. Conflicting movements between right turning vehicles on the VT 104a approach and right turning motorists that use the road that acts as some kind of a slip lane.				X	X	X		Immediate to Mid Term Actions (within 24 months) Develop (and construct) a low cost project to strip and signs the approach as one left turn lane and one right turn lane (This will require modifying the island on the northeast corner of the intersection to accommodate trucks with a wider radius and possibly a truck apron as to not make the approach too wide. It will also be highly desirable to close off the access to what acts as a "slip lane")
