Richford Streetscape Audit Summary: 6/13/2022

Richford Streetscape Audit Points of Interest

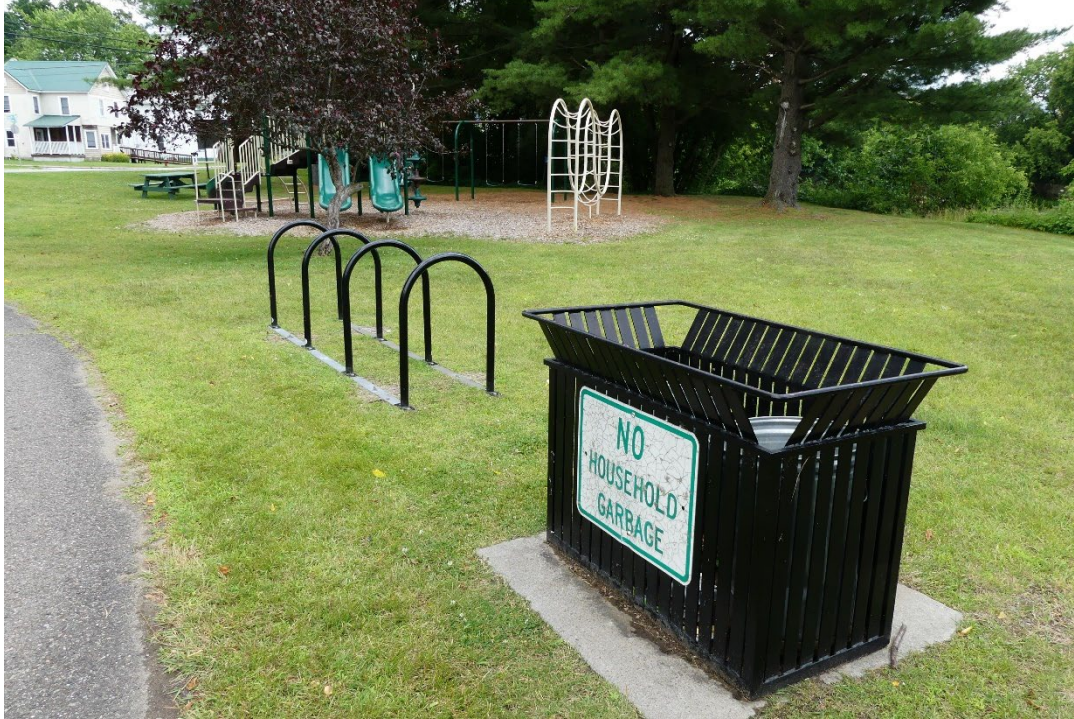
A: Davis Park is a positive feature of this area and serves as a local destination.

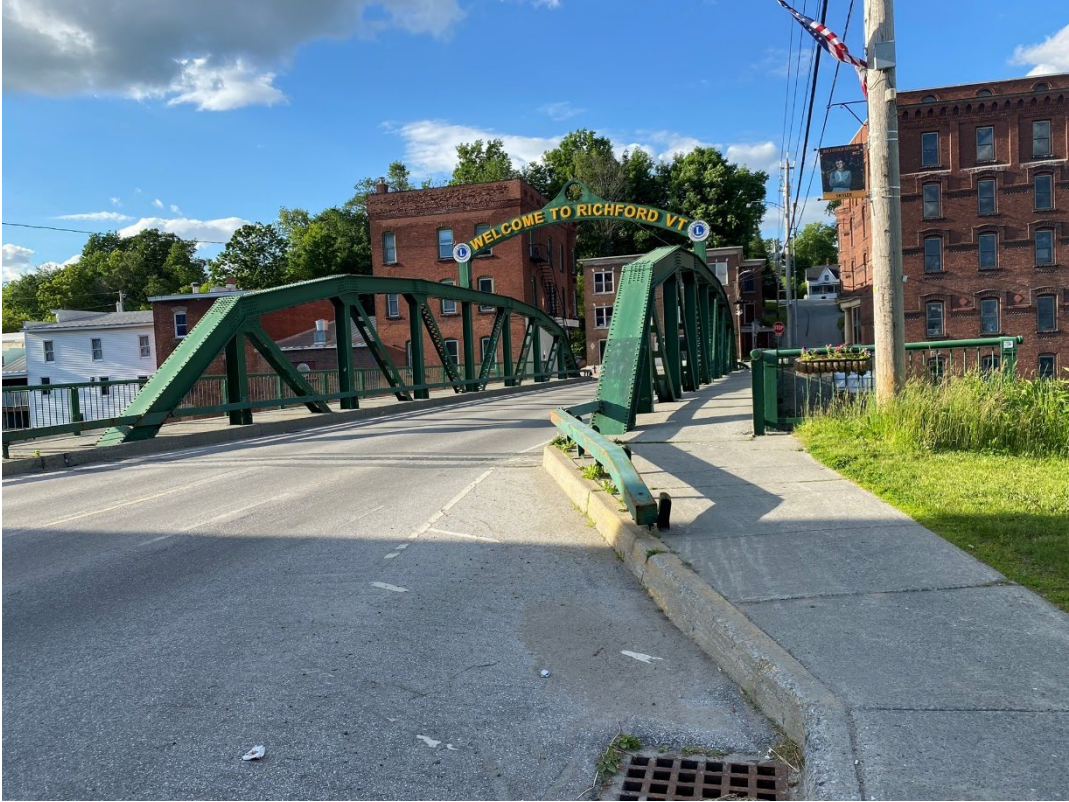
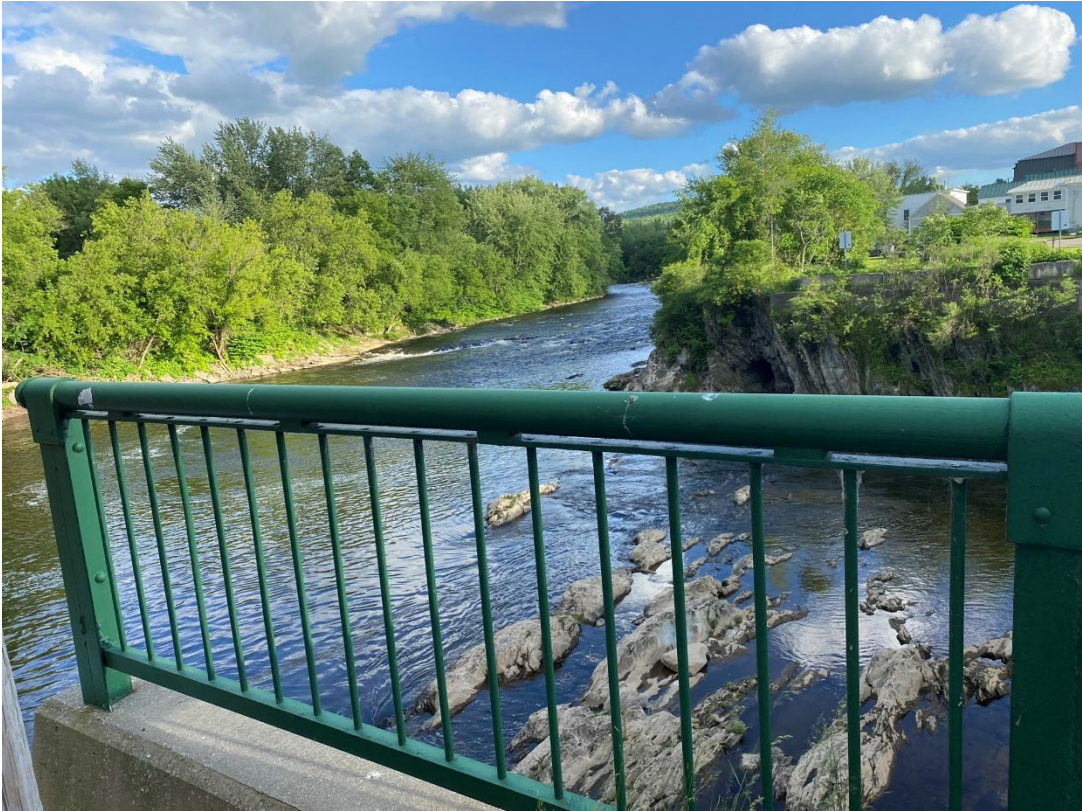
F: The Richford Main Street bridge and the views of the Missisquoi River along the bridge are positive defining features of Richford's downtown.

F: The Richford Main Street bridge and the views of the Missisquoi River along the bridge are positive defining features of Richford’s downtown.
